# **Aquatic Biodiversity Assessment**

## **Proposed Maintenance Management Plan for Laingsburg to Droerivier 132 kV Overhead Line, Western Cape.**

**Prepared for Zurtari (Pty) Ltd by Dr. Jackie Dabrowski**

**Confluent Environmental (Pty) Ltd**

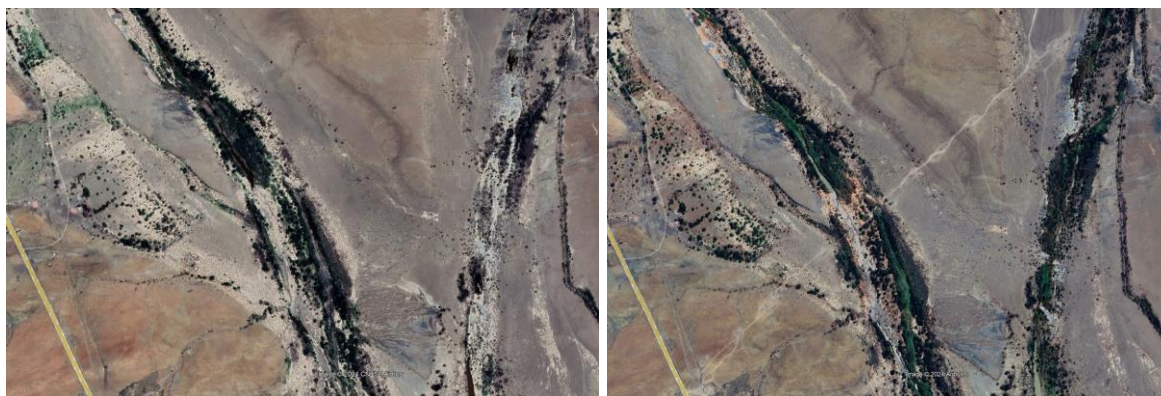
Figure 9. Comparative satellite image of the Koekemoer and Leeu Rivers at Leeu Gamka showing the landscape before maintenance (2021, left) and during maintenance when a dirt track became evident along the line (Feb 2024, right).

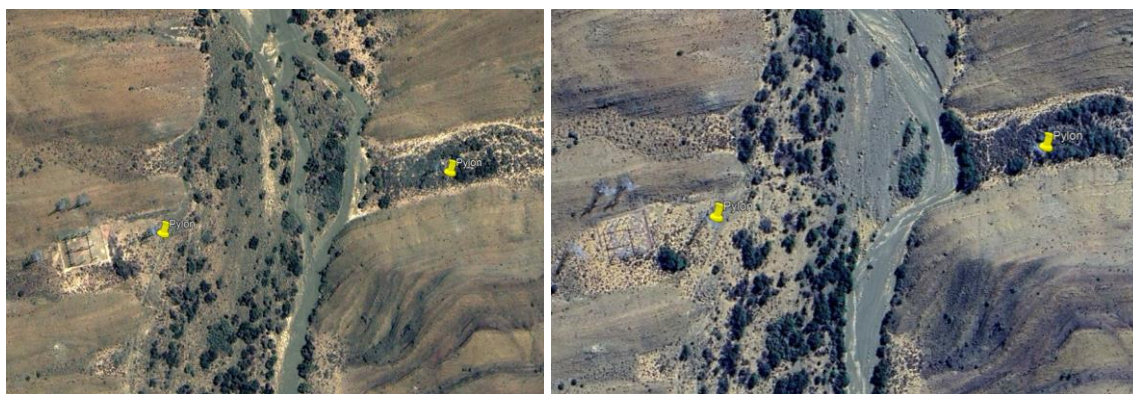
At the Geelbek River the western pylon is on the edge of the riparian zone, while the eastern pylon is located in dense vegetation in a drainage line with limited access (Figure 10). There are an additional 2 or three pylons in this drainage line. Should these pylons ever need replacement, they should be moved out the drainage line to a more accessible alignment and out of the drainage line. It must be noted that while the drainage line wasn't inspected during the site visit, it is more than likely that it seldom (If ever) experiences flowing surface water. Water movement is likely via interflow, but this can still impact pylon foundations. There is some minor soil disturbance around the substation near the western pylon in 2003, but apart from altered channel morphology and sediment deposition the site appears similar in 2024 to 2003.

Figure 10. Pylons at the crossing for the Geelbek River located showing the eastern pylon in a densely vegetated watercourse in 2003 (left) and 2024 (right).

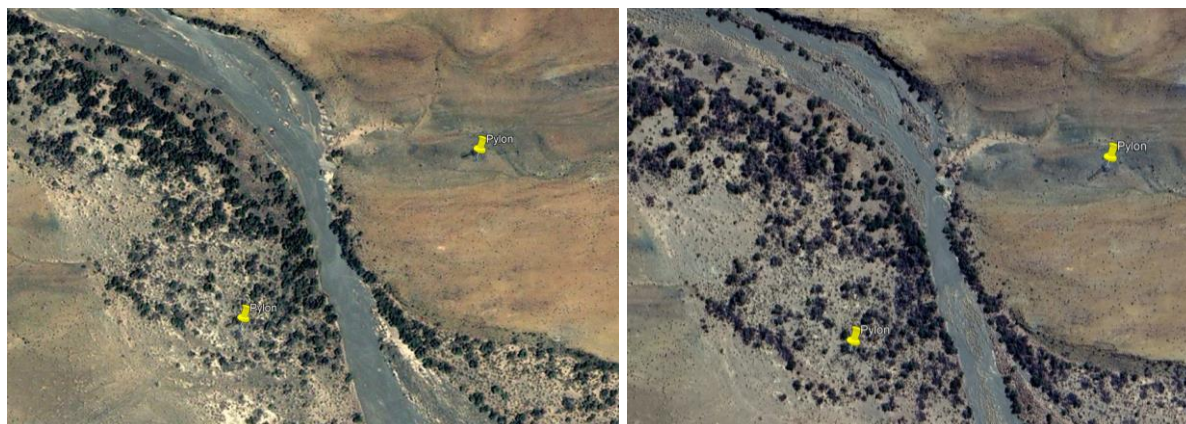
The crossing at Klip River, southwest of Leeu Gamka, is the only one of the larger drainage lines where the pylons could be better located. The southern one is in the riparian zone although not close to the channel, and the north-eastern pylon is possibly located in an overland wash zone, although these are not defined as a watercourse in terms of the NWA.

This may however render the pylon more susceptible to erosion or destabilisation of the foundations.

Figure 13. The Klip River indicating the two nearest pylons at the crossing (yellow pins) in 2003 (left) and 2024 (right).

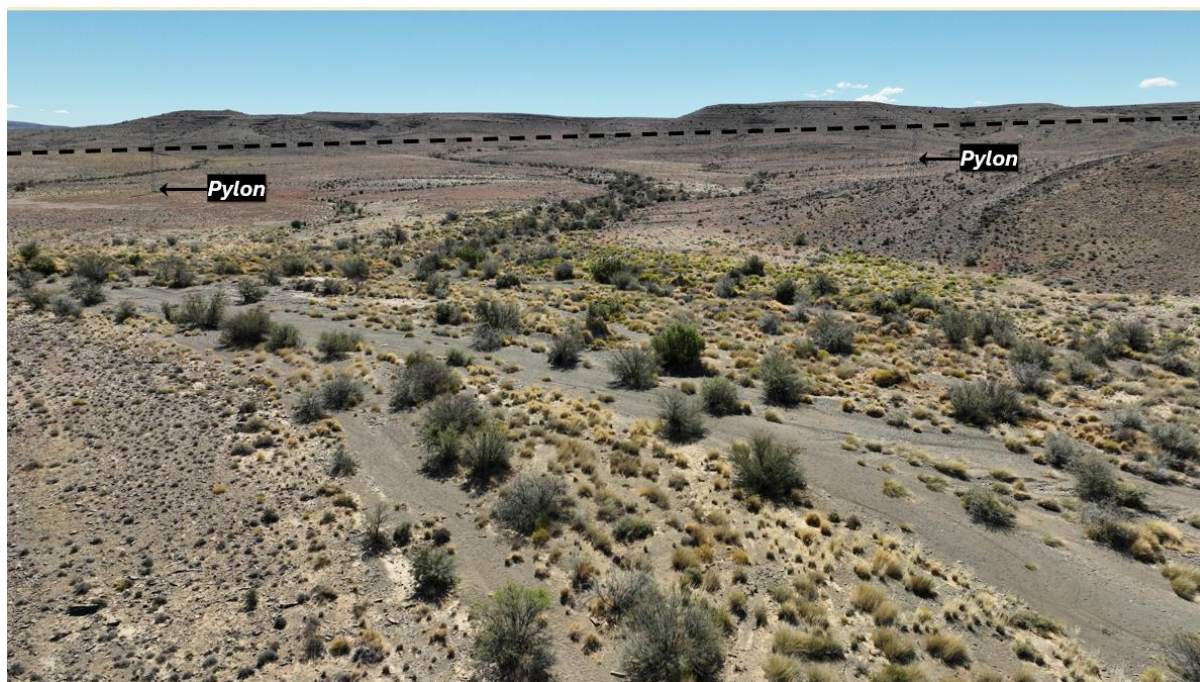
At every point the power line was observed crossing watercourses the pylons were located outside of channels or direct flow paths and for the most part were not located in riparian zones (Figure 14). This was also observed in the satellite imagery for most of the larger river crossings, except for the Klip River (Figure 13). Vehicle access to the line and pylons is difficult or impossible in many areas, meaning that any maintenance would require the creation of new tracks (Figure 14).

Figure 14. Typical power line route (dashed line) approximately 50 km east of Laingsburg across an unnamed tributary of a medium-sized drainage line. Pylons are indicated outside of watercourses and riparian zones and access is very limited for maintenance with no clear existing tracks (Coordinates: 33° 4'31.23"S, 21°25'42.52"E)

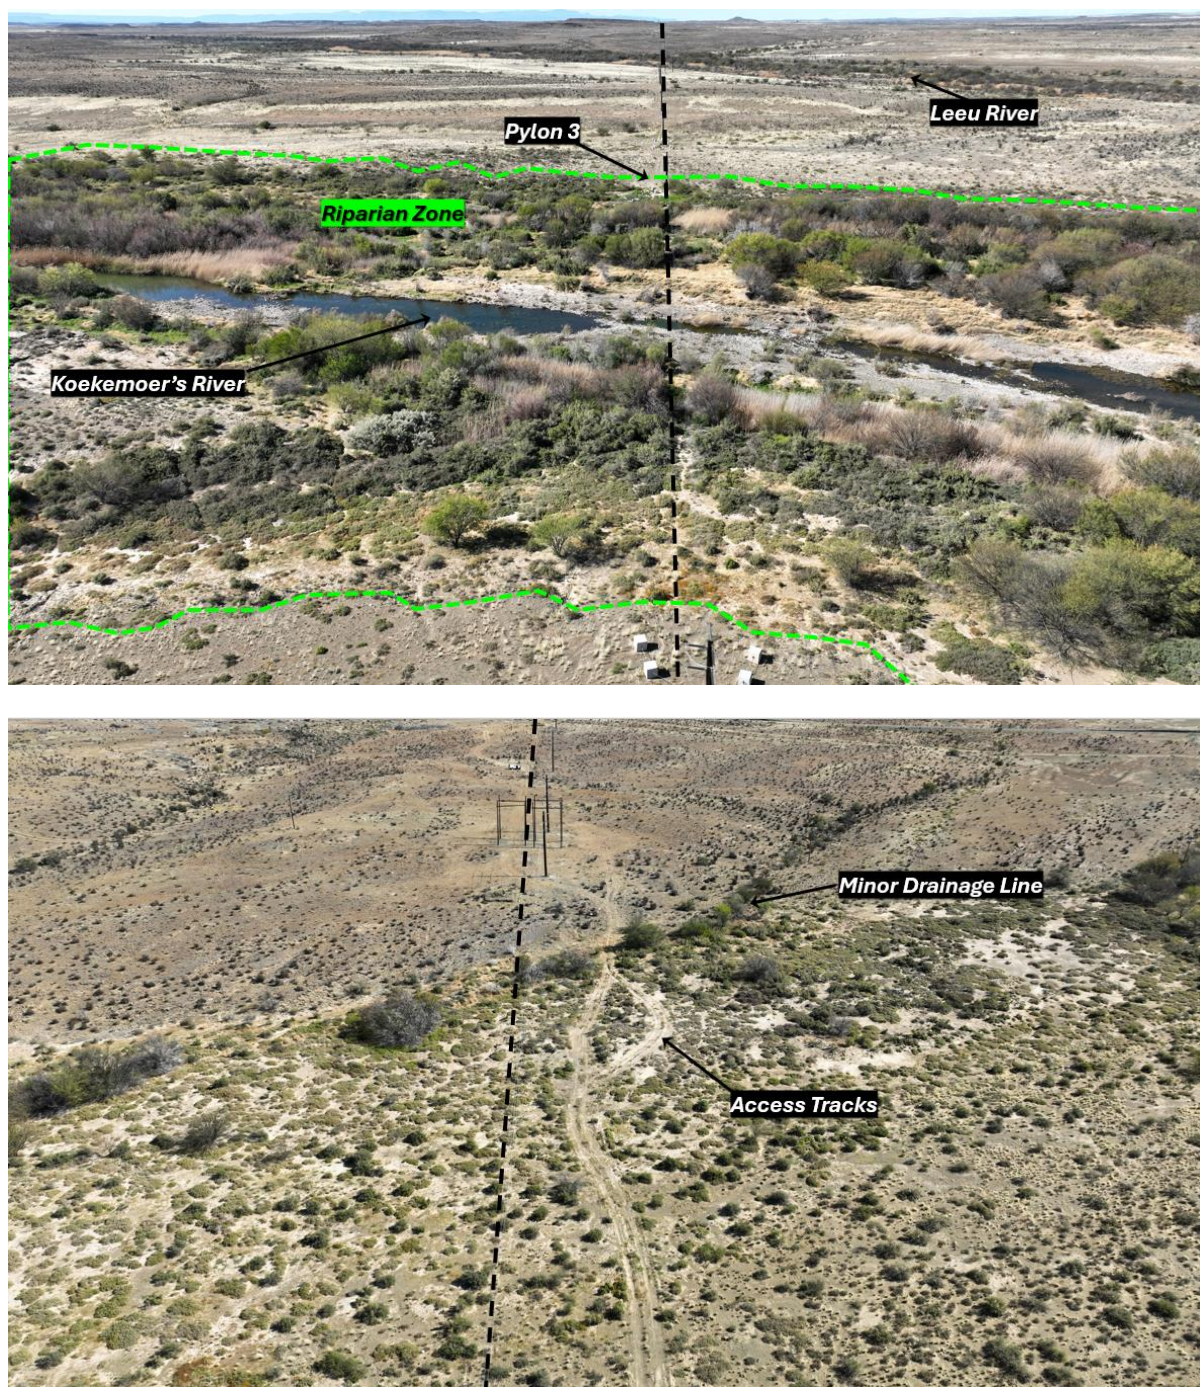
At Leeu Gamka the only pylon proposed near the edge of the riparian zone is Pylon 3 and the location is located further beyond (east) of the riparian vegetation, which is a positive factor as it will mean reduced habitat disturbance. The Koekemoer's River had the strongest flowing water of all the rivers assessed during the site visit with clear water that appeared to have minimal impacts. A new track created to access the line for emergency repairs has a minimal impact at small drainage line crossings but there is evidence that tracks could be further minimised by ensuring only a single track is used, instead of creating additional unnecessary tracks (Figure 18).

Figure 18. Annotated drone photos of relevant points at Leeu Gamka. Dashed black line indicates the power line in all photos.

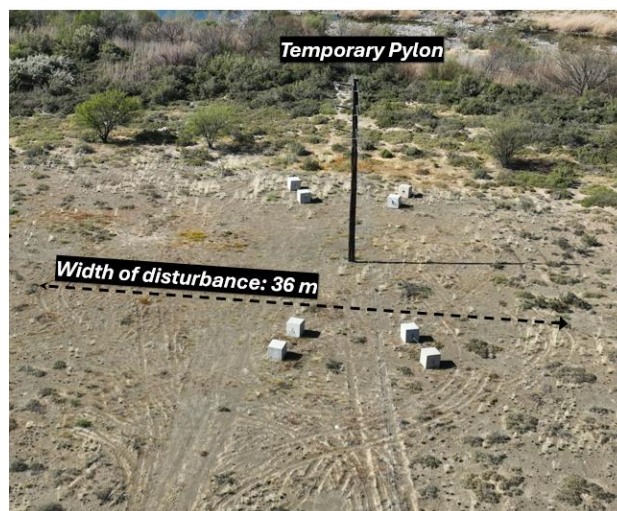
Although not located in the riparian zone, the disturbance footprint to erect a temporary pylon on the edge of riparian vegetation was checked in terms of its extent (Figure 19). The width of the servitude is 32 m and the extent of vehicle tracks around the pylon was 36 m wide. Therefore, steps must be taken to ensure the disturbance footprint is kept within the servitude area and minimised as far as possible.

Figure 19. Temporary pylon adjacent to the riparian zone of the Koekemoer's River showing the width of disturbance (vehicle tracks and disturbed/cleared vegetation).

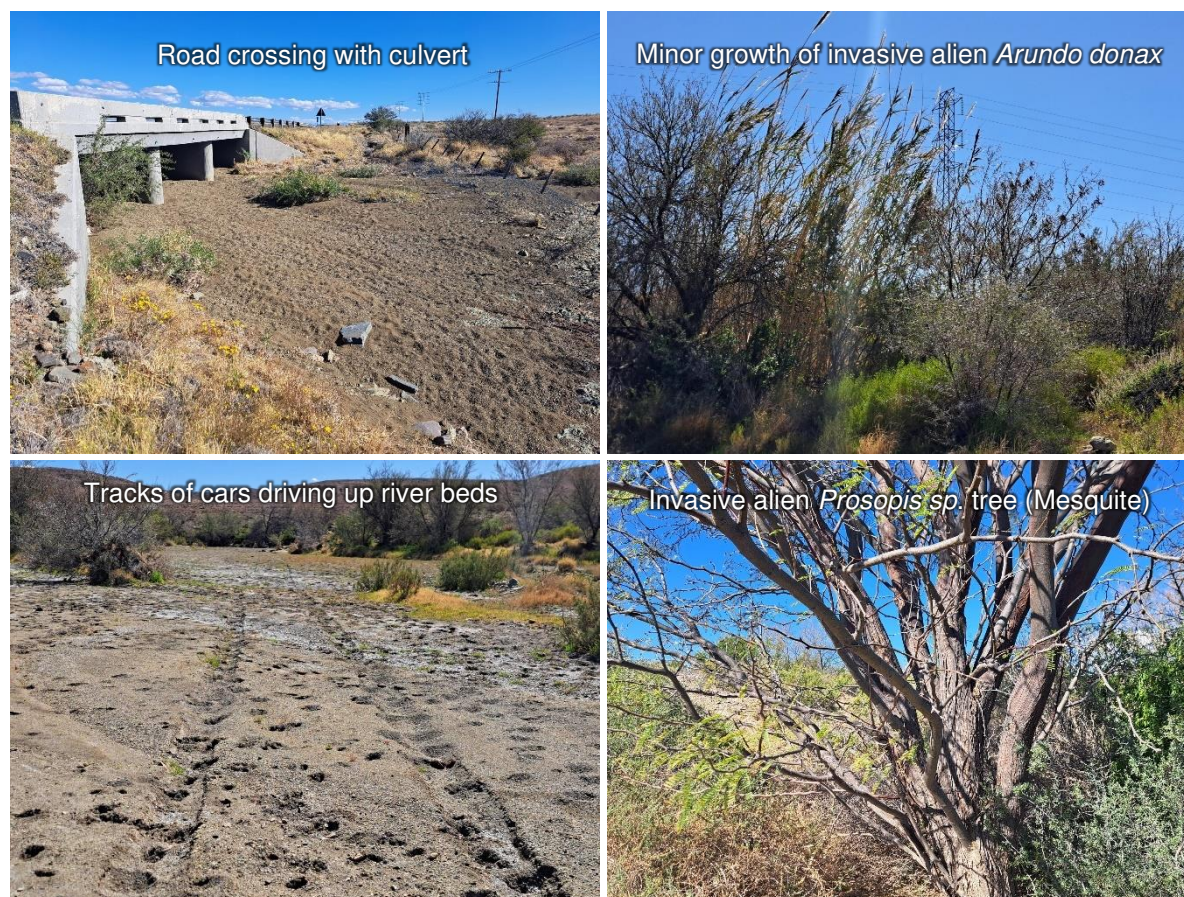
All of the drainage lines and rivers assessed were in a good to excellent condition and would be rated as **A/B which is in a Natural to Largely Natural** condition according to the Index of Habitat Integrity. There are minor impacts such as alien vegetation, but only two species were observed during the site visit. One was an individual *Prosopis sp.* tree (Mesquite) and *Arundo donax* (Spanish reed) was observed at the Bloed River in a small area. Areas of more significant invasion including other species are likely present, but were not observed during the site visit. Additional impacts are mainly related to existing linear infrastructure including the N1 highway (and other road crossings) and the railway line which includes bridge crossings over the larger rivers. Given the remoteness of most of the rivers there is very little rubbish dumping and most litter is windblown. As there is no permanent water in most watercourses there are no alien invasive aquatic animals or macrophytes (aquatic plants) expected. In most cases the riparian vegetation is in a natural state and little to no erosion is evident.

Figure 22. Photos of some impacts typically affecting the Present Ecological State of watercourses crossed by the powerline.

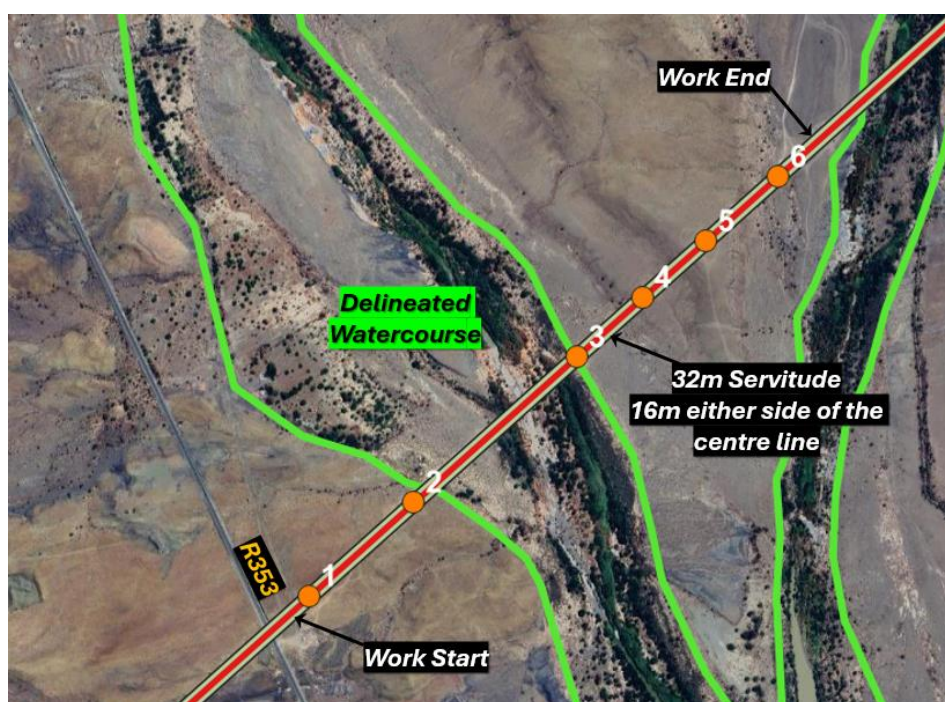
Figure 23. Annotated satellite image of the Leeu Gamka site indicating the extent of maintenance actions, location of pylons to be maintained, main access road and Eskom servitude. All shown in relation to the delineated watercourse.

- The Eskom servitude is 32 m across the width of the line (16m either side) and is indicated.
- The main access road is the R353
- The delineated watercourse will be a No-Go area for materials stockpiling and heavy machinery/vehicles for the duration of the maintenance work. This must be indicated with clear signage by the construction / maintenance manager.

- The only activity that can take place across the watercourse is stringing with as low a footprint of disturbance as possible.

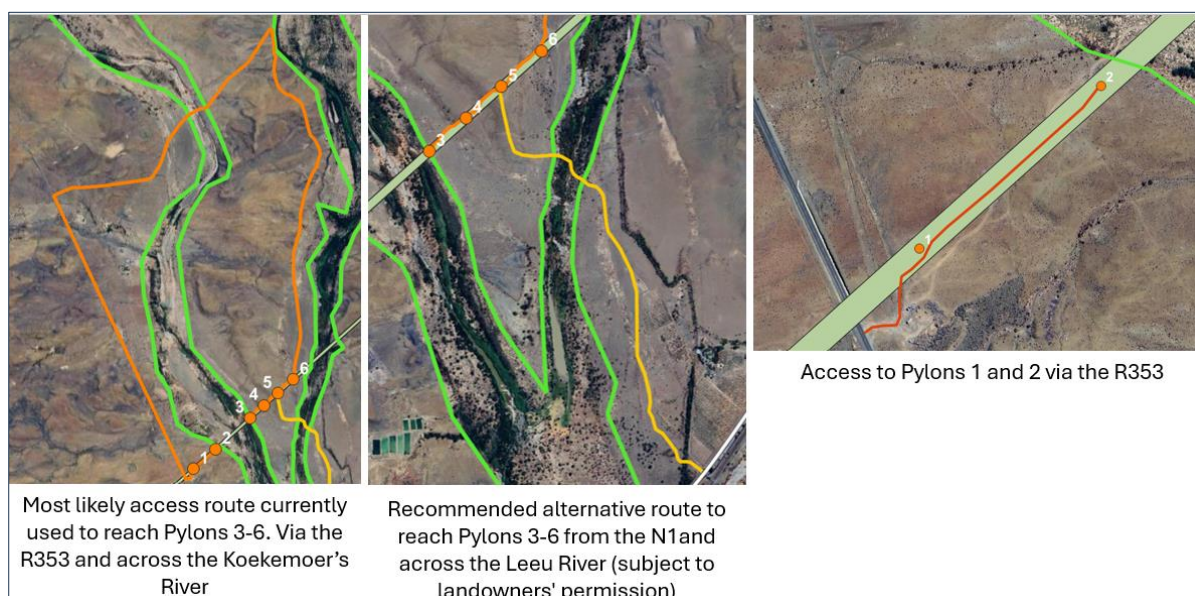
Figure 24. Indicated access routes currently in use and a recommended alternative for different parts of the power line.

- The final track selection must be provided to all drivers with instructions to limit their route to the track indicated only. Substantial and long-term damage can be done to the surrounding veld by driving multiple tracks, which can take years to recover.
