Memorandum

To	Natanya Whitehorn, Deon Esterhuizen	From	Danica Mong, Steven Seymour
Copy	Gary Davis	Reference	1002570-0000-REP-GG-0001-Rev0
Date	2023-09-27	Pages (including this page)	12
Subject	Olifants Management Model Programme Bulk Raw Water Study Phase (OMMP-BRWSP): Geotechnical Desktop Study for Environmental Authorisation of the Proposed Mokopane Water Treatment Works

This memorandum provides a geotechnical desktop study for the proposed Mokopane Water Treatment works in the Limpopo Province. The intention of this geotechnical desktop study is to provide a site sensitivity verification assessment of the site as it pertains to the environmental authorisation process. The desktop study therefore focusses on the geotechnical aspects of the sites from an environmental perspective. The assessment was limited to a desktop study only and no site walk-over was conducted.

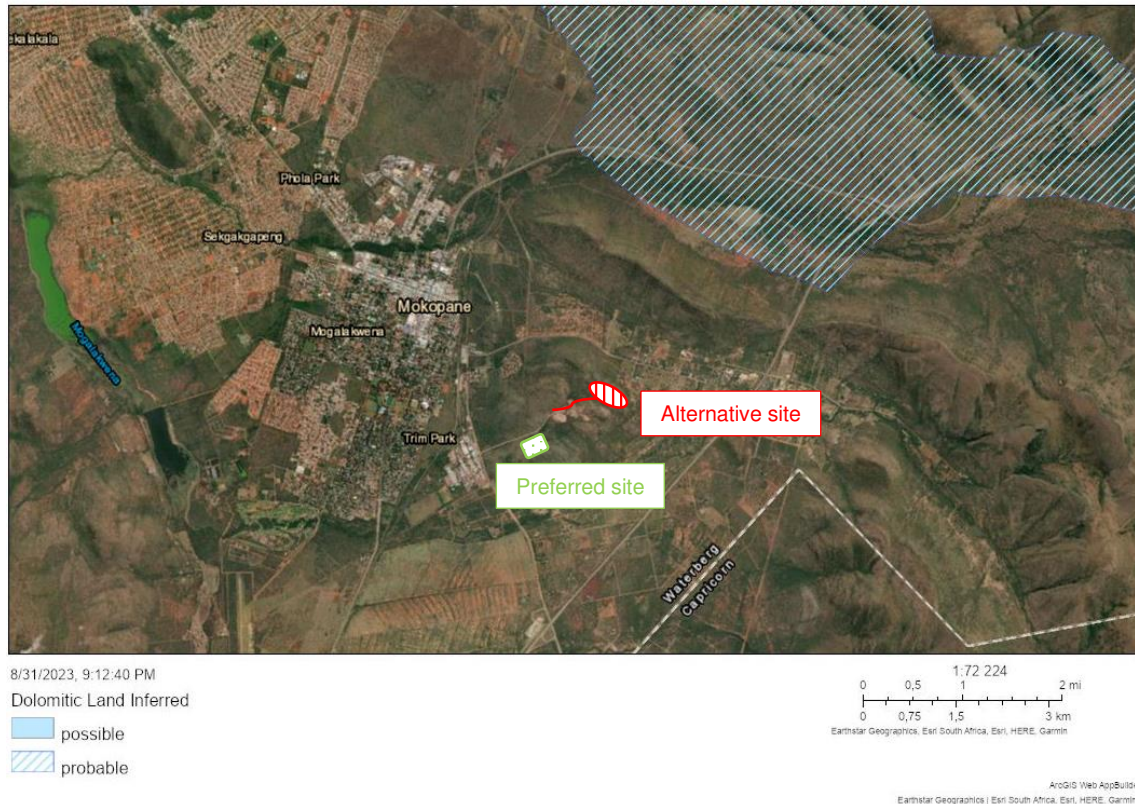
Figure 3 Inferred dolomitic risk map in the Limpopo Province South Africa (Council for Geoscience, 2023)

The sites are not underlain by potentially soluble rock such as dolomite. However, for reference, as shown in Figure 3, the Council for Geoscience (2023) indicates that there is probable dolomitic rock located approximately 5 km to 7 km northeast of the alternative site. It is likely that the probable dolomitic land refers to the Malmani dolomites of the Chuniespoort Group approximately 7 km northeast of the alternative site (Figure 2). Notwithstanding, the dolomite is a considerable distance away from the sites and is not considered a risk for the current sites.

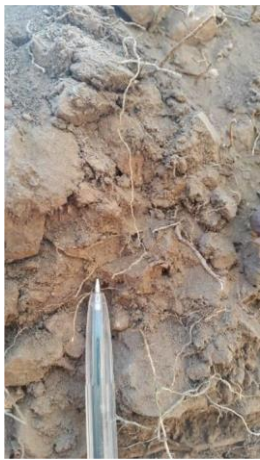
Figure 8 Upper open structured silty sand colluvium (PTP 4)

The ground profile from the twelve (12 no.) water plant test pits is summarised in Figure 7. The test pits were hand-excavated and limited to a maximum depth of 1.2 m. From surface, a small depth of clayey silty sands was encountered, from 0.1 m to 0.7 m (Figure 7). This material was described as topsoil, colluvium, reworked colluvium, or material of mixed origin, with overall consistency of medium dense to dense, and with an open soil structure (pinholed) (Figure 8). The open soil structure is indicative of potentially collapsible soil in its natural state, however the soil thickness at the site appears to be thin.

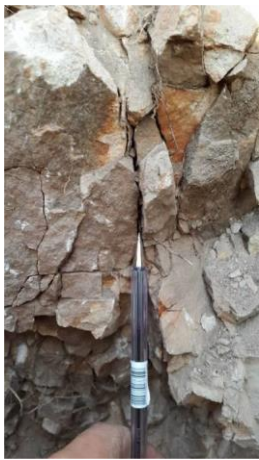
Figure 9 Highly fractured and jointed quartzitic sandstone (PTP 1)

Below the upper soil, refusal was generally encountered on quartzitic-sandstone (Figure 7). The quartzitic-sandstone was typically described as coarse-grained, highly fractured, extremely close to closely jointed (Figure 9). The rock hardness at refusal depth of the quartzitic-sandstone was assigned an ISRM grade of R3 (medium strong rock).

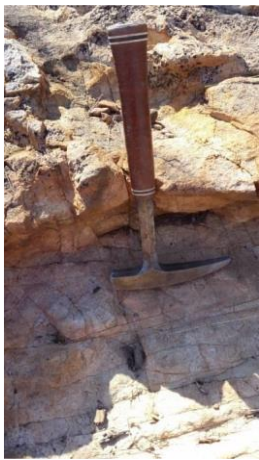
Figure 10 Quartzite outcrop (PTP 11)

Three (3 no.) test pits, near the south of the plant boundary (PTP 9, 11, and 12), were terminated on quartzite at shallow depths, of which one test pit (PTP 11 in Figure 10) refused on the surface (quartzite outcrop). It is inferred that the southern extent of the plant area is overlain by quartzite with a quartzite ridge, and the north-eastern portion by quartzitic sandstone. In general, the excavation conditions at termination depth were described as 'hard' according to the South African code for earthworks, SABS 1200 D-1988 (SABS, 1988).

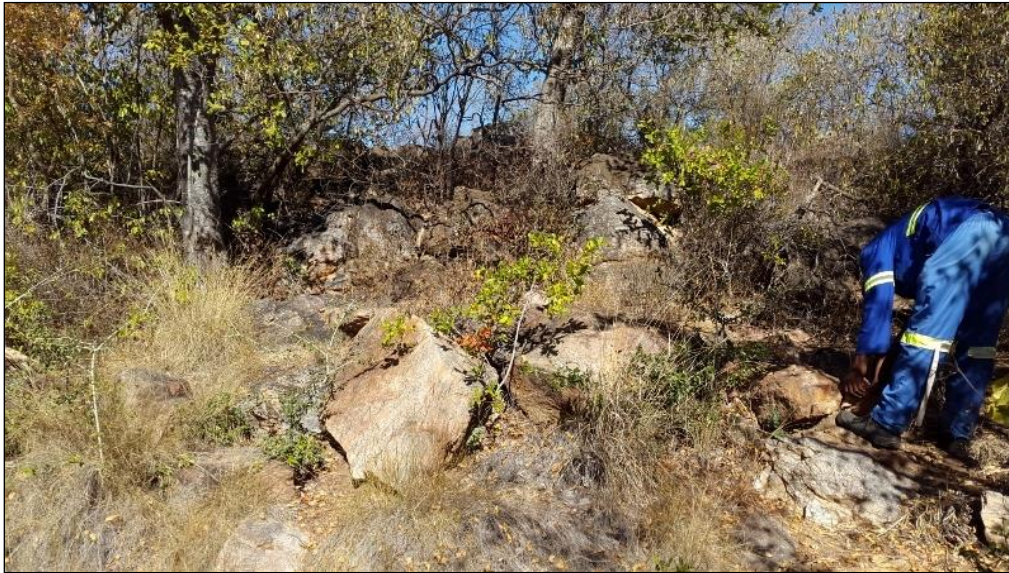
Figure 11 Typical vegetation and quartzite boulders (photograph taken from southern slope in direction south-west) (WSM Leshika Consulting, 2016)

Abundant, slightly weathered to unweathered boulders of 0.5 m and greater were located in the vicinity of the test pits in the plant area (Figure 11). Therefore, boulder excavation might be required.
