**SPECIALIST REPORT – Terrestrial Biodiversity Update:  
Phase 2F Pipeline**

**Zutari**

**Ekoinfo CC & Associates**

November 2024

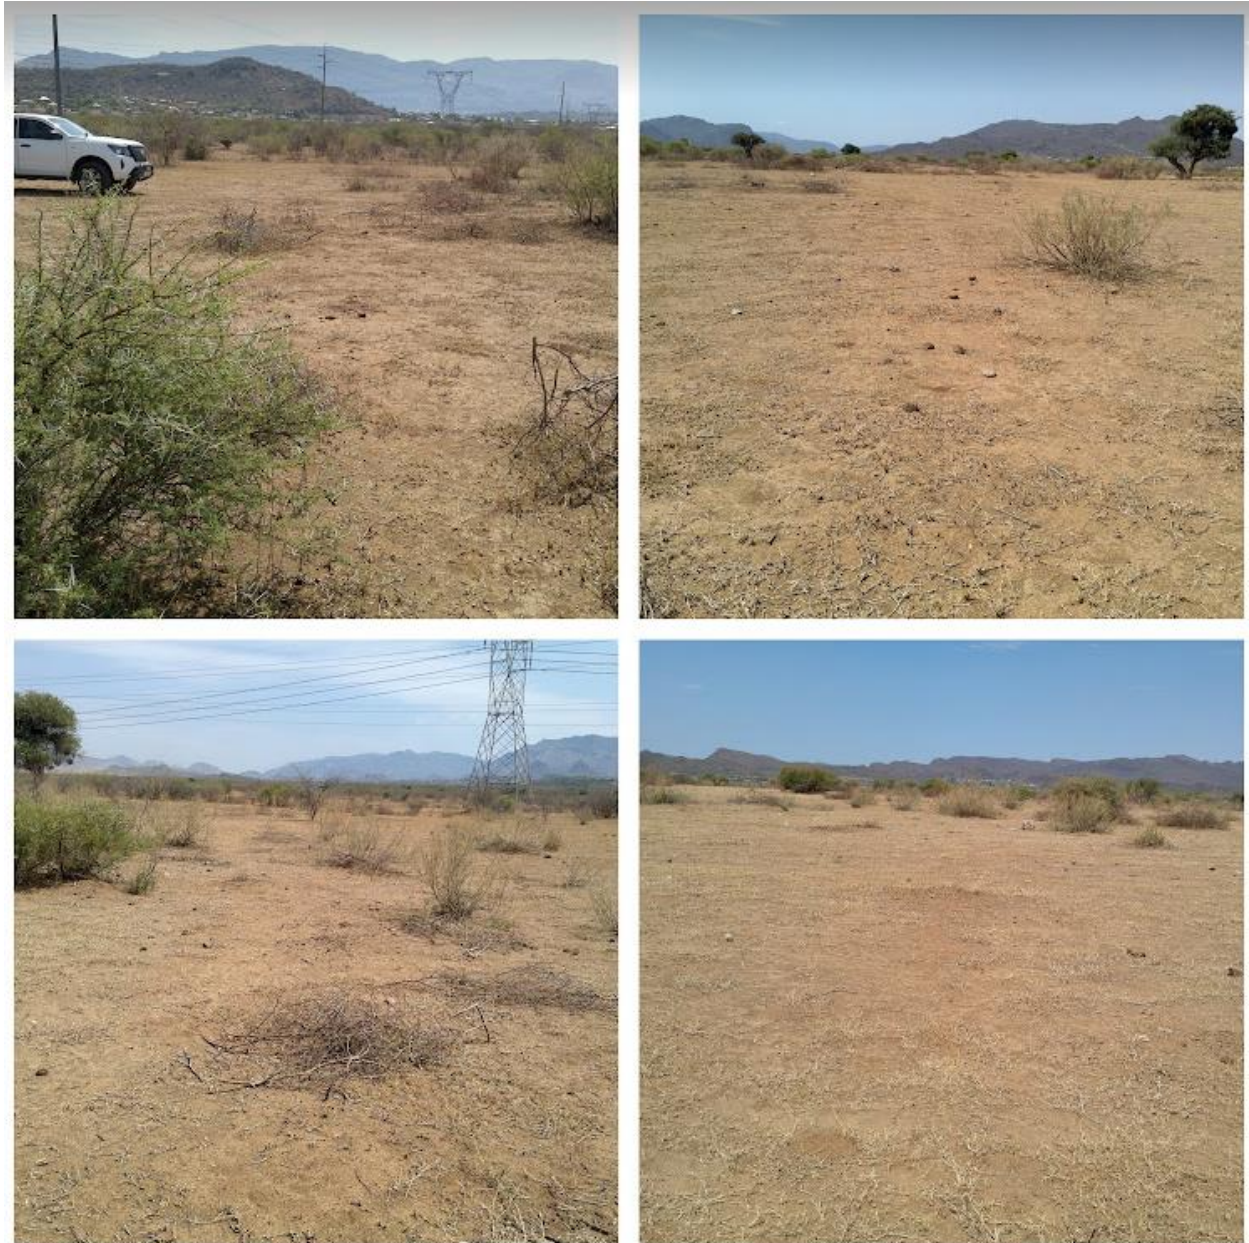
**Photo plate 1: No herbaceous cover due to the timing of the survey in November 2024 prior to the rain**

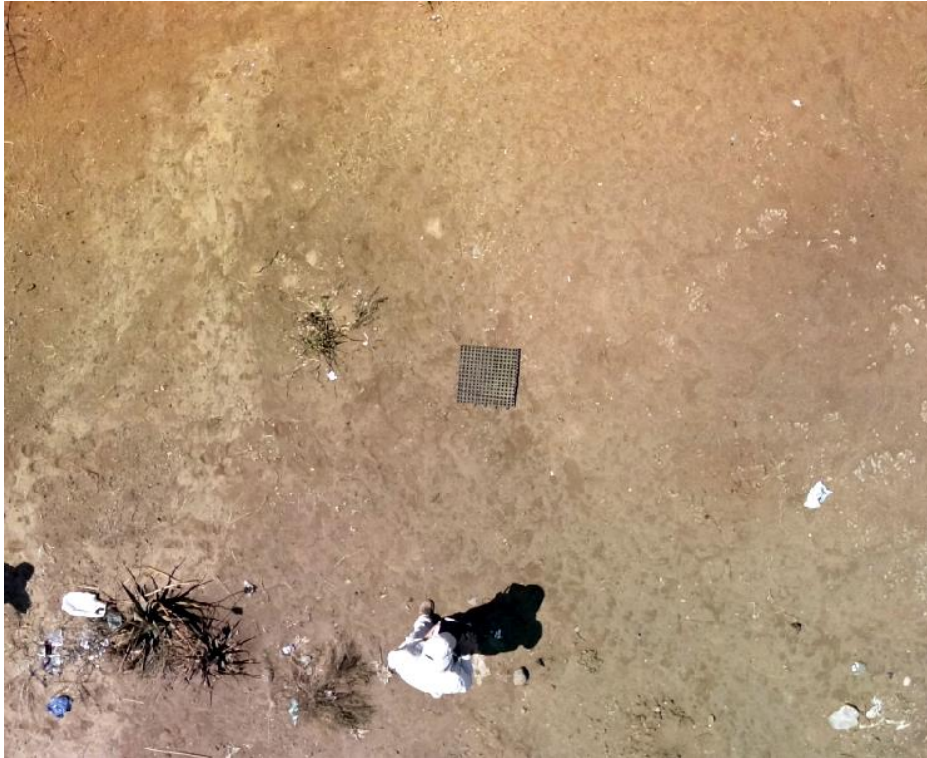
Natural colour (Red, Blue, Green) image showing the absence of herbaceous cover

NDVI (Red & Near infrared) results confirming the absence of herbaceous cover (green = actively growing plants)

**Photo plate 2: Absence of herbaceous cover (forbs and grasses) does not make it possible to calculate rehabilitation criteria from the NDVI analysis**

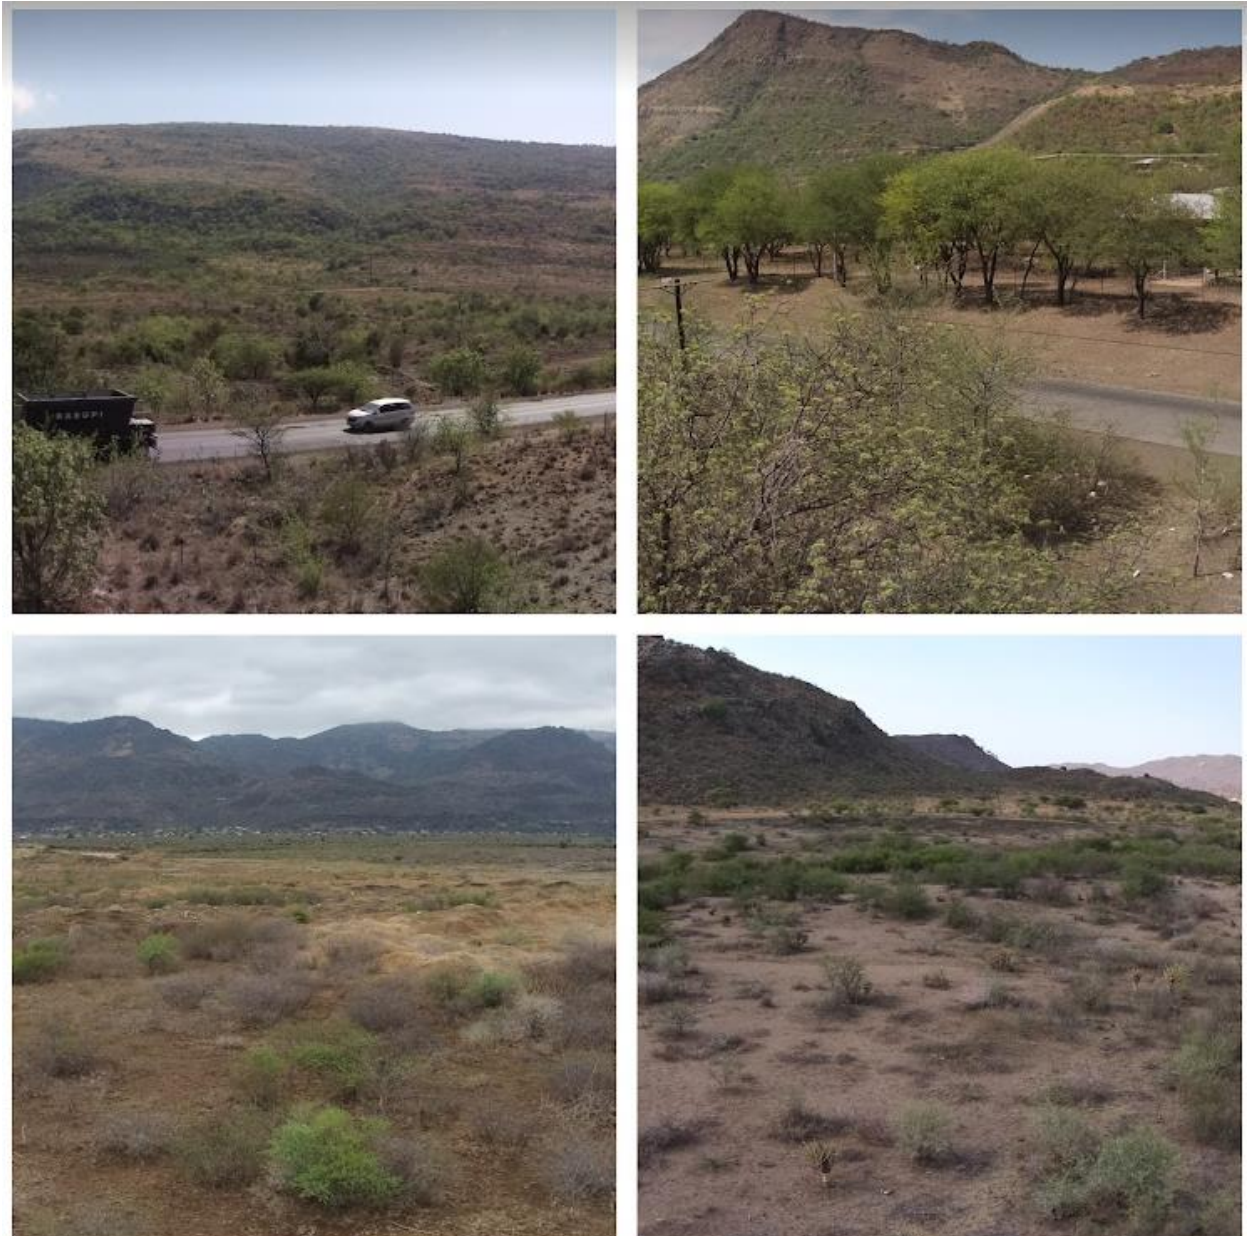
**Photo plate 3: Photographic evidence of the remaining persistent natural vegetation mainly on the high lying steep areas of the landscape**

From this analysis it is evident that the remaining natural vegetation (biodiversity habitat) in the landscape across four quaternary catchments, are not experiencing significant pressure, resulting in limited habitat fragmentation on a regional scale, which does not place populations at risk (Turner *et. al.* 2001, Wiens *et. al.* 2006). Figure 11 and Table 3 support this statement, with 29% of the landscape associated with study area representing transformed areas. In total 69% (132 706 ha) represents persistent primary/ climax vegetation, mainly associated with the high lying and steep areas in the landscape in which the pipe line is planned (Photo plate 3).

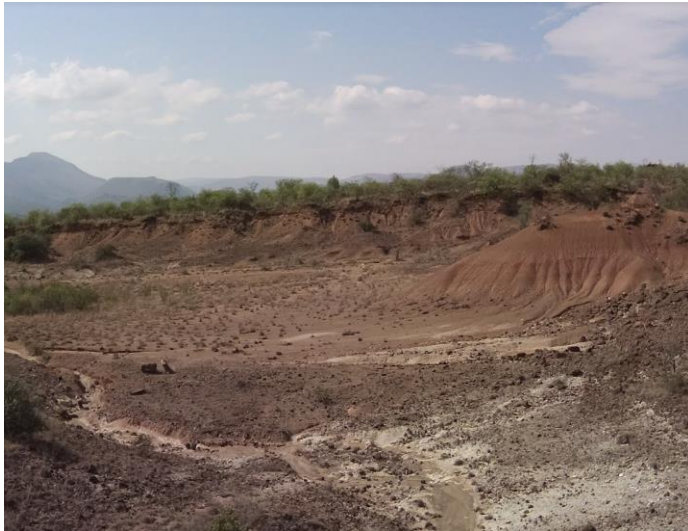
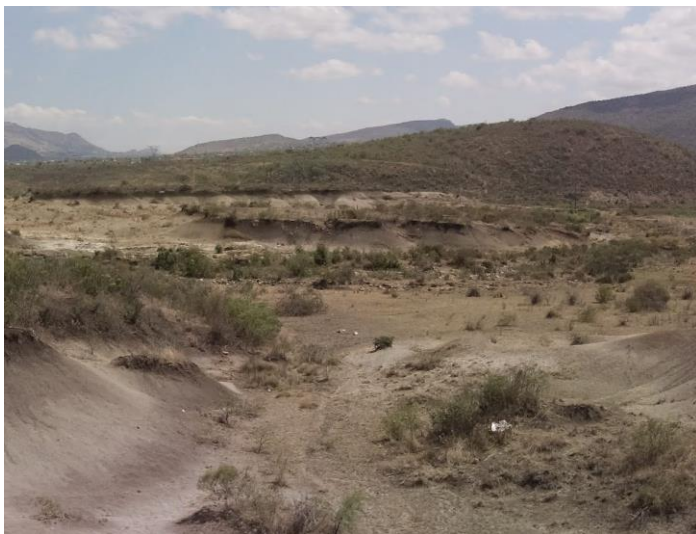
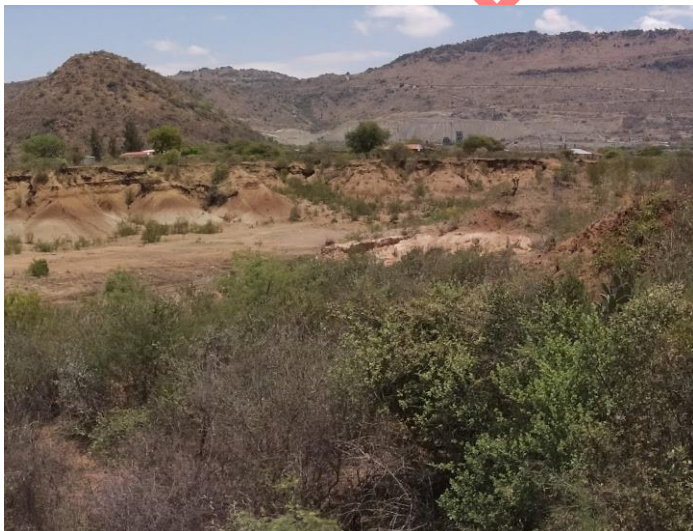
**Photo plate 4: Aerial based oblique images taken at the three plots where *Seersia batophylla* were observed**

The main areas where high impacts or negative consequence can occur is in association with outcrops (boulders or sheet) and existing eroded areas with a high presence of endemic plants (Photo plate 4). Alternative construction methods as highlighted in Appendix D should be considered.

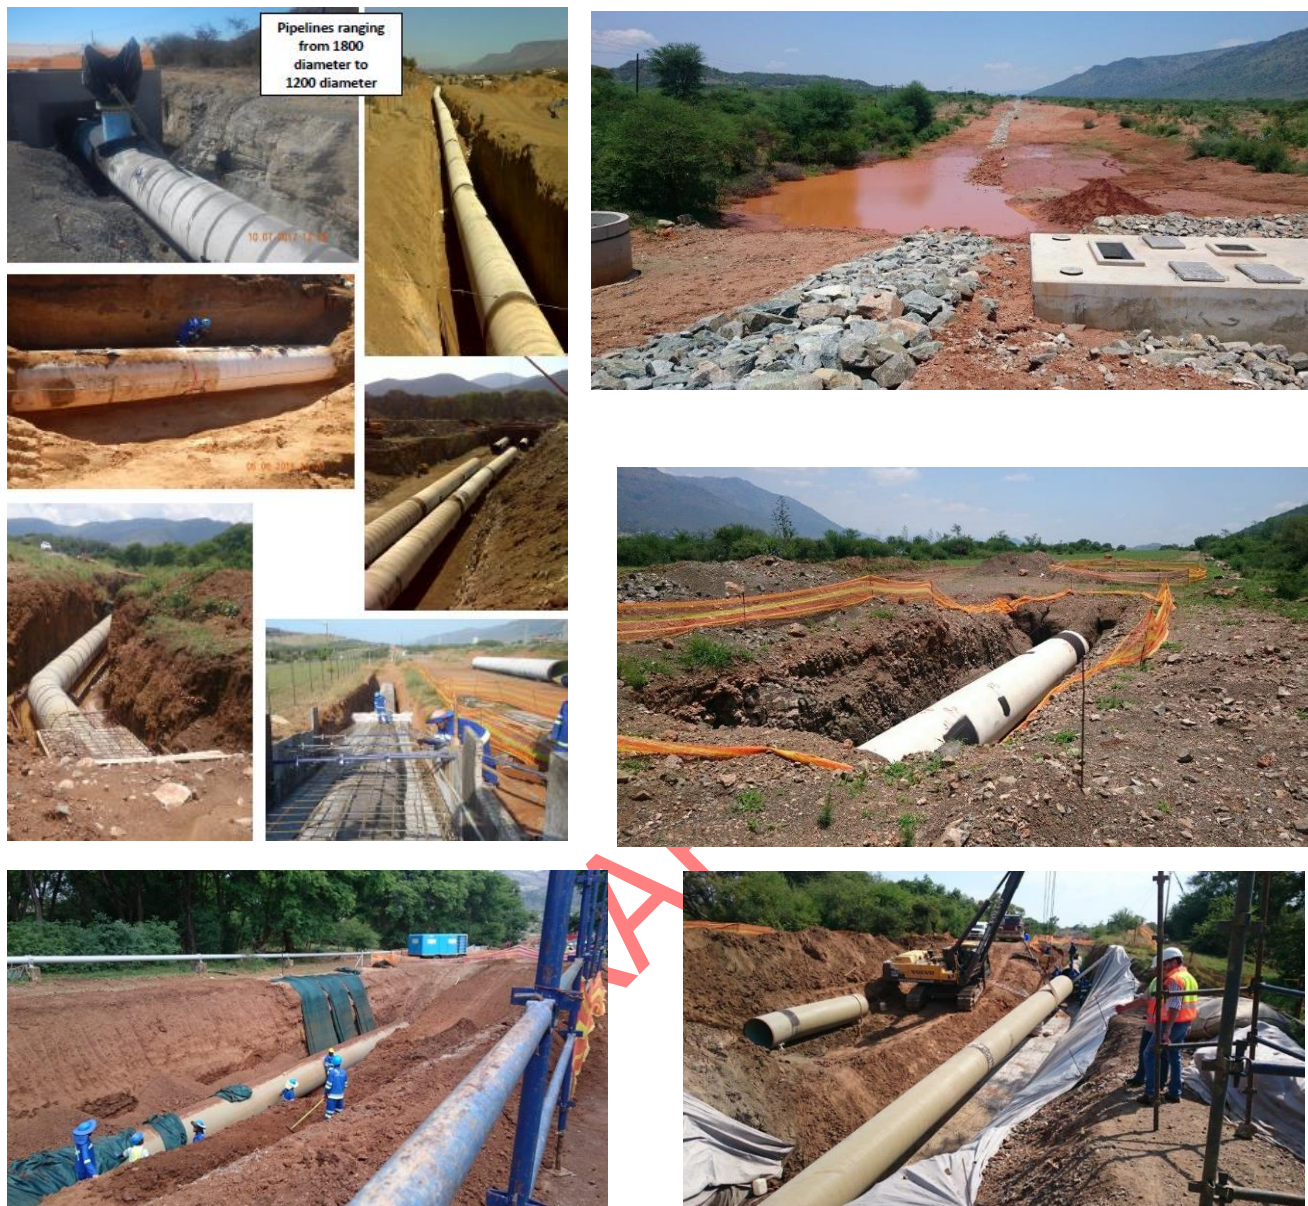
**Photo plate 5: Images showing the construction of the bulk water supply pipeline – Phase 2C (Various sources)**

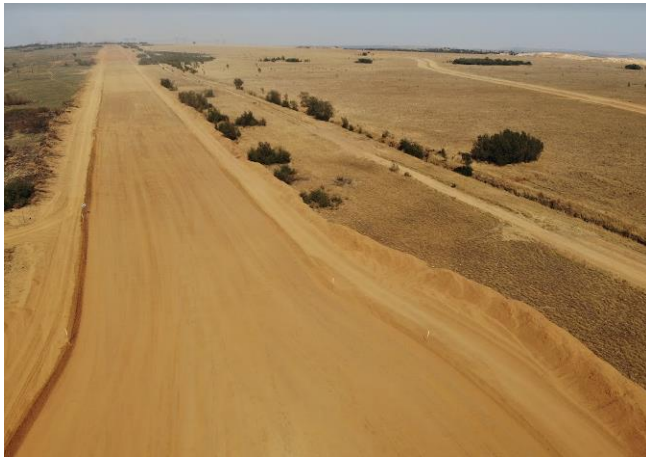
Start of dragline walkway – topsoil separated from subsoil (EkolInfo CC - Aug 2019)

**Photo plate 6: Overview of how the effective topsoil management results in the full recovery of a disturbed areas with minimal cost**

If the topsoil is effectively managed, this impact will be even less as the above ground disturbance will be restored through natural succession (Photo plate 6). It is CRITICAL that the topsoil should be stored separate from the subsoils and placed on top of the subsoils. The removed topsoil should be replaced in the same vicinity from which it had been removed.

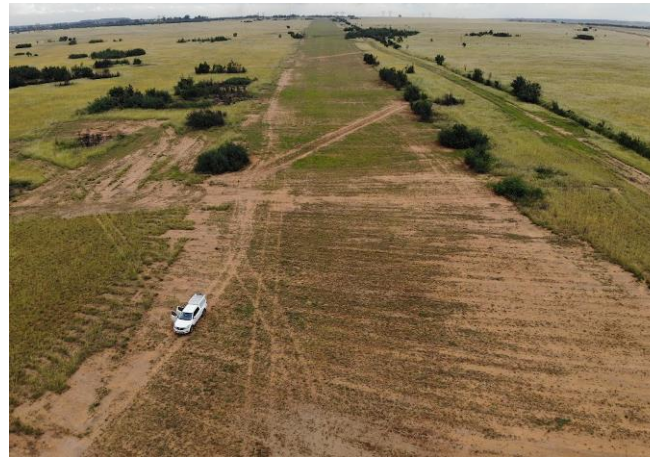
Topsoil returned in the same location – no fertiliser, no seed added (EkolInfo CC - Feb 2020)

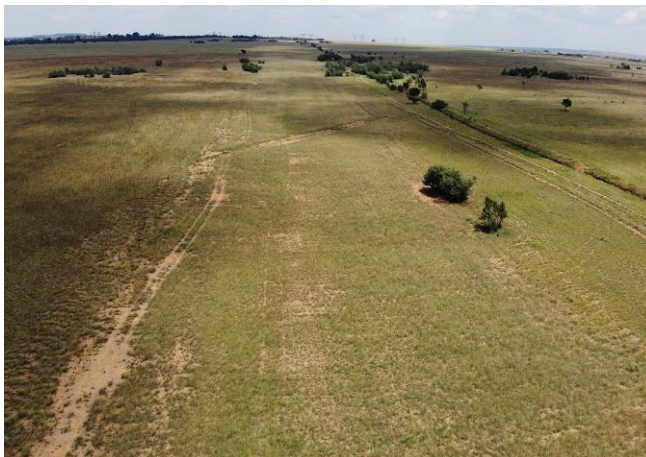
Manual labour addressed surface crusting (bare patches) and alien vegetation (EkolInfo CC – Feb 2021)

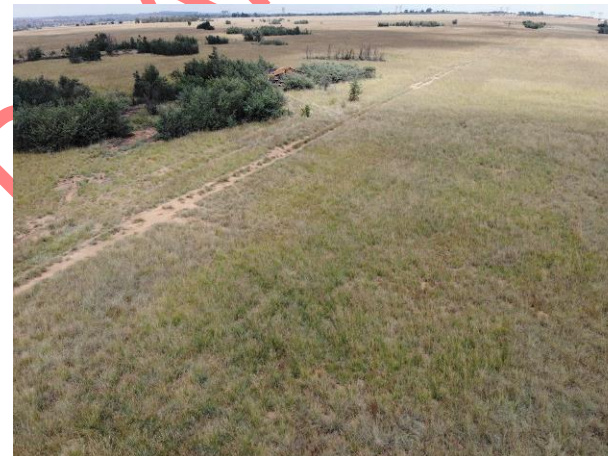
Difficult to distinguish the disturbed dragline walkway from the undisturbed area (EkolInfo CC – Feb 2022)

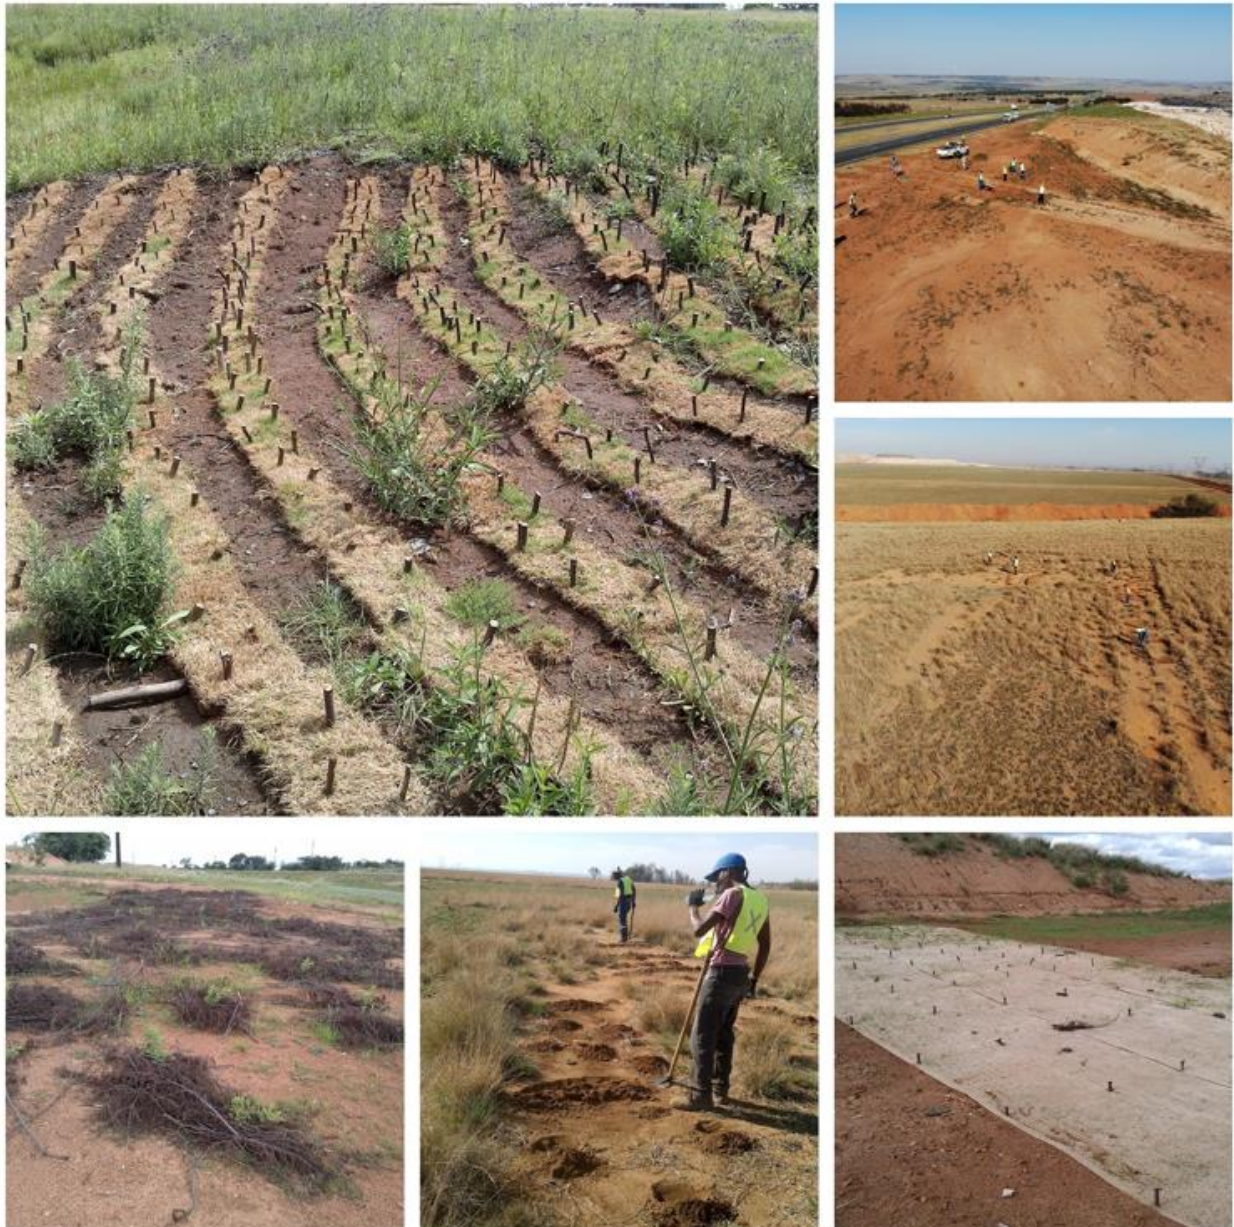
**Photo plate 7: Soft manual labour-based techniques used to improve water infiltration and – retention in bare patches (EkolInfo CC Dragline walkway 2019 – 2022)**

Once the topsoil had been replaced within the same area, the servitude can be maintained with local labour and soft water infiltration techniques (Photo plate 7).

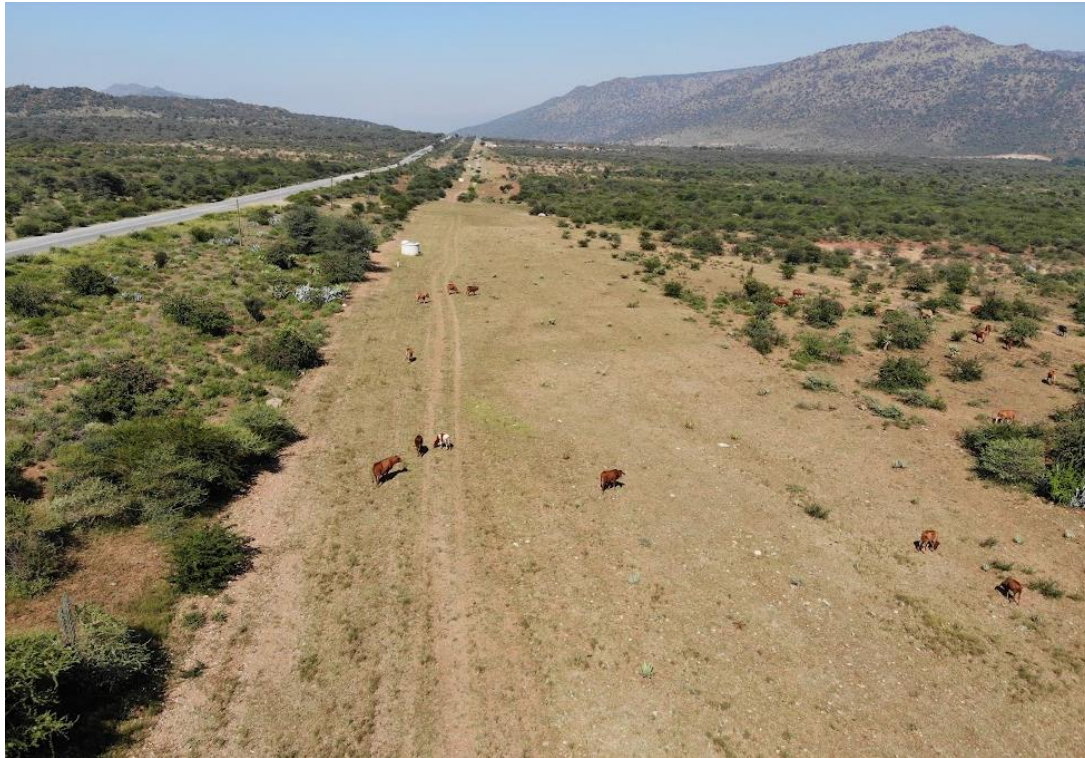
**Photo plate 8: Concentration of local domestic animals on the 2C servitude post rehabilitation (EkolInfo CC 2019)**

- **Overgrazing:** Animals can quickly strip vegetation from rehabilitated areas, exposing soil to erosion and delaying recovery.
- **Soil Compaction:** Heavy grazing and trampling by animals compact the soil, reducing its water-holding capacity and making it harder for vegetation to re-establish.
- **Localized Habitat Degradation:** Concentrated grazing pressure can damage not only the rehabilitated area but also adjacent ecosystems, spreading the impact.
