City of Cape Town

**BASELINE ASSESSMENT OF ADDITIONAL PRODUCTION  
BOREHOLES  
IN THE STEEBRAS WELLFIELD (H1A2 & H1A5),  
FRESHWATER SPECIALIST INPUT**

**June 2019**

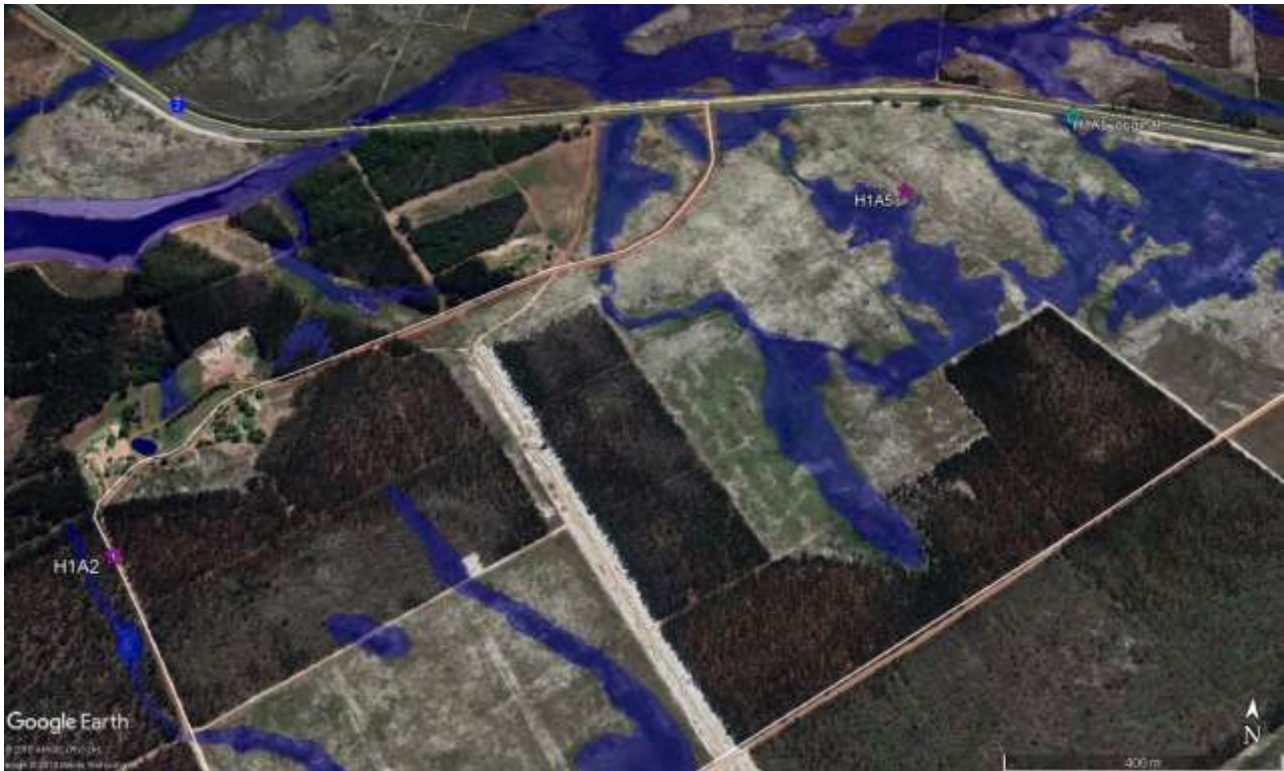
**Figure 1** The location of the two additional production boreholes proposed in the Steenbras Wellfield.

The purpose of this report is to provide an account of freshwater ecosystems potentially impacted by the footprint of these additional boreholes within the Steenbras Wellfield, with recommendations for the alternatives at H1A5, together with input and recommendations to minimize impacts and risk at the preferred site (Figure 1).

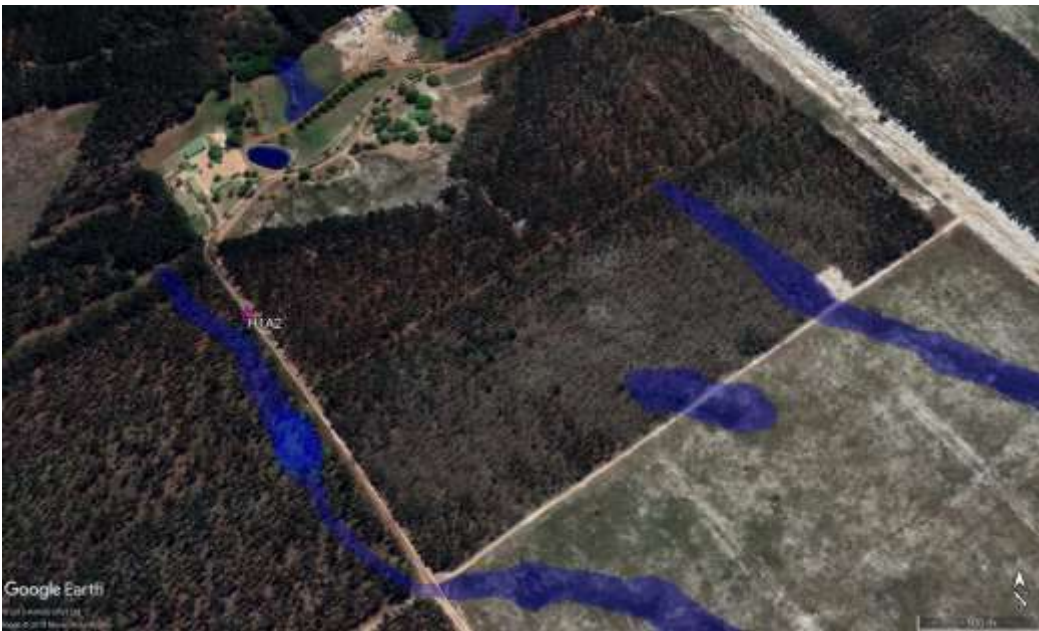
**Figure 2** Position of H1A2 adjacent to the road showing the proximity of wetland seep immediately west.

This production borehole falls within quaternary catchment G40A adjacent to an existing access road within a recently felled pine plantation in Steenbras (Figure 2). The site slopes northwards with a channelled seep draining towards the Steenbras Dam. Although the seep and channel have been impacted by the mature pine plantation, the habitat supports remnant stands of *Berzelia lanuginosa* with *Bechnum* sp. ferns (Figure 3). Some vegetation within the footprint of the borehole is indicative of temporary wetland along the margins of the permanently saturated and seasonally inundated seep wetland, including *Syncarpha* sp and *Cliffortia atrata*. Major existing impacts to this wetland habitat include the dominance of a mature pine plantation that has affected the integrity of natural vegetation cover and resulted in some erosion of the channel. Also, the integrity of the system has been affected by hydrological alterations associated with diversion of flows away from the seep habitat to accommodate the road. The system is therefore not pristine but it supports wetland habitat with a high potential for rehabilitation now that the pine trees have been removed and efforts are planned to reinstate flows to this system from upstream (Ewart-Smith and Boucher 2019). Thus, this wetland represents a system that is likely to recover such that it provides intact habitat within a threatened ecosystem type and is thus considered *of Moderate to High Ecological Importance and Sensitivity*.

A portion of the temporary wetland habitat will be lost to accommodate the footprint of the drilling rig and associated vehicles during drilling activities. This habitat is currently disturbed by the presence of pines and thus its sensitivity to disturbance and thus the impact is considered low to moderate prior to consideration of any rehabilitation intervention. With efforts to rehabilitate this habitat following drilling, it is likely that residual impacts and thus risk would be low (Table 1). Spillage of drilling effluent however, if not contained effectively, poses a moderate to high risk to the channelled seep habitat immediately west and south of the site. Also, this area is vulnerable to erosion if used as a recipient of pump test discharge water and the risk is considered high without the consideration of mitigation (Table 1).

**Recommendations:** It is recommended that topsoil from the site be removed and appropriately stored prior to preparation for drilling such that these materials can be replaced and used in efforts to rehabilitate the disturbance footprint. Effluent runoff needs to be controlled and contained within sufficiently sized sumps placed adjacent to the road. Sandbags should be placed along the western edge of the sandbags such that any uncontrolled overflow is directed towards the road and away from the wetland. The potential of spillage from the drilling site should be closely monitored by an ECO. Drilling effluent and pump test water should be discharged directly to the Steenbras Dam via a temporary pipe system that avoids the wetland habitat as far as possible. Assuming all mitigation is effectively implemented, the risk to freshwater ecosystems associated with the percussion drilling of H1A2 is considered low to moderate, due to the close proximity of the site to wetland habitat. In the unlikely event that

drilling effluent does enter the wetland habitat, the need for remediation measures should be assessed by a suitably qualified ecologist and implemented if necessary.

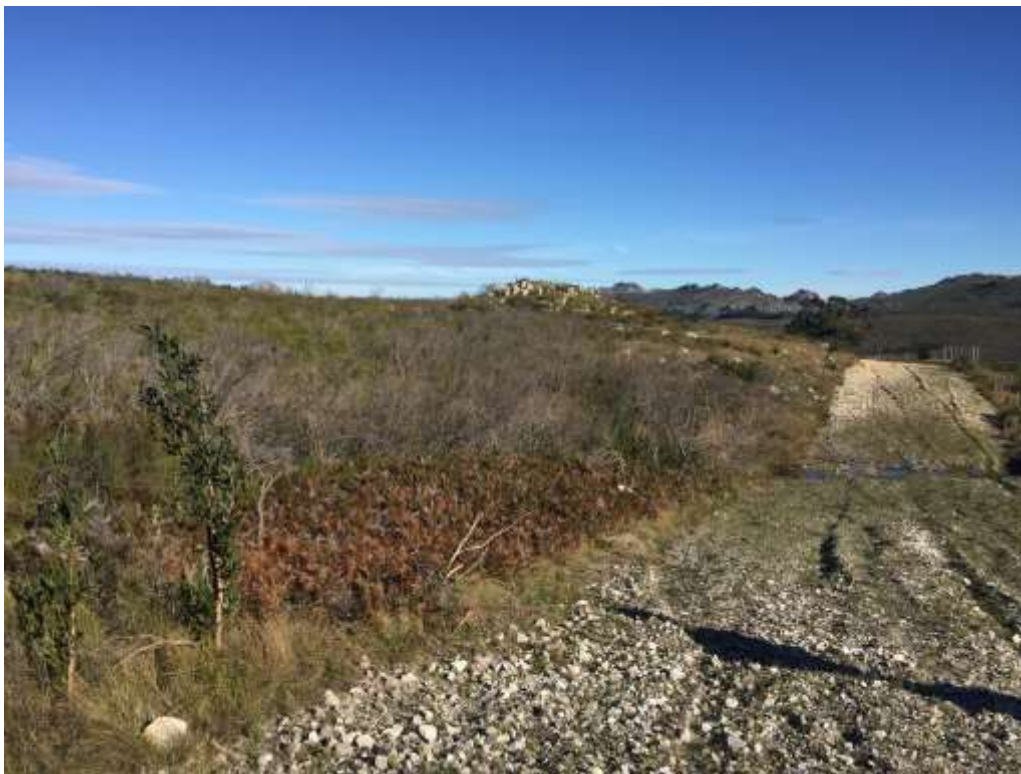
**Figure 5      The channelled seep habitat adjacent to H1A5\_original showing the channel through the firebreak**

**H1A5\_original:** This site is situated on deep saturated (wetland) sandy soils within a firebreak on the border of the Steenbras Reserve, immediately adjacent to the N2 highway. Gently sloping seep wetlands characterise the area to the west of the firebreak, some with channelled outflow that crosses the firebreak and discharges to wetland habitat on the east of the N2 highway via pipes. The seep and channel immediately downslope of H1A5\_original can be described as a seasonally inundated, permanently saturated system dominated by *Psoralea pinnata* (burnt) and *Calopsis paniculata* along the channel margins, with *Pteridium aquilinum* and *Pennisetum macrourum* across the seasonally saturated slopes (Figure 5). The area has been burnt in recent years but is relatively intact, with only a few juvenile alien plants (including *Acacia melanoxylon*, *A. mearnsii* and *Pinus pinaster*) scattered through the wetland. The channel flowing via pipes below the N2 highway is somewhat impacted locally by contaminated runoff from the road, together with litter, although the water quality and habitat appear relatively unimpacted a short distance downstream of the N2 Highway. The channel margin in this reach is dominated by *Psoralea pinnata* and *Berzelia* (both recently burnt), together with a dense stand of obligate wetland species such as *Todea sp.*, *Calopsis paniculata* and arum lilies (*Zantedeschia aethiopica*) with healthy in-channel clumps of *Isolepis digitata* (Figure 6). Similar to the seep habitat upslope of the N2 Highway, the slopes flanking the channel are dominated by *Pteridium aquilinum*. These habitats are relatively intact and offer wetland habitat representative of a threatened ecosystem type and together are considered of *High Ecological Importance and Sensitivity*.

**immediately upslope of the N1 Highway.**

The actual footprint for drilling operations and associated sumps and vehicles would be confined to the existing firebreak. Access to the site would also be via the firebreak which is dominated by deep sandy saturated soils typical of wetlands within the area. The maintenance of this area as a firebreak means that the footprint impacts are considered of low significance, although the area would be vulnerable to the formation of dongas with frequent vehicular activity, particularly during the winter wet season when the soils are saturated and even inundated in places. The formation of erosion dongas would affect the sediment loads and hydrological functioning of the wetlands downslope of the N2 highway and thus the footprint (and access route) imposes a moderate risk to the integrity of these wetlands, if not mitigated (Table 2). Also, spillage of sediment laden effluent with rotafoam, if not mitigated would result in an impact of high significance to the wetlands and stream downstream of the N2 Highway (Table 2). Similarly, discharge of pump test water into this small channel would pose a high risk of erosion to this system (Table 2).

**Recommendations:** The drill site should be contained through the placement of sandbags along the northern extent of the site, between the drilling footprint and the channel. It is recommended that vehicular movement to and from the site be limited as far as possible to minimise the risk of erosion and donga formation through the firebreak. Furthermore, it is recommended that coarsely crushed sandstones chips are sourced from the Rockview quarry to stabilise the access route and drilling footprint as far as possible. Should potential erosion and donga formation be effectively monitored and managed, then the risk associated with the actual footprint of drilling is considered low

(Table 2). Sufficiently sized temporary sumps should be placed within the firebreak to contain effluent discharge. The efficacy of sumps to contain effluent during the wet winter period is however questionable, considering the currently saturated state of the sediments, even at the start of the wet season and thus the risk of spillage into the downstream channel and wetlands remains moderate (Table 2). Thus, potential spillage of effluent should be closely monitored by an ECO at all times. In the event of accidental effluent spillage into the stream and / or wetland, a suitably qualified freshwater ecologist should be alerted immediately such that any remediation measures deemed necessary can be implemented immediately to reduce the extent and duration of any impacts. No effluent or pump test water must be discharged into the channel and wetland habitat. The following two options to prevent such discharge into natural freshwater habitats are proposed:

*Option 1:* Pipe discharge below the N2 and run along the disused track east and adjacent to the N2 Highway, then dissipate runoff into the pine plantations further north.

*Option 2:* Pipe discharge northwards along the firebreak and discharge into the Steenbras Dam.

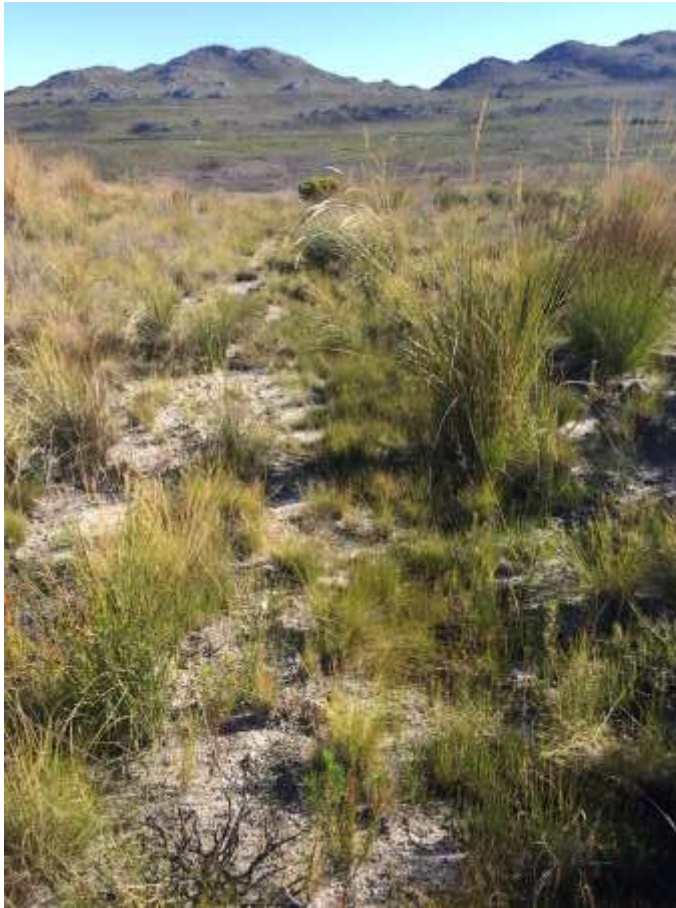
**Figure 7** H1A5\_alternative is situated within seasonally saturated wetland on an old disused track that has largely recovered.

**H1A5\_alternative:** The old track on which this borehole has been sited has not been used for many years and thus much of the natural vegetation has recovered. The seasonally saturated north facing wetland through which the old track traverses is dominated by the wetland grass, *Merxmuellera* sp. with clumps of *Psoralea pinnata* and restios (mainly *Restio bifurcus*). The outer margins are dominated by broad swathes of the wetland fern *Pteridium aquilinum*. Nevertheless, the seasonal wetland habitat was previously under pine plantations and appears to have been burnt in recent years. The area is characterised by deep sandy substrates which have eroded either side of the old track. This has somewhat affected natural drainage through the wetlands and efforts to stabilise eroded channels with stony material is evident either side of the old track. . Also, some alien vegetation, including *Acacia mearnsii* has invaded the area. The site is however relatively intact, supporting a moderate to high diversity of wetland vegetation typical of seasonal seeps within Kogelberg Sandstone Fynbos. As a threatened habitat type, this system is considered of *High Ecological Importance and Sensitivity*. Access to this site via the old track (Figure 8), together with the footprint of drilling, including sumps as mitigation, would result in the loss and / or disturbance of this wetland habitat. Also, the vulnerability of this habitat to further erosion could result in long term impacts of high significance. Thus, percussion drilling at H1A5\_alternative, even with mitigation, is considered an impact of high significance that poses a high risk to freshwater ecosystems. .

H1A5\_original, with mitigation is therefore considered the preferred alternative from a freshwater ecological perspective
