City of Cape Town

**BASELINE ASSESSMENT OF ECOSYSTEMS POTENTIALLY  
IMPACTED BY THE WELL-FIELD DEVELOPMENT AT  
STEENBRAS**

**FRESHWATER AND BOTANICAL SPECIALIST REPORT**

**March 2019**

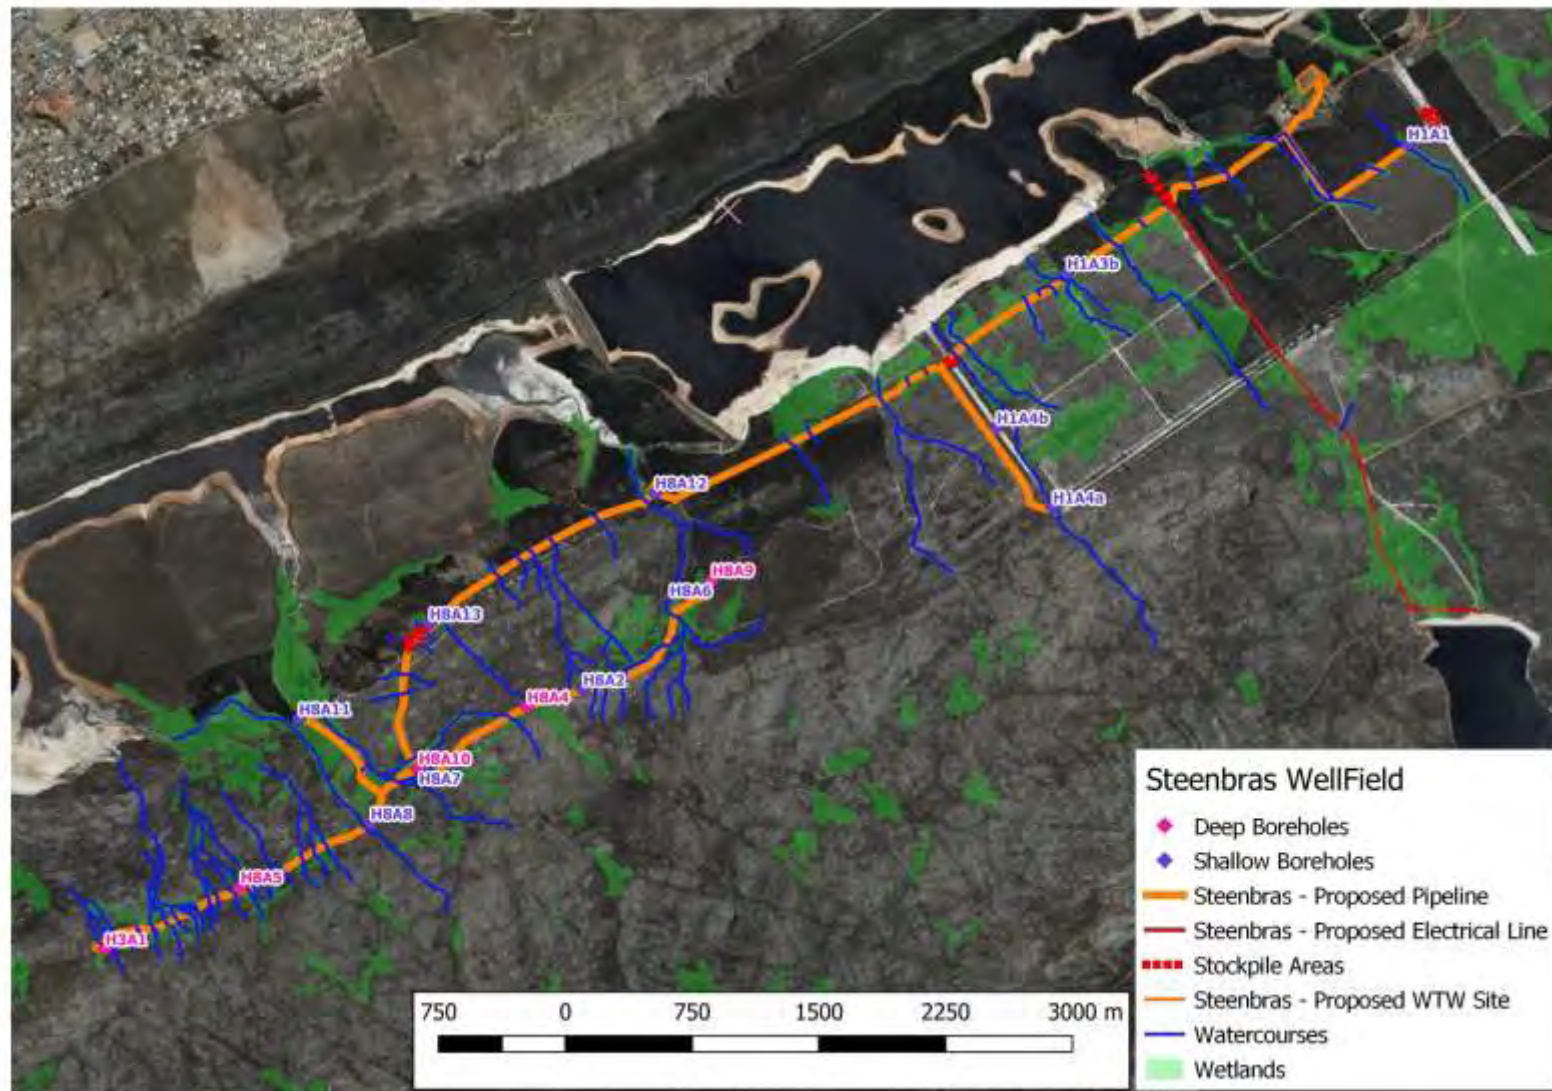
Figure 1.1 Location of the Borehole sites and infrastructure network within the proposed Steenbras wellfield.

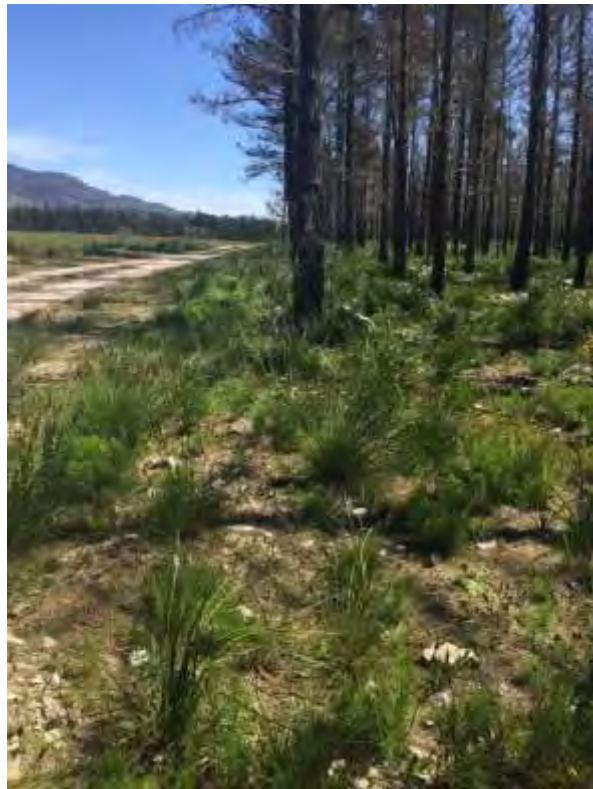
**Figure 3.2** Temporary wetland habitat in pine plantations at Steenbras.

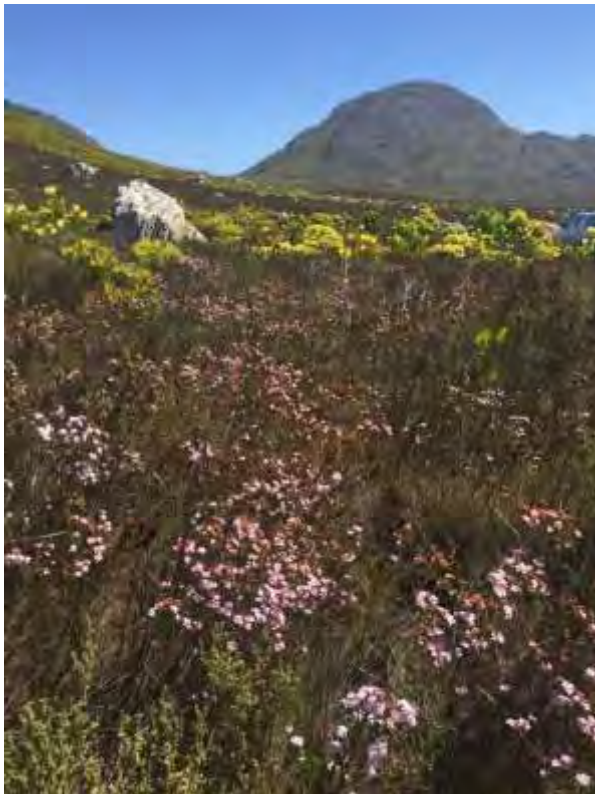
**Figure 3.3** Seasonally saturated wetland habitat at Steenbras.

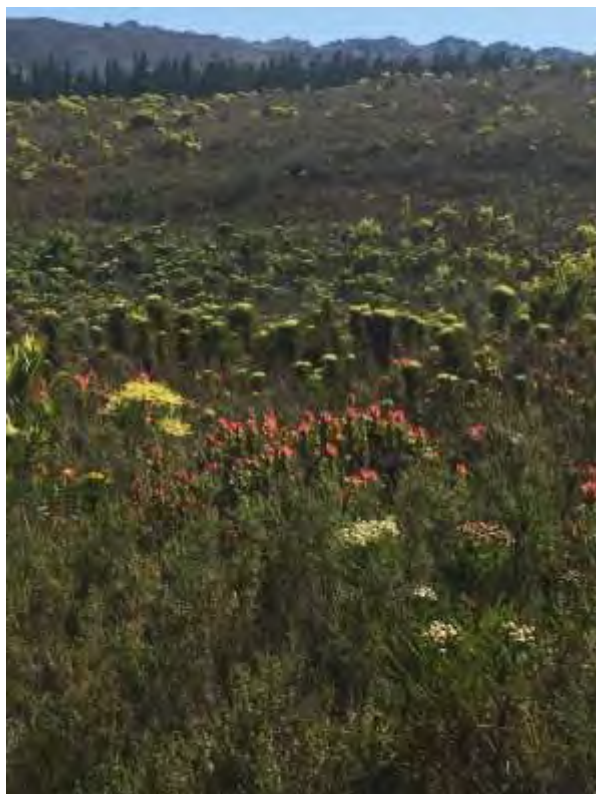
**Figure 3.4** Permanently saturated wetland habitat at Steenbras.

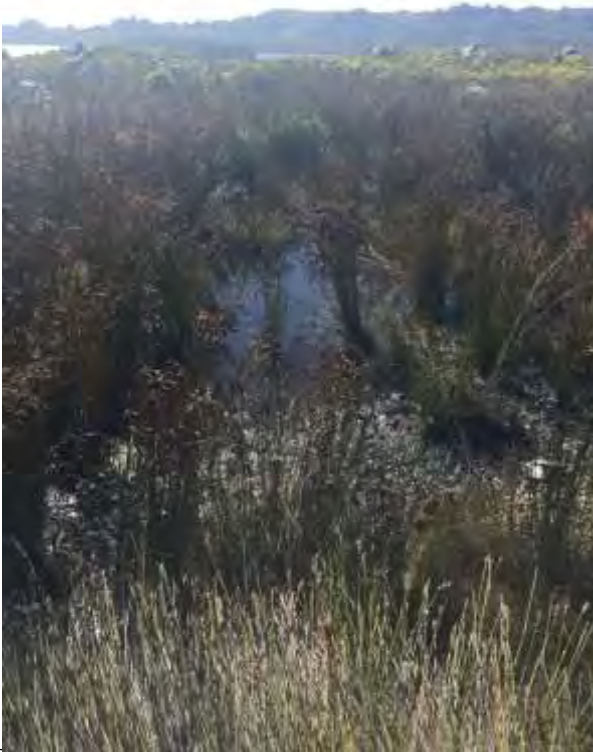
**Figure 3.5** Permanently saturated but seasonally inundated wetland habitat.

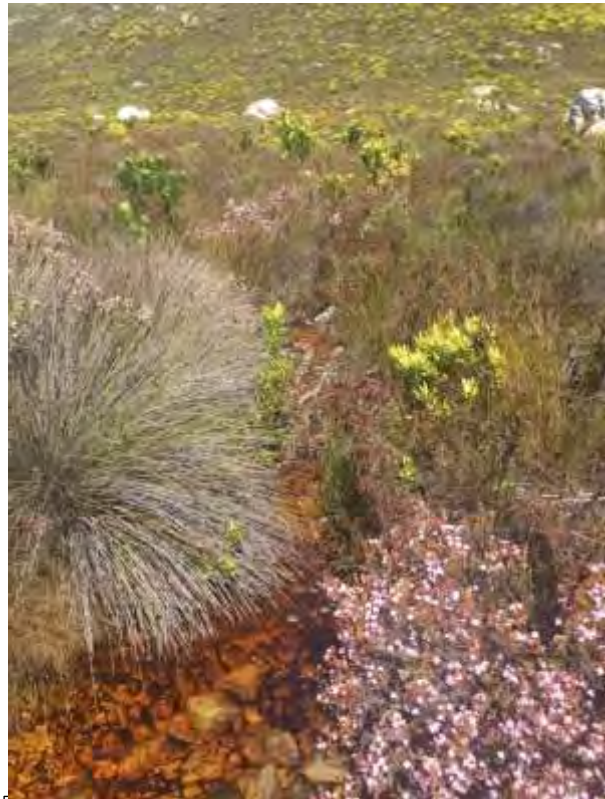
**Figure 3.6** Seasonal or ephemeral channels in Steenbras.

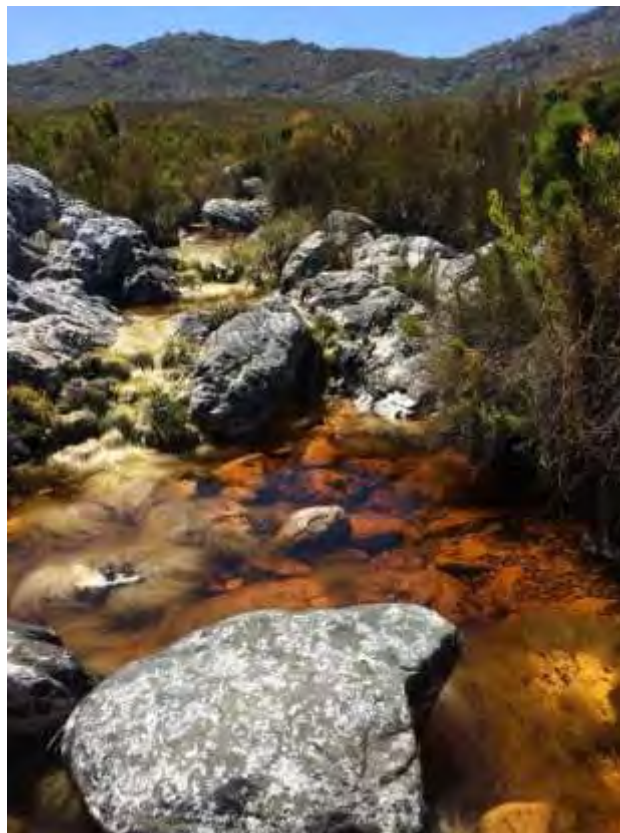
**Figure 3.7** Perennial Rivers with riparian habitat in Steenbras.

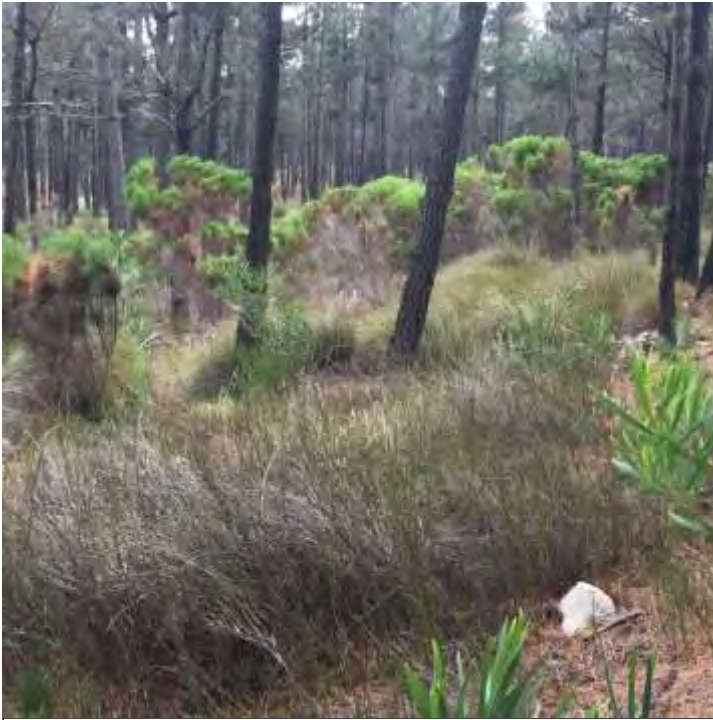
**Figure 3.8** Wetland habitats within pine plantations in Steenbras.

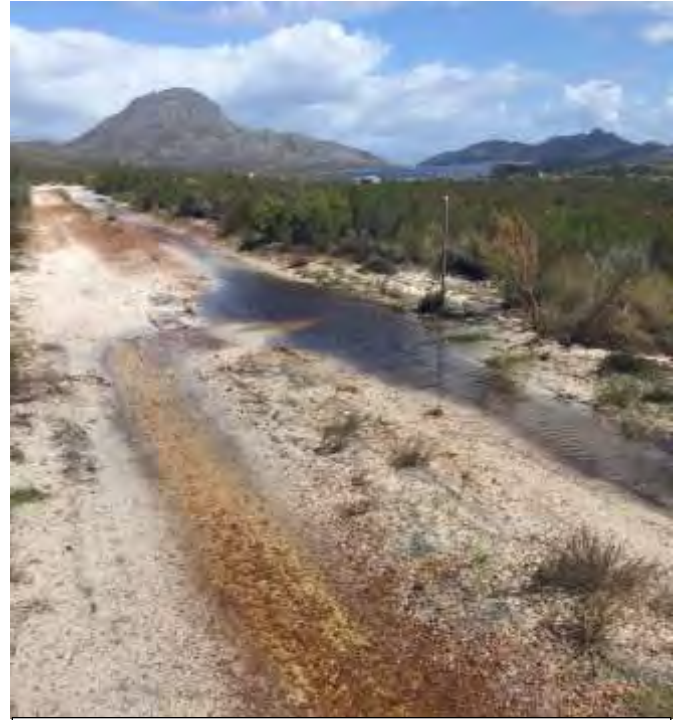
**Figure 3.9** Example of diverted runoff caused by the roads that bisect wetlands and result in drying out of wetlands downslope of the road.

- The road crossings over perennial streams have impacted somewhat on the local hydraulics of these streams which in turn affects the quality of instream habitat. Also, river crossings affect the ecological connectivity of these systems as longitudinal movement of aquatic biota is affected by obstructed flows, particularly towards the end of the dry season when these systems are naturally at their driest.

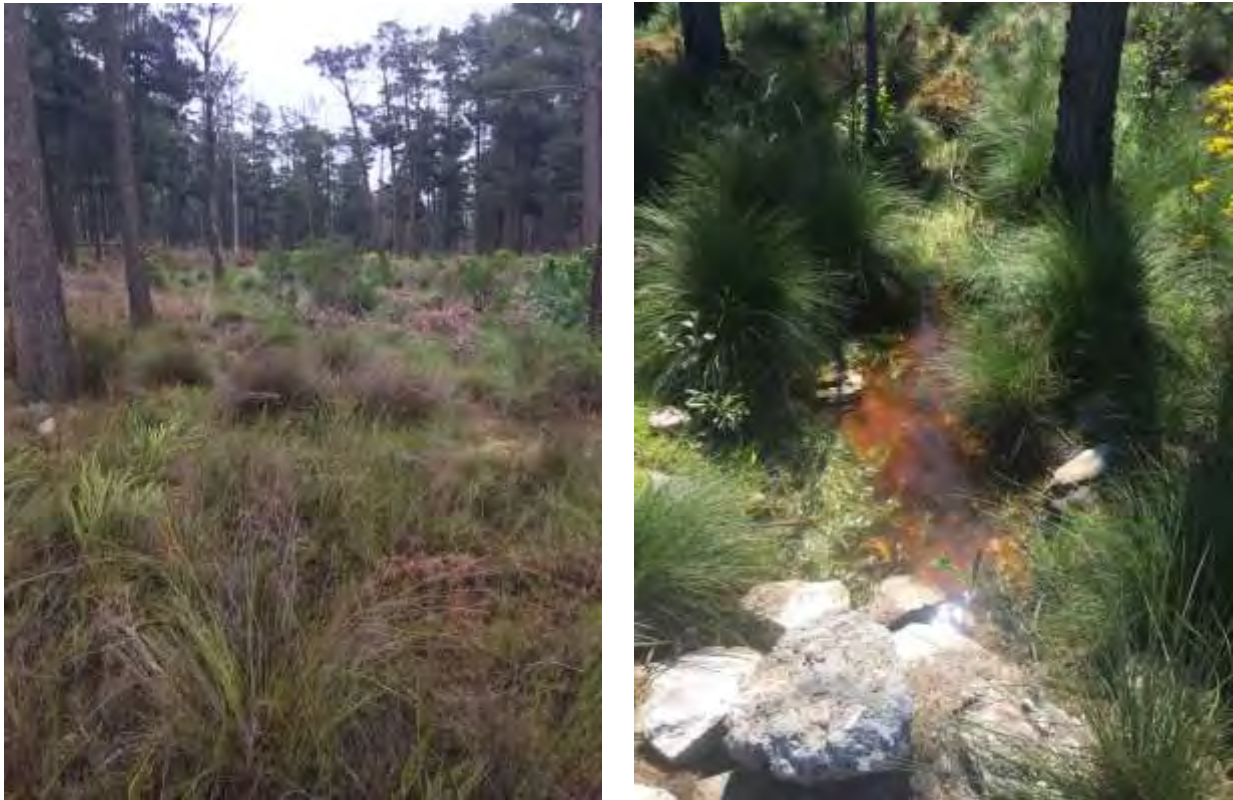
**Figure 4.3** a) Site of borehole H1A1 prior to clearing, b) immediately adjacent to a permanent wetland with seasonal flow in winter.

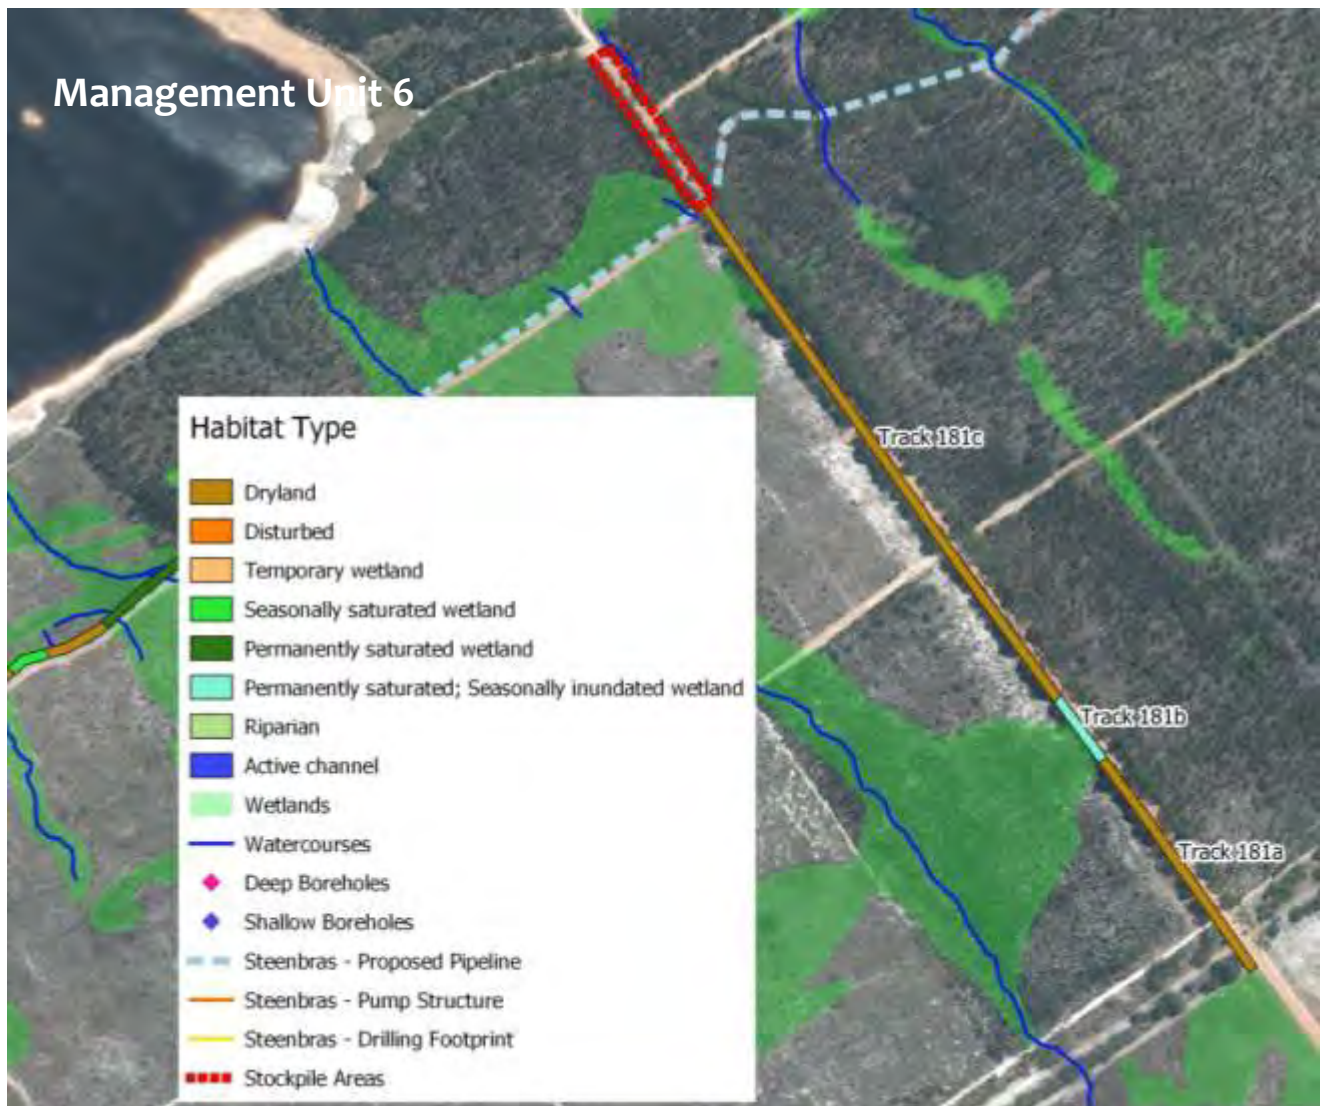
Figure 4.13 Management Unit 6: Spatial extent of Habitat Types.

The below ground powerline route in this MU is along a road that passes through dense mature *Eucalyptus* plantations to the east with a line *Eucalyptus* immediately west with either Pine plantations or recently felled pine trees further west. With the exception of an area of permanently saturated and seasonally inundated wetlands to the west, the habitat within this MU is highly disturbed dryland with low Ecological Importance and Sensitivity.

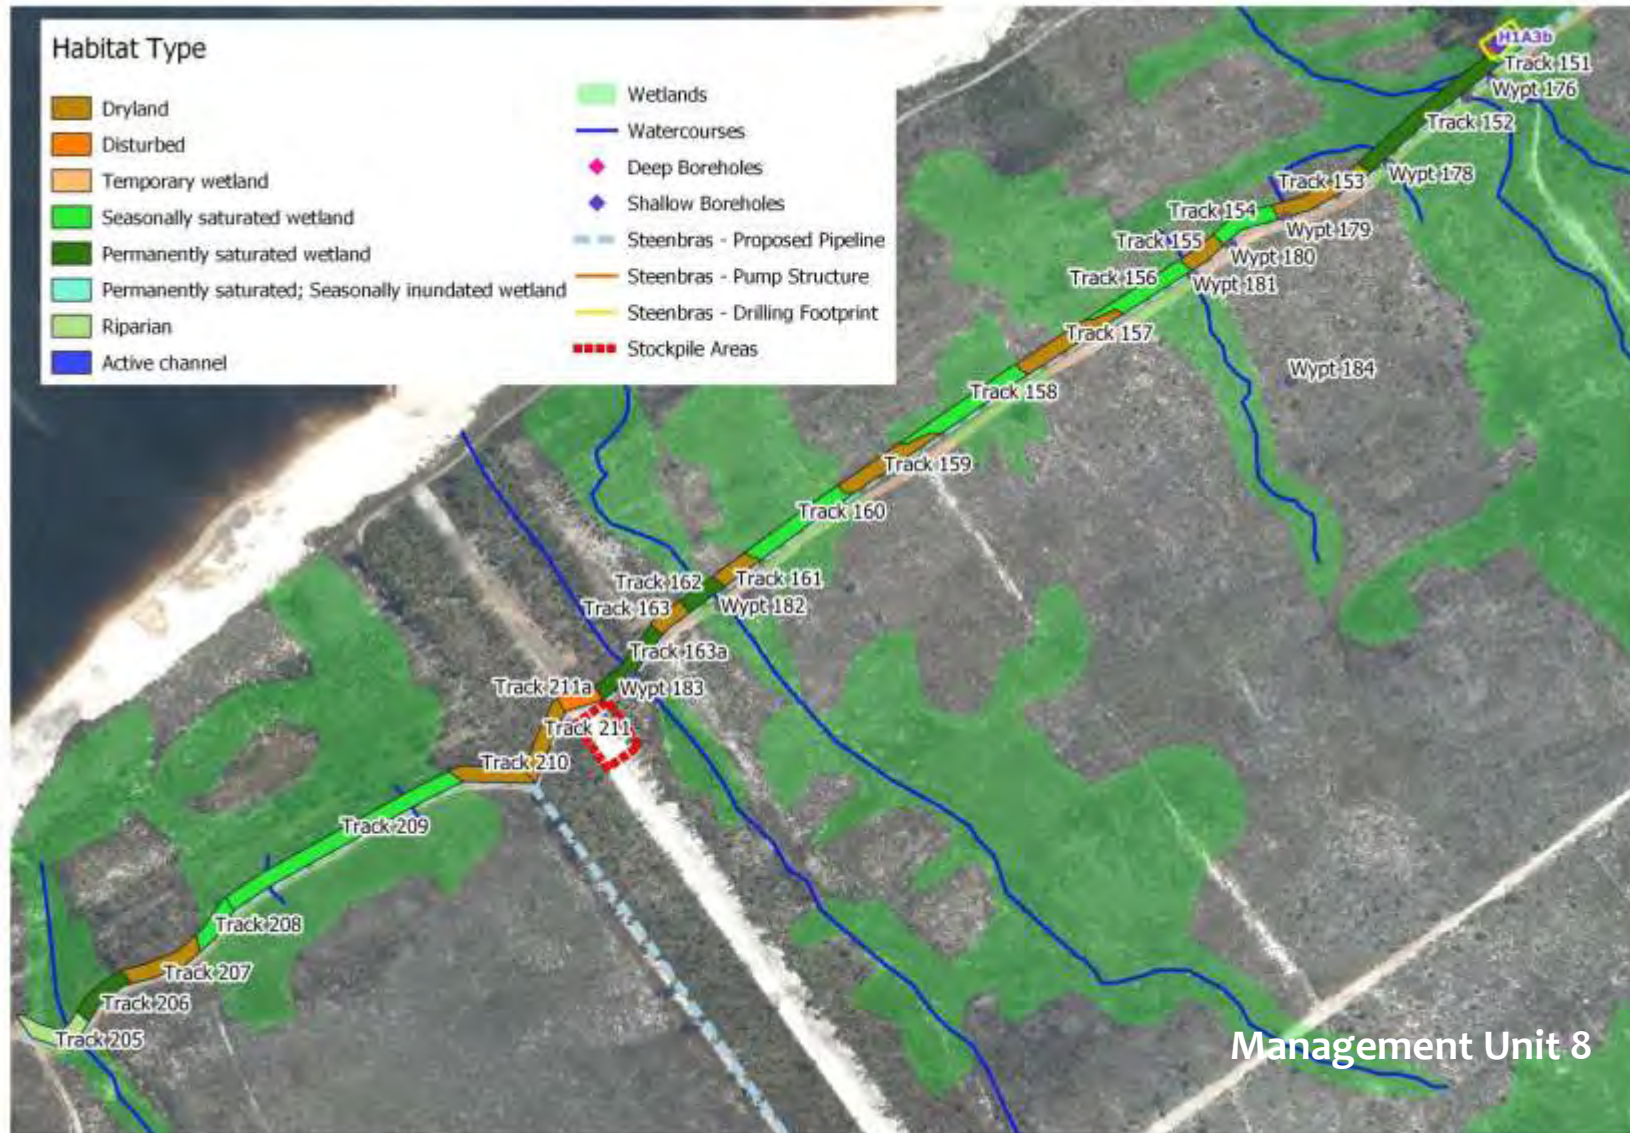
Figure 4.17 Management Unit 8: Spatial extent of Habitat Types.

This management unit includes an area that is naturally vegetated but secondary habitat following the removal of a mature pine plantation. Wetlands are extensive, both seasonally and permanently saturated systems, separated by small areas of sandy dryland. Several natural channels cross the road via culverts within this area, with one perennial stream at the western end of the route. Most of the wetlands are considered of High to Moderate Ecological Importance and Sensitivity, while the drylands are of Moderate ES, largely due to disturbance from the road. Areas of low ecological sensitivity are those through the firebreak and *Eucalyptus* trees west of the fire break.

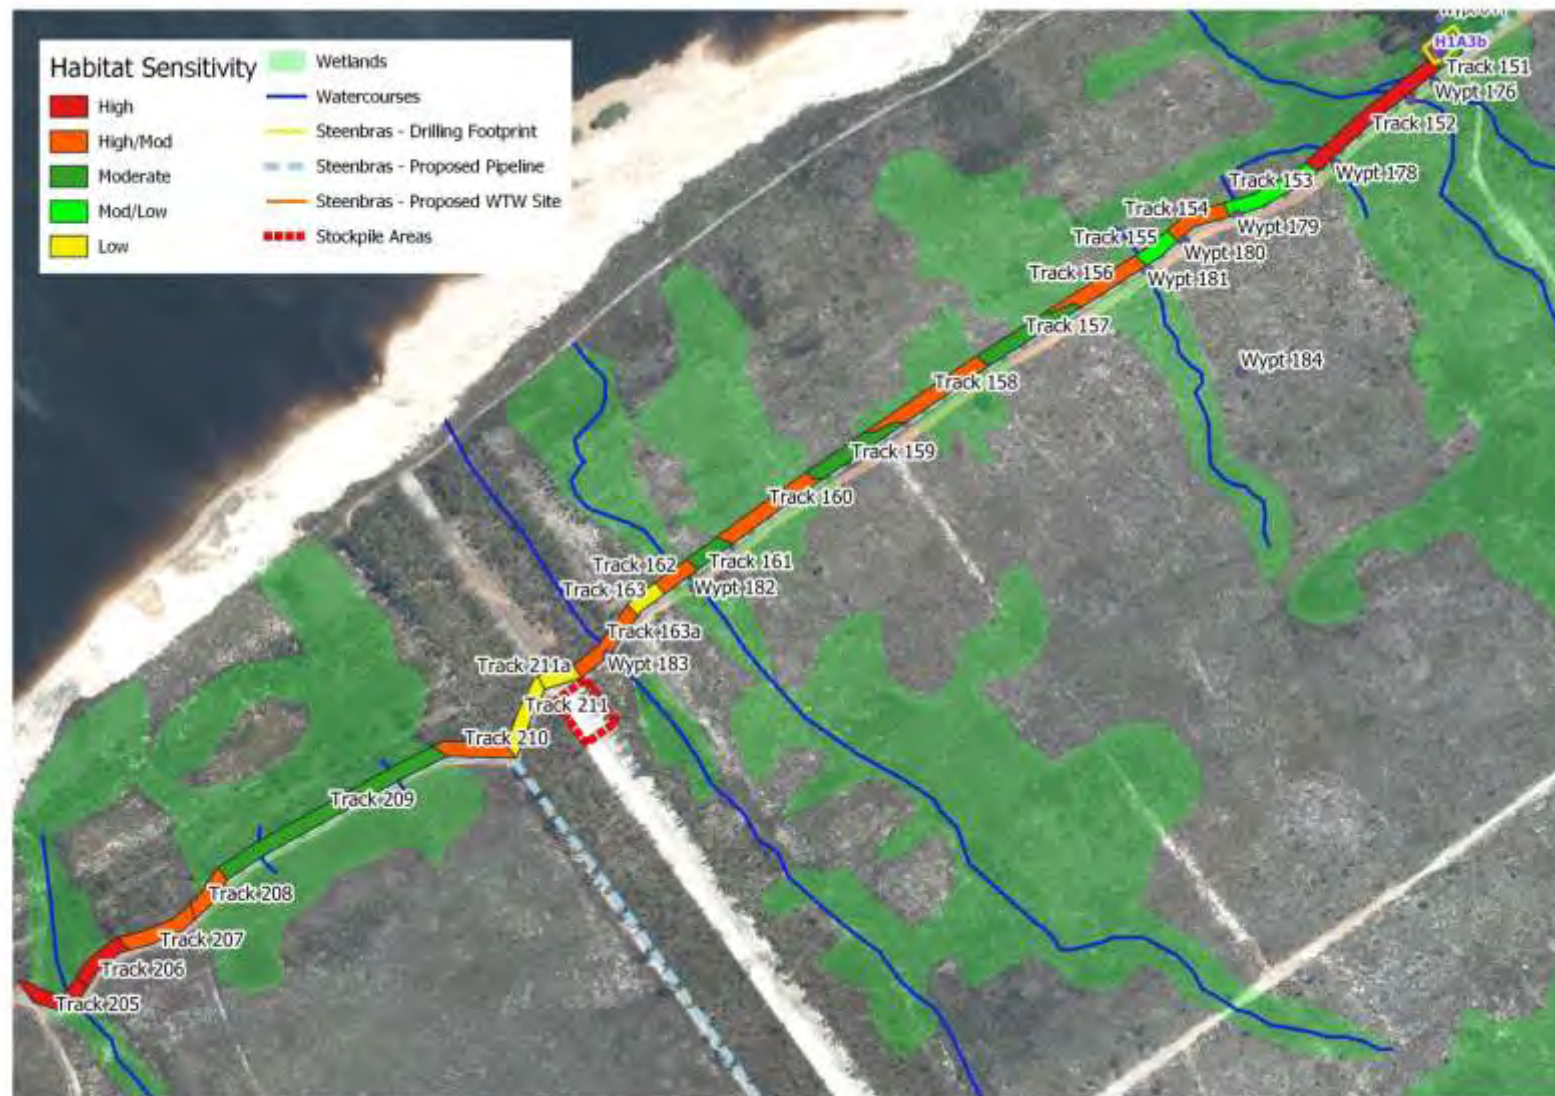
Figure 4.18 Management Unit 8 Habitat Sensitivity.

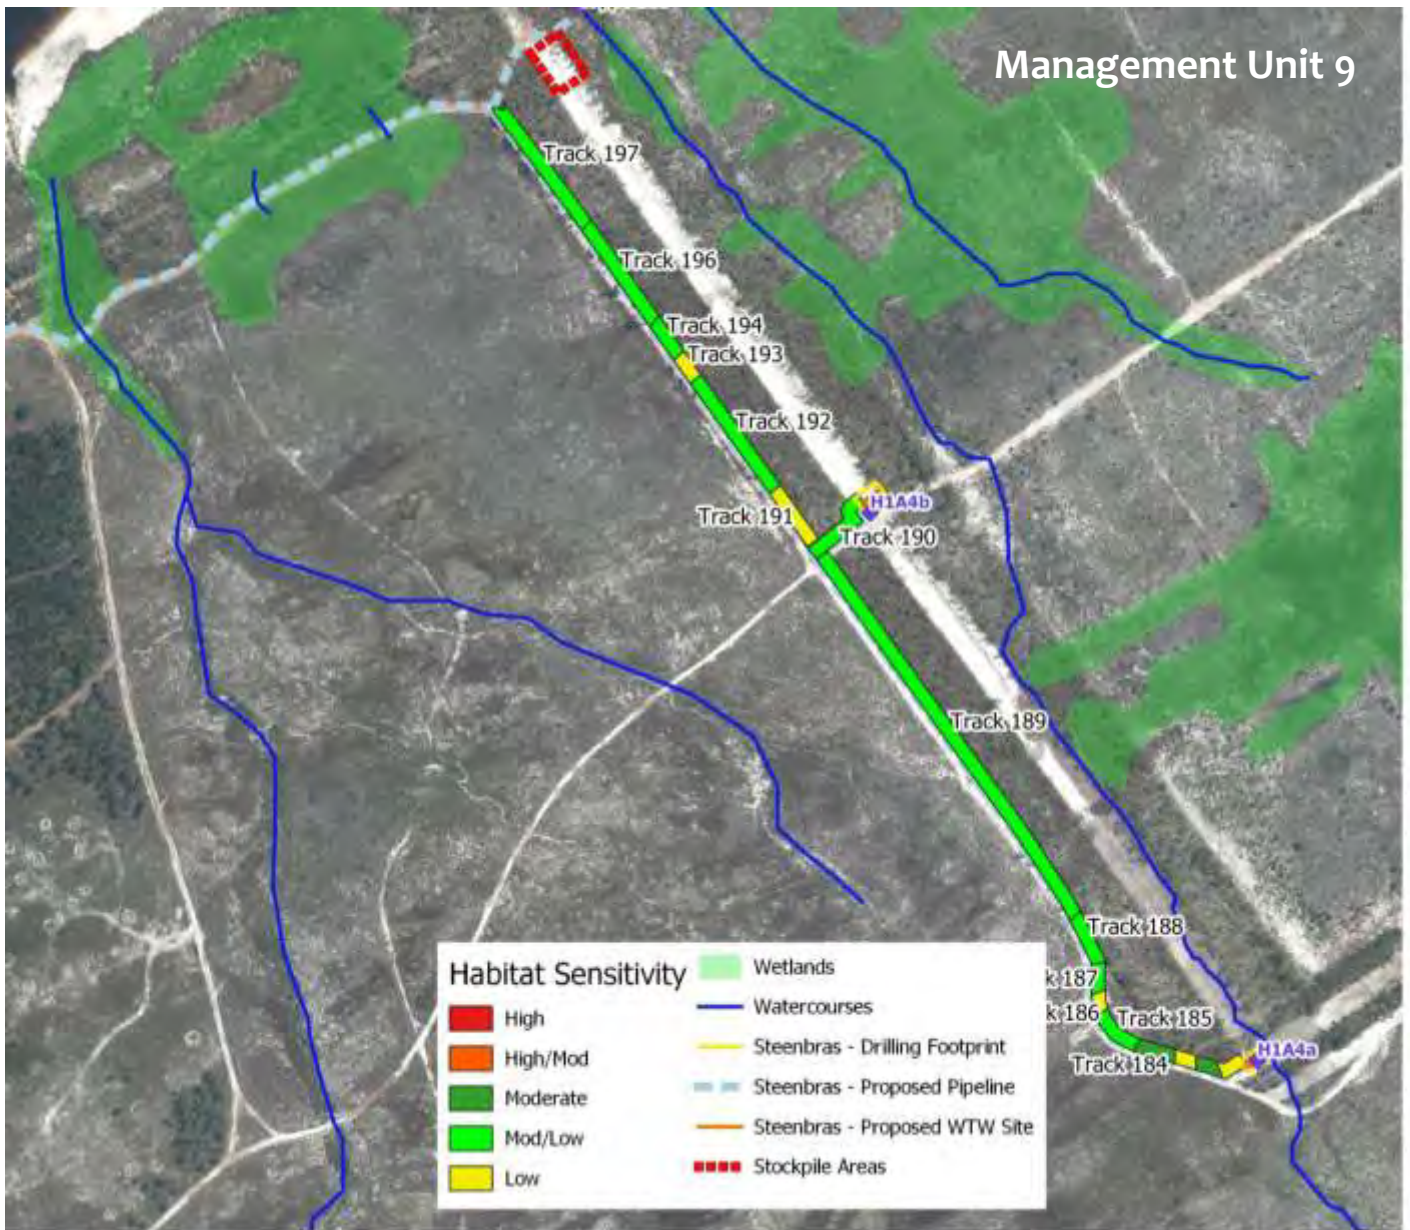
Figure 4.20 Management Unit 9 Habitat Sensitivity.

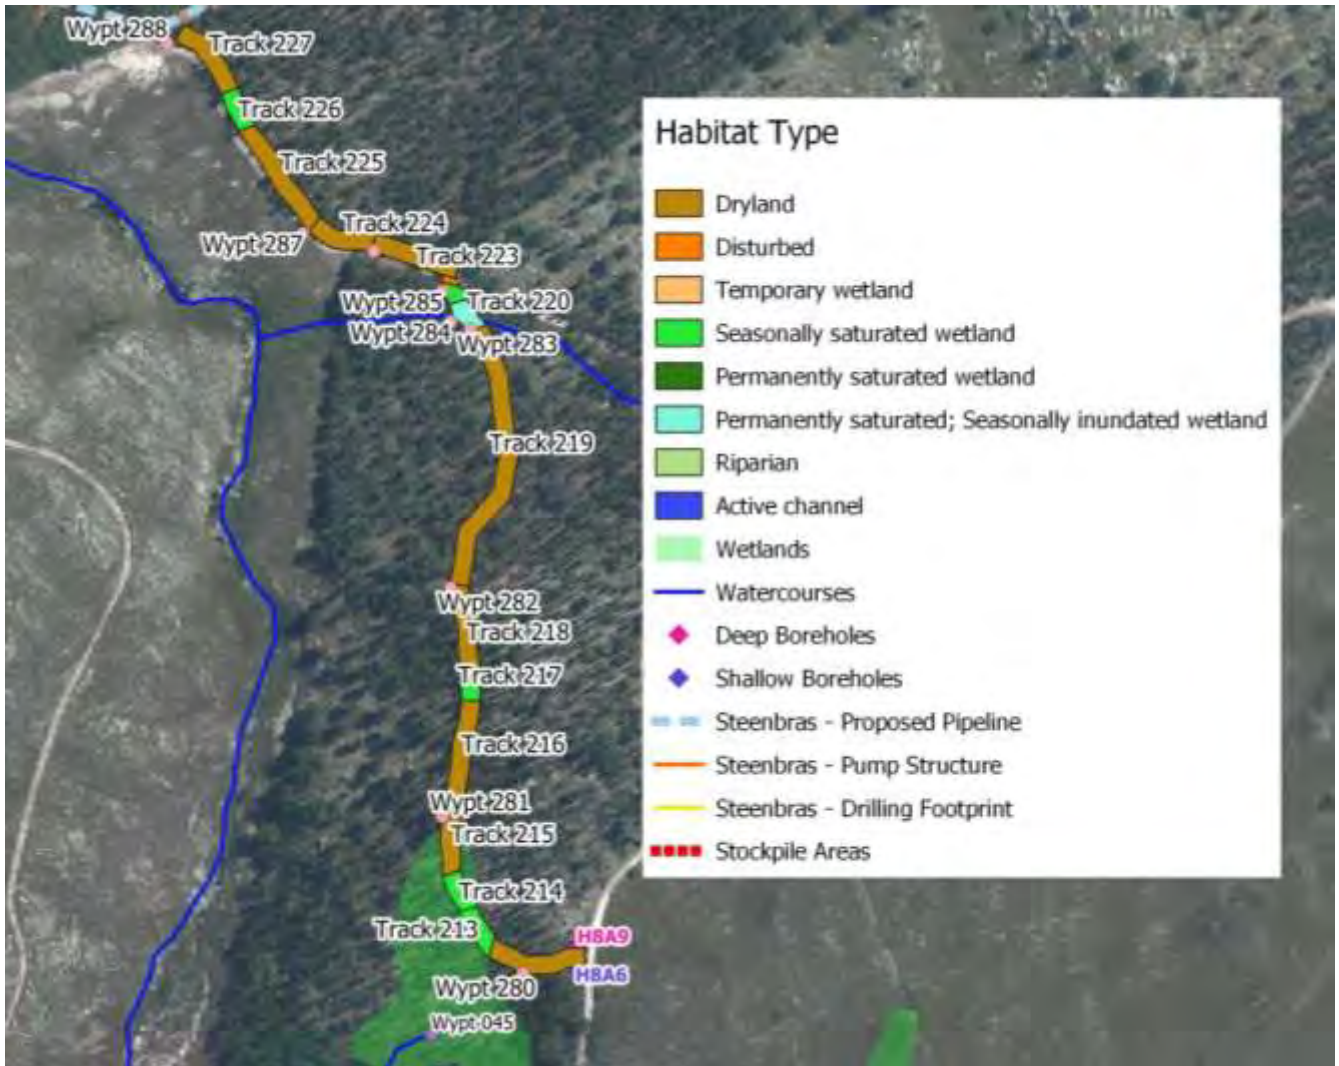
Figure 4.41 Management Unit 17: Spatial extent of Habitat Type.

The majority of Management Unit 17 includes sandy dryland through mature pine plantations with small sections through seasonally saturated wetland habitat (Figure 4. 41). There are a few rocky areas, particularly adjacent to the dirt road (Track 224) where the pipeline/powerline route would traverse a rocky outcrop with large boulders of Moderate to High sensitivity (Figure 4.42; Table 4.17).
