# Bulk Waterline within the Morkels Cottage Conservation Area – Erven 32581, 32582 and 34477 Strand

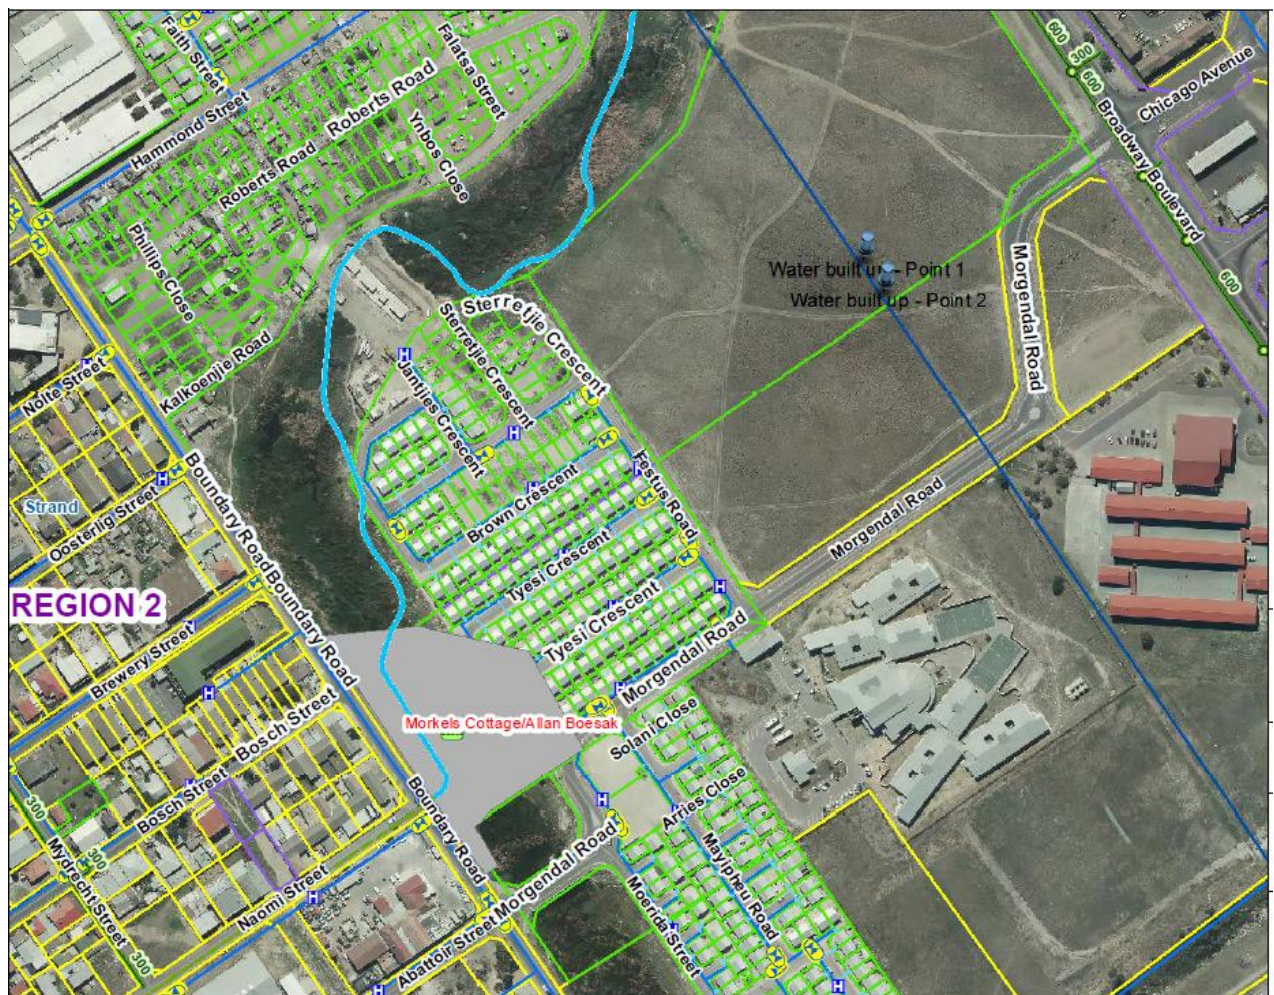
Figure 4: Bulk water line with leaks within the Morkel's Cottage Conservation Area

**An example of a MS for remedial works i.e. leaks:** The City of Cape Town - Bulk Water Department needs to effect remedial repairs on the 810mm DN Steel Steenbras Pipeline, location as specified in aerial image (figure2) below.

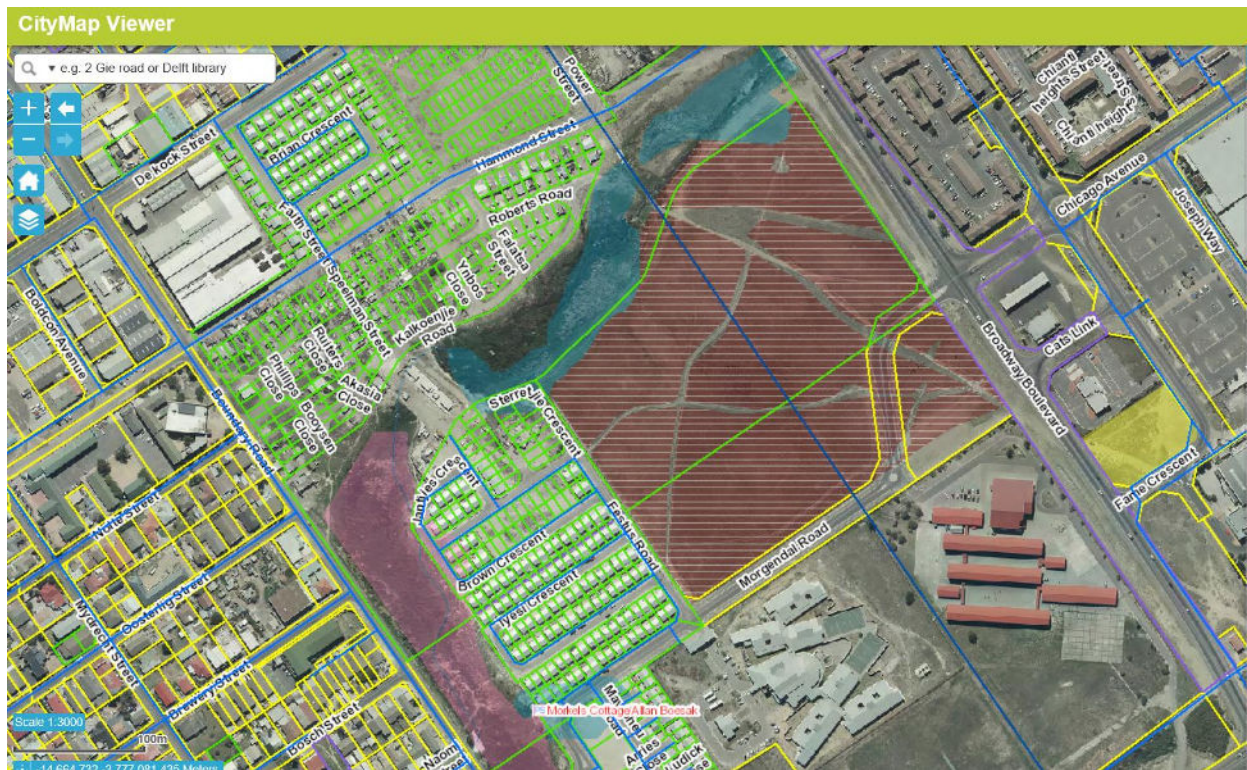
Figure 5: Bulk Water line (blue line) and Conservation Area (Red polygon)
