## **PLANT SEARCH, RESCUE AND RELOCATION, AND HABITAT MANAGEMENT PLAN**

**FOR THE AUTHORISED 132 KILOVOLT  
TRANSMISSION POWERLINES TO CONNECT THE  
200 MEGAWATT SIBANYE GOLD PHOTOVOLTAIC  
ENERGY FACILITY FOR SIBANYE GOLD LIMITED IN  
WESTONARIA, GAUTENG PROVINCE.**

**Prepared for:** Zutari  
**Prepared by:** Scientific Terrestrial Services (Pty) Ltd.  
**Report author:** C. Steyn (Pr. Sci. Nat)  
**Report reviewers:** N. Cloete (Pr. Sci. Nat)  
**Report Reference:** STS 222029  
**Date:** May 2022  
Amended January 2023

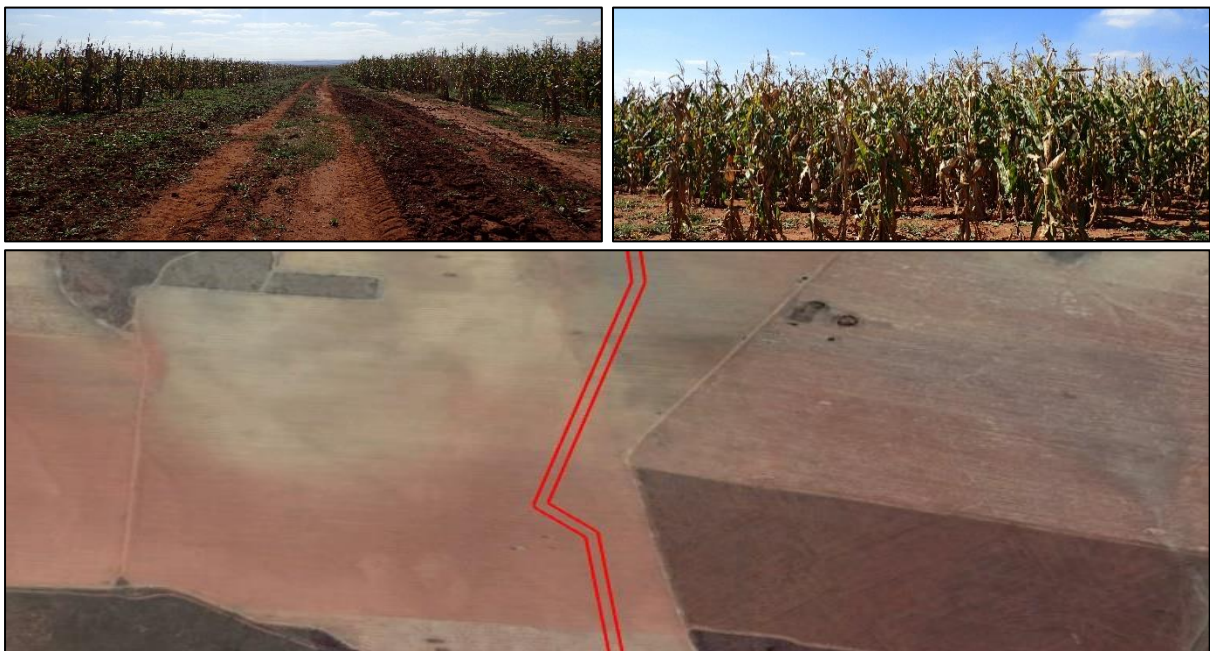
Figure 5: Representative photos of the Transformed Habitat on site.

**Transformed** areas (Figure 5) associated with crop fields, mining areas and associated infrastructure. Floral sensitivity is low and not representative of the natural vegetation type. No floral SCC were associated with this unit during the SAS 215197 (2016) field assessment, nor were any recorded during the 2022 floral walkdown.

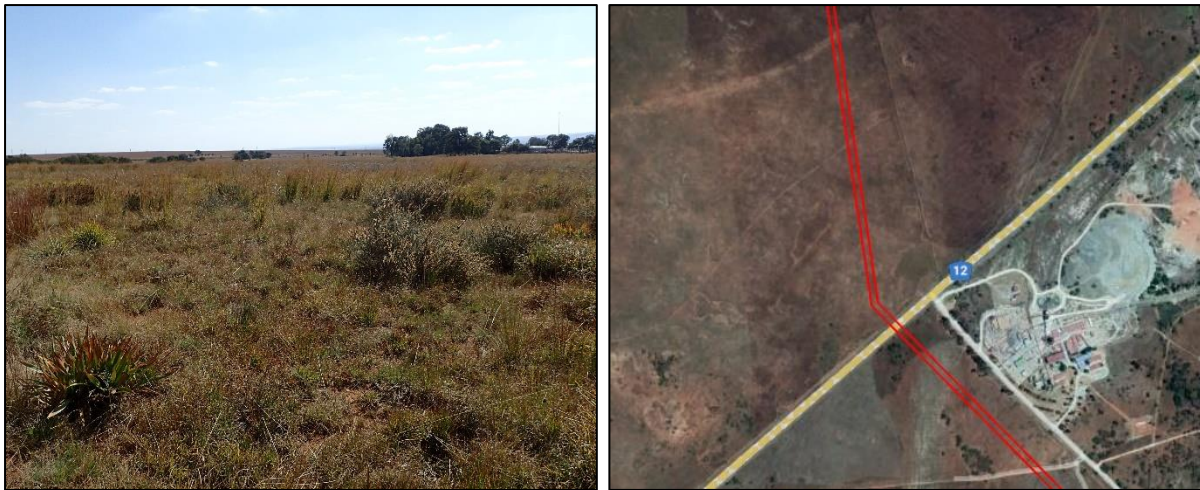
**Figure 6: Representative photos of the Secondary Grassland Habitat on site.**

**Secondary grasslands** (Figure 6) where edge effects from agriculture and other activities have led to the transformation of natural grassland habitat to a secondary state of ecological succession. Floral SCC were not mentioned for this habitat unit during the SAS 215197 (2016) field assessment; however, several Orange Listed species were recorded during the 2022 floral walkdown.

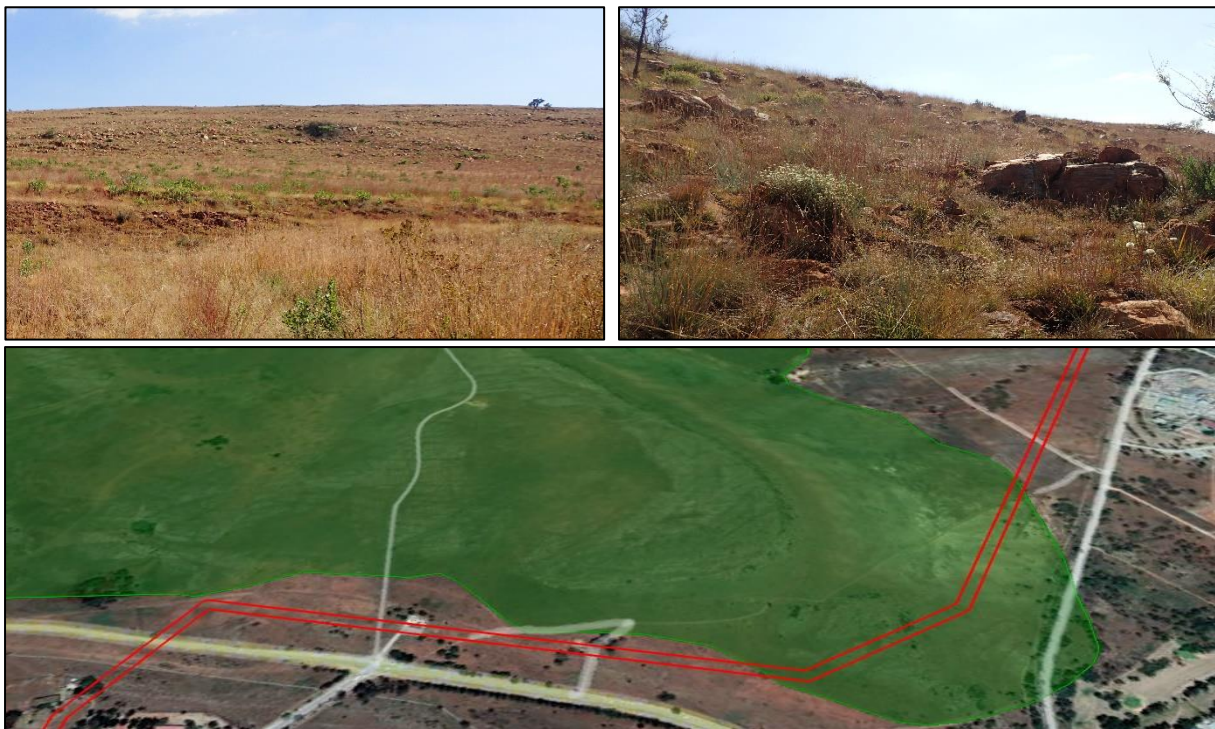
**Figure 7: Representative photos of the Ridge Habitat on site outlined in green in the bottom photo.**

**Ridges** (Figure 7) associated with Gauteng Shale Mountain Bushveld - according to 2018 Final Vegetation Map of South Africa, Lesotho, and Swaziland (SANBI, 2018a), as well as the 2018 Terrestrial ecosystem threat status and protection level - remaining extent (SANBI, 2018b; Skowno et al., 2019). This habitat unit is associated with rocky ridges and higher elevation areas within the study area. Primary grassland conditions predominate this habitat unit, and the overall habitat integrity and ecological function is high. Floral SCC were associated with this unit during the SAS 215197 (2016) field assessment and were recorded during the 2022 floral walkdown.

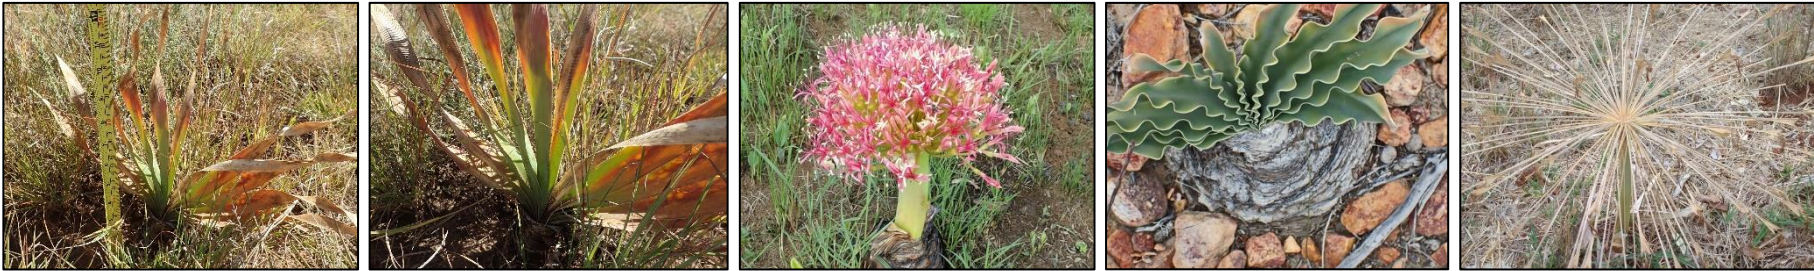
| REFERENCE PHOTOS | |
|---|---|
| The first two photos were taken on site. The last three are from online resources (iNaturalist – Photo Licence: CCO <sup>5</sup> ). | |

| REFERENCE PHOTOS | |
|---|---|
| <b>Condition and size class of species within footprint area</b> | All specimens in site were moderately large, healthy individuals. The bulb varied between 8 cm and 15 cm in diameter above ground (below-ground not measured). The fan of the leaves was dying back at the time of assessment, but it could be established that the fans reached approximately 30 cm – 50 cm in height. |

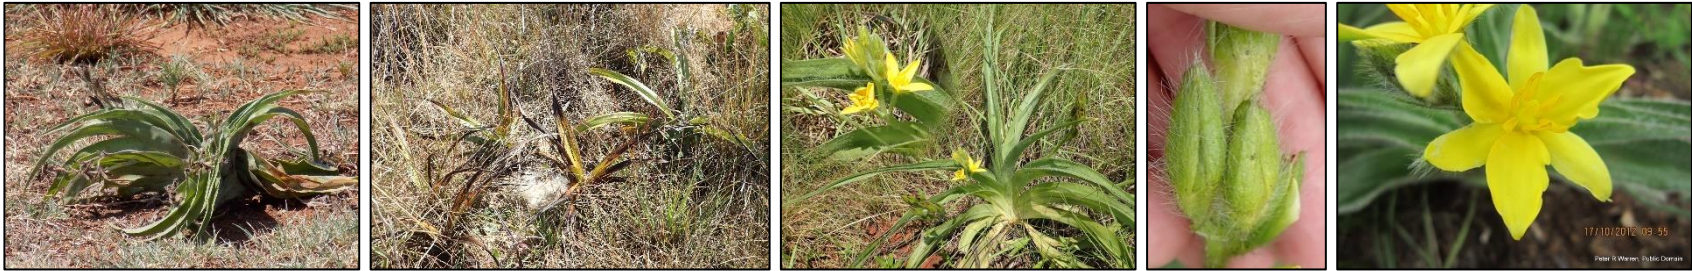
| REFERENCE PHOTOS | |
|---|---|
| The first two photos were taken on site. The last three are from online resources (iNaturalist – Photo Licence: CCO <sup>8</sup> ). | |

| REFERENCE PHOTOS | |
|---|---|
| <b>Condition and size class of species within footprint area</b> | <p>All specimens in site were moderately large, healthy individuals. The species were starting to die back for the winter (leaves fall off and the plant will no longer be visible above ground).</p> <p><b>Number of species recorded:</b> approximately 143 specimens.</p> |
