# **Groundwater Impact Assessment for the Proposed Expansion of the Klip Road Cemetery, Grassy Park, Cape Town**

Prepared by  
**GEOSS**  
26 June 2024

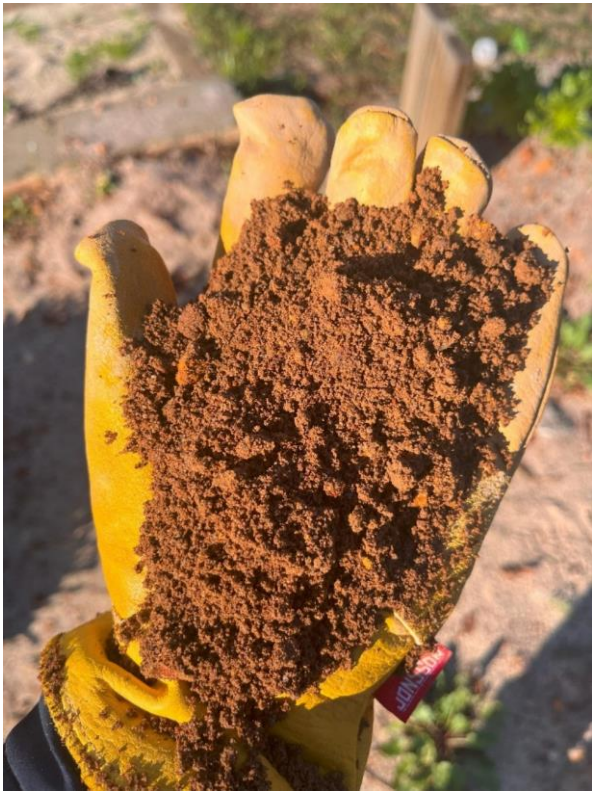
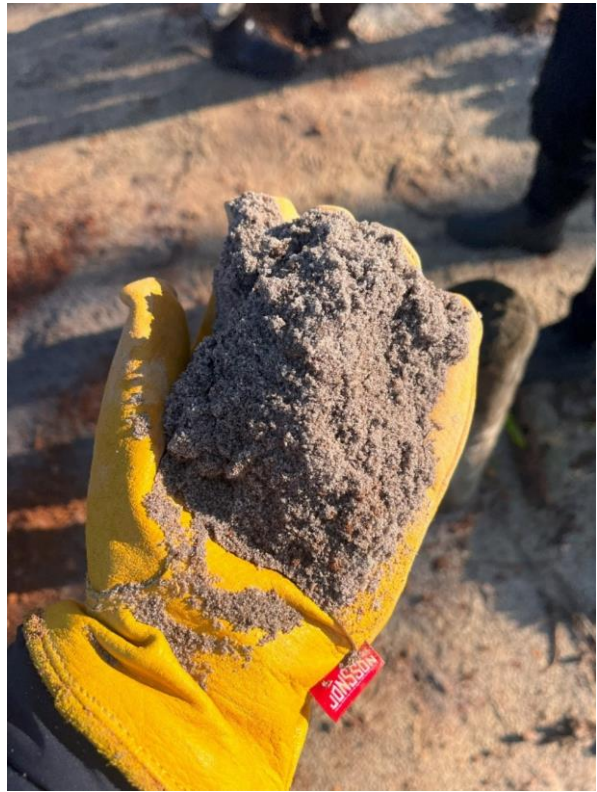
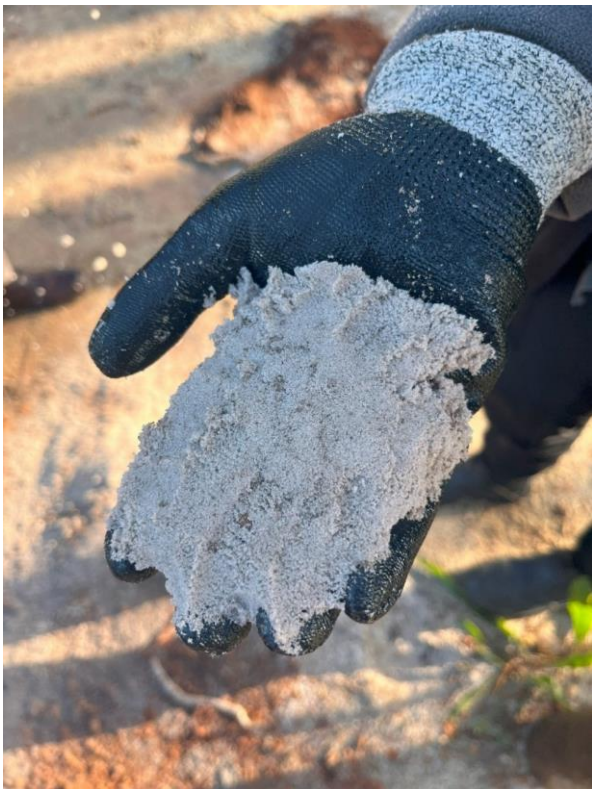
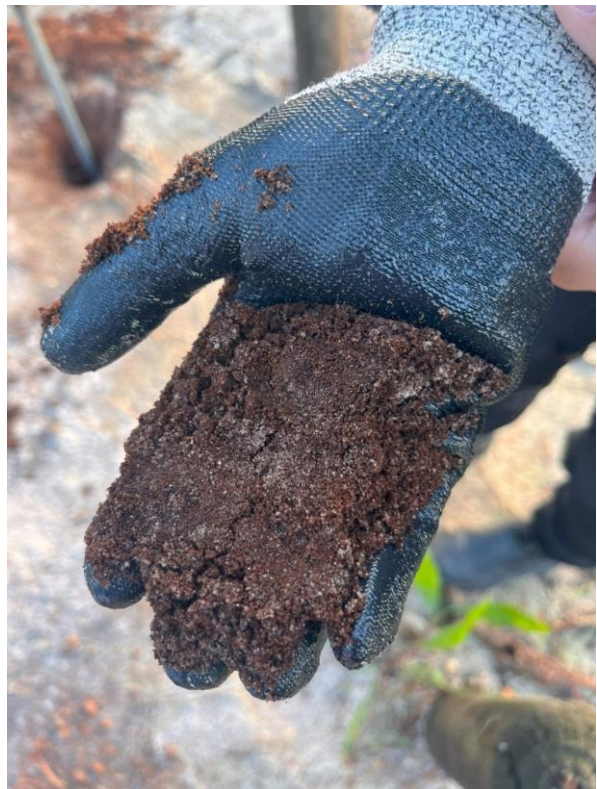
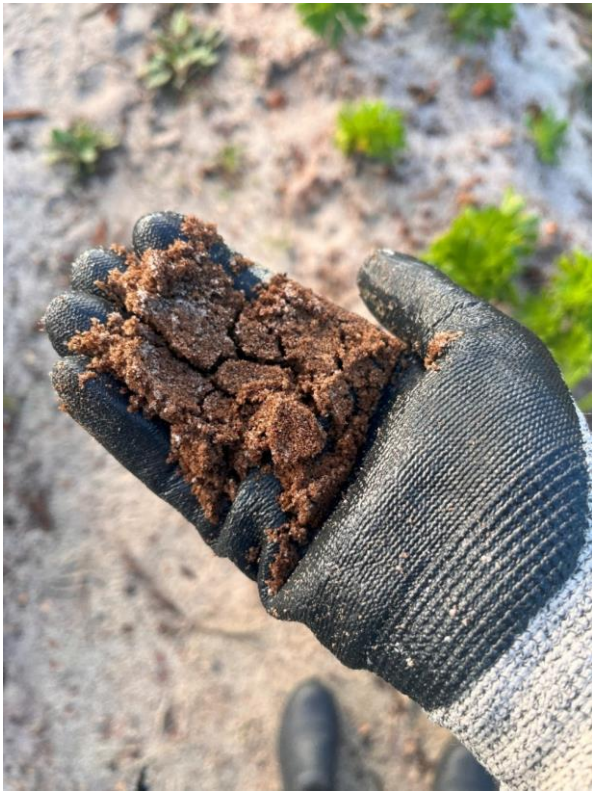
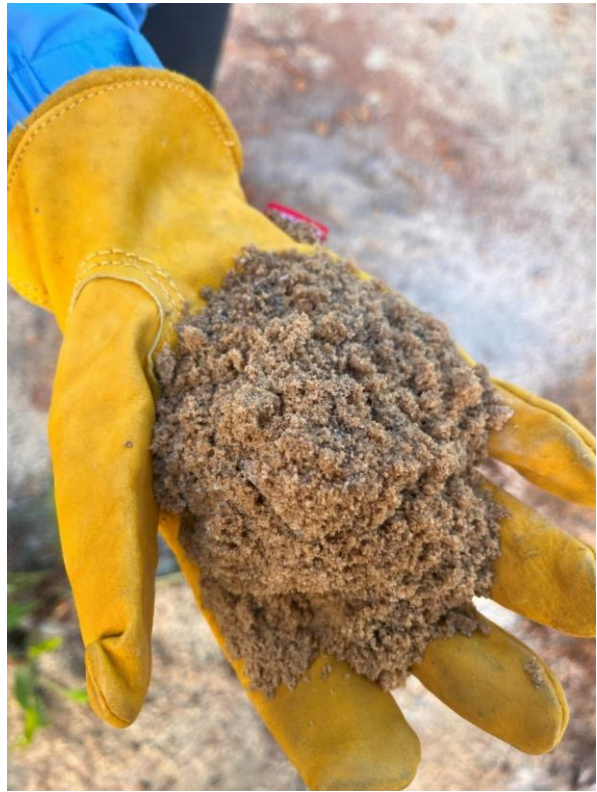
*Photo 1 - 10: Soil profiles encountered at PZ1*

A site walk-over sought to identify and confirm hydrological and hydrogeological features of relevance. It must be noted that during the desktop assessment portion of the study, prior to the site visit, piezometer locations were planned along the suspected flow path, in undeveloped areas. During the site visit, however, not all of these sites were accessible as they have been used as burial spaces. This is particularly true for PZ1. Field photographs are presented in Appendix C.

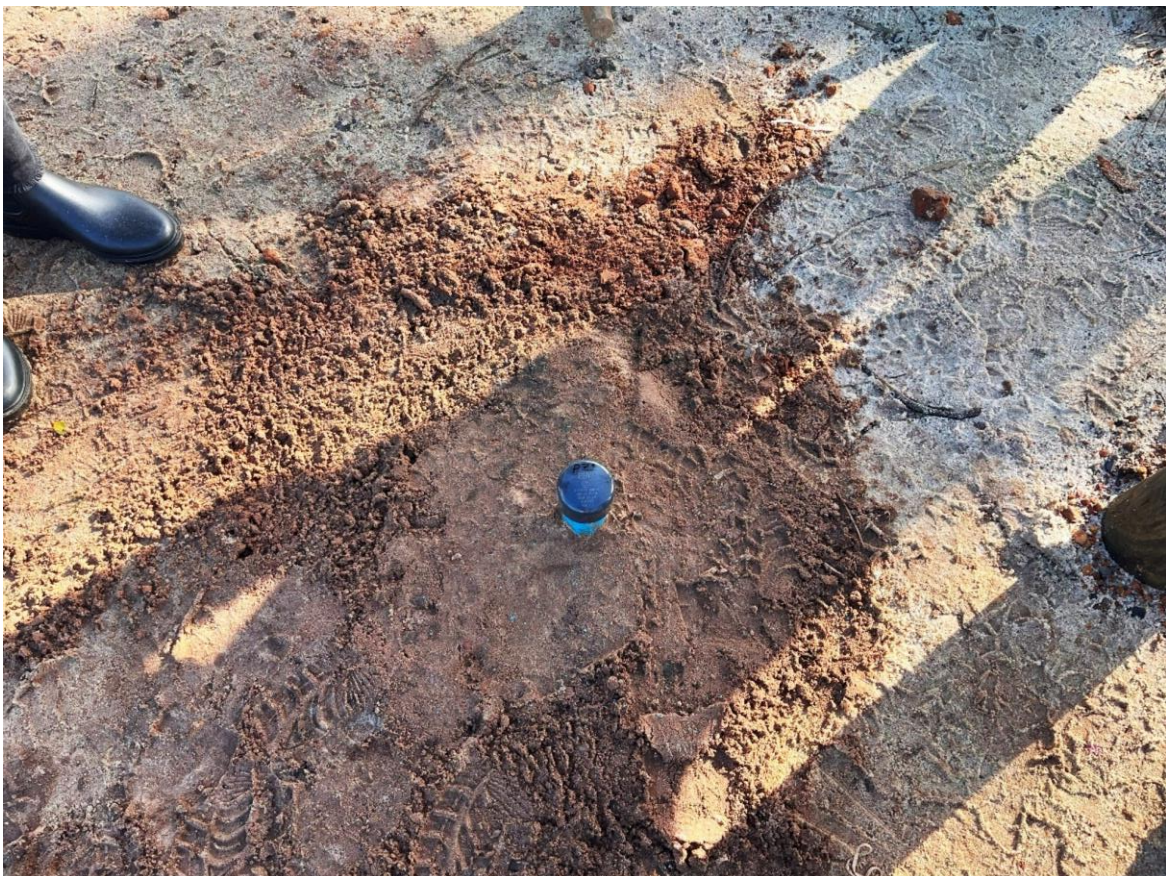
*Photo 11: Piezometer 1 (PZ1)*

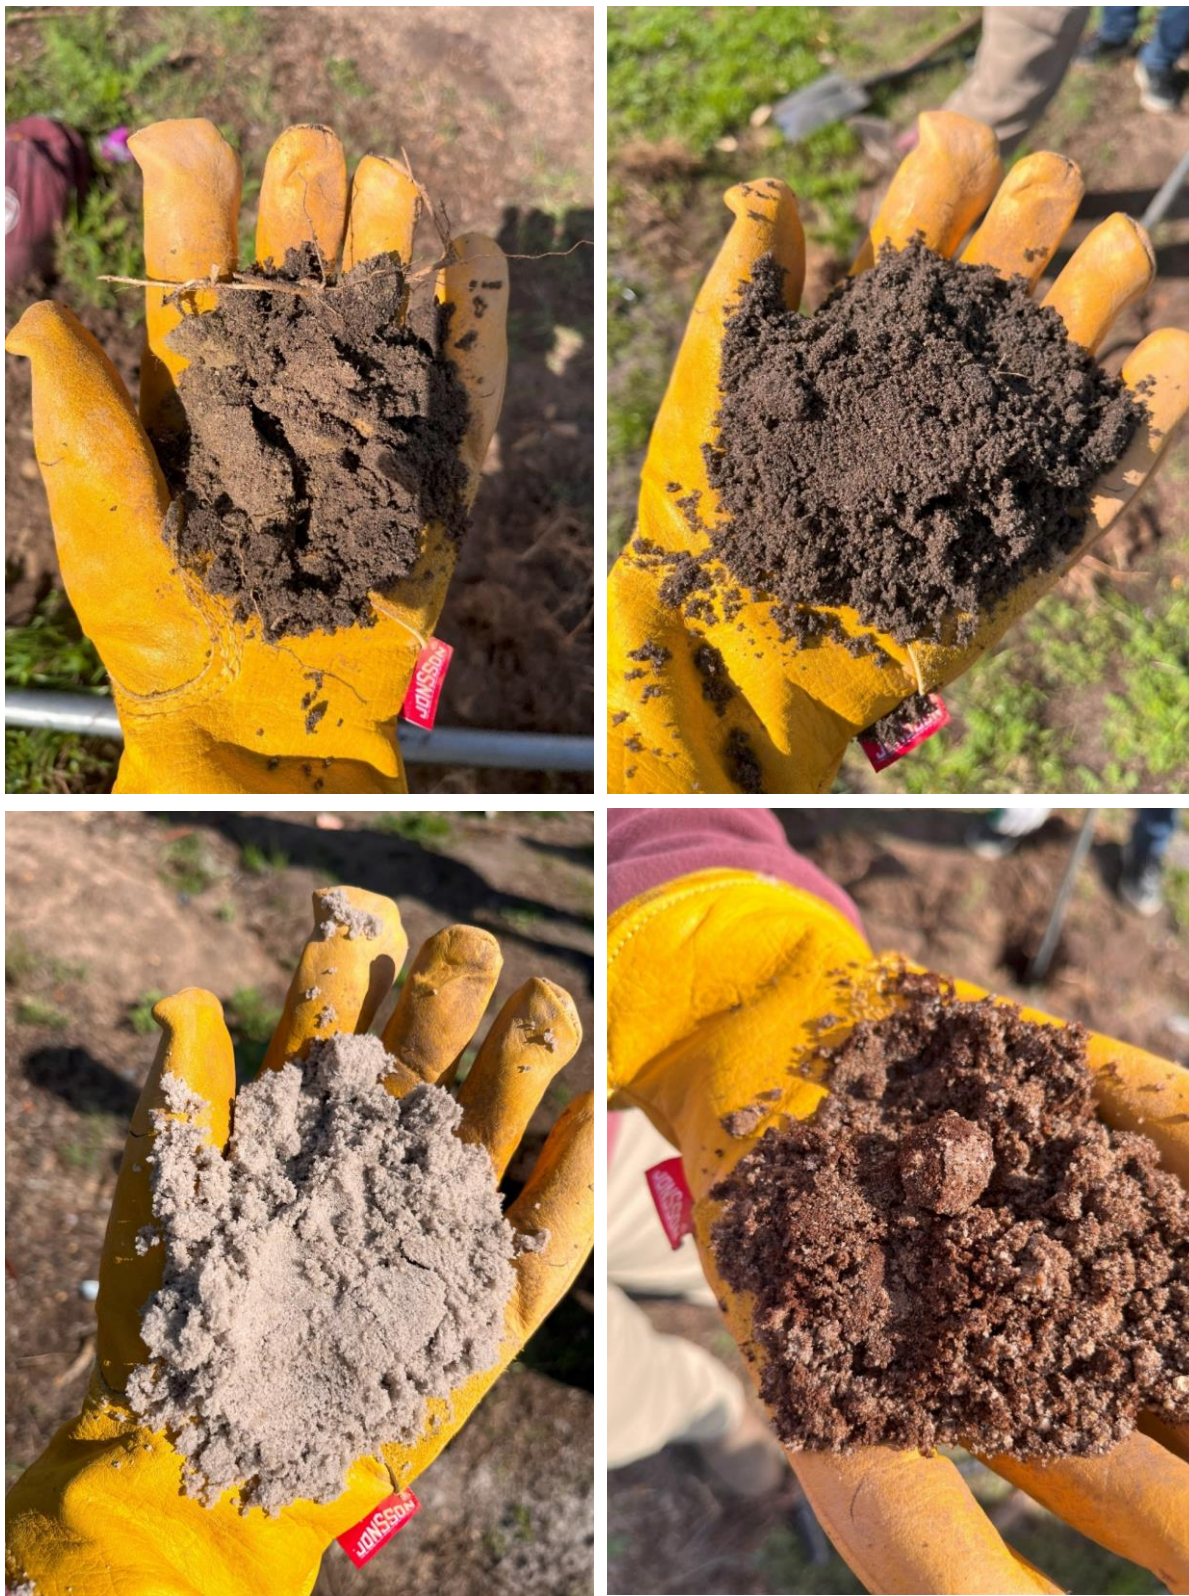
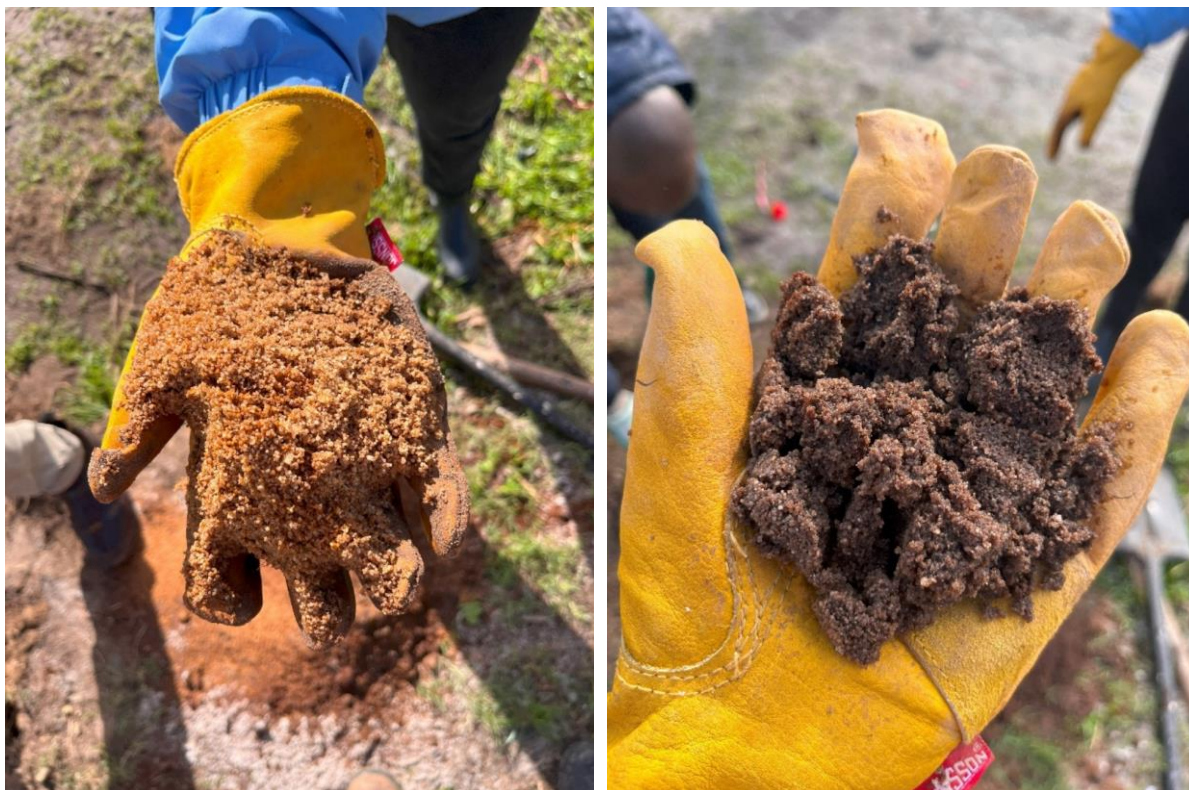
Photo 12 - 17: Soil profiles encountered at PZ2

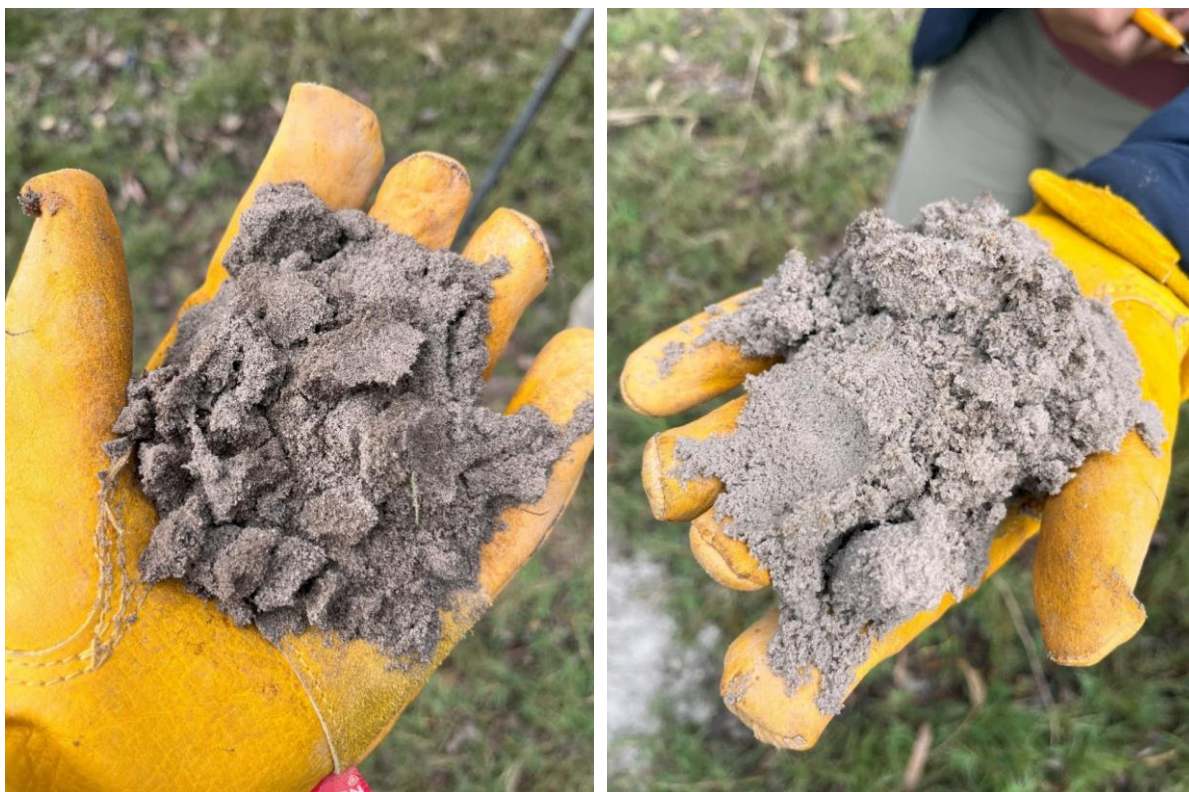
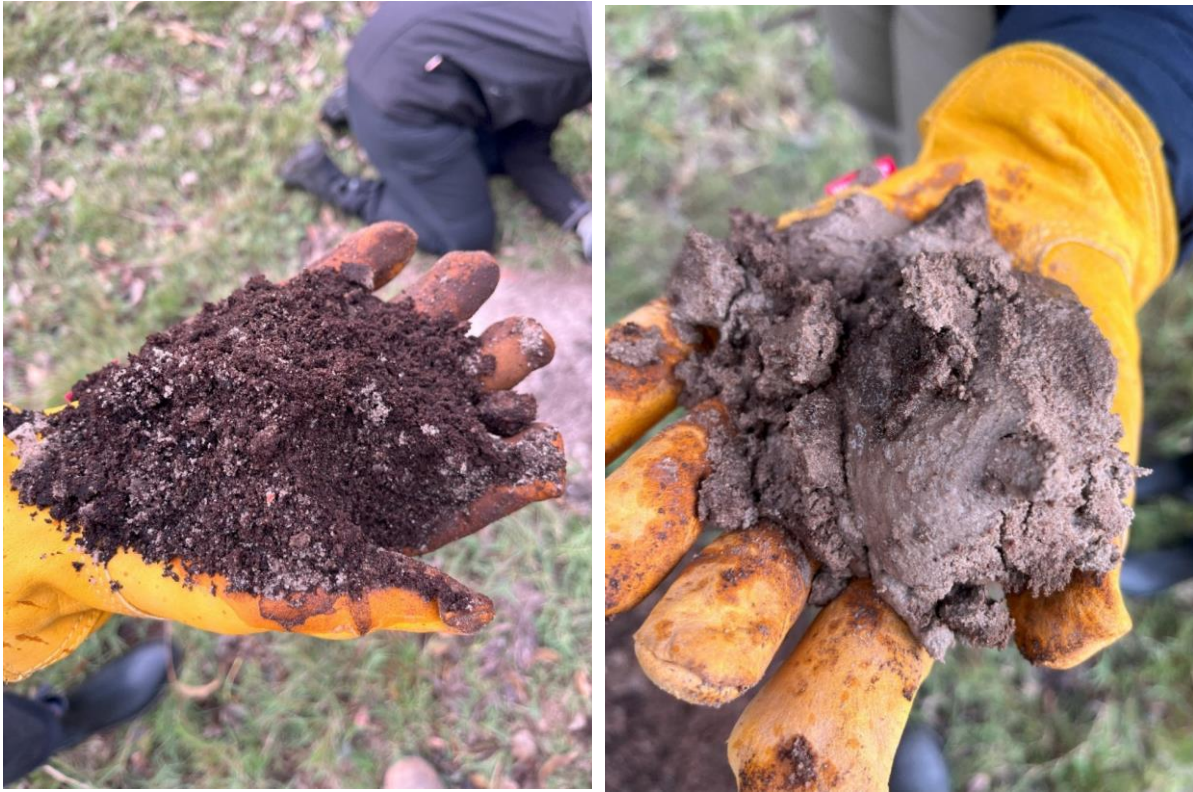
Photo 18 - 21: Soil profiles encountered at KRC\_PZ3 and piezometer 3 (KRC\_PZ3)

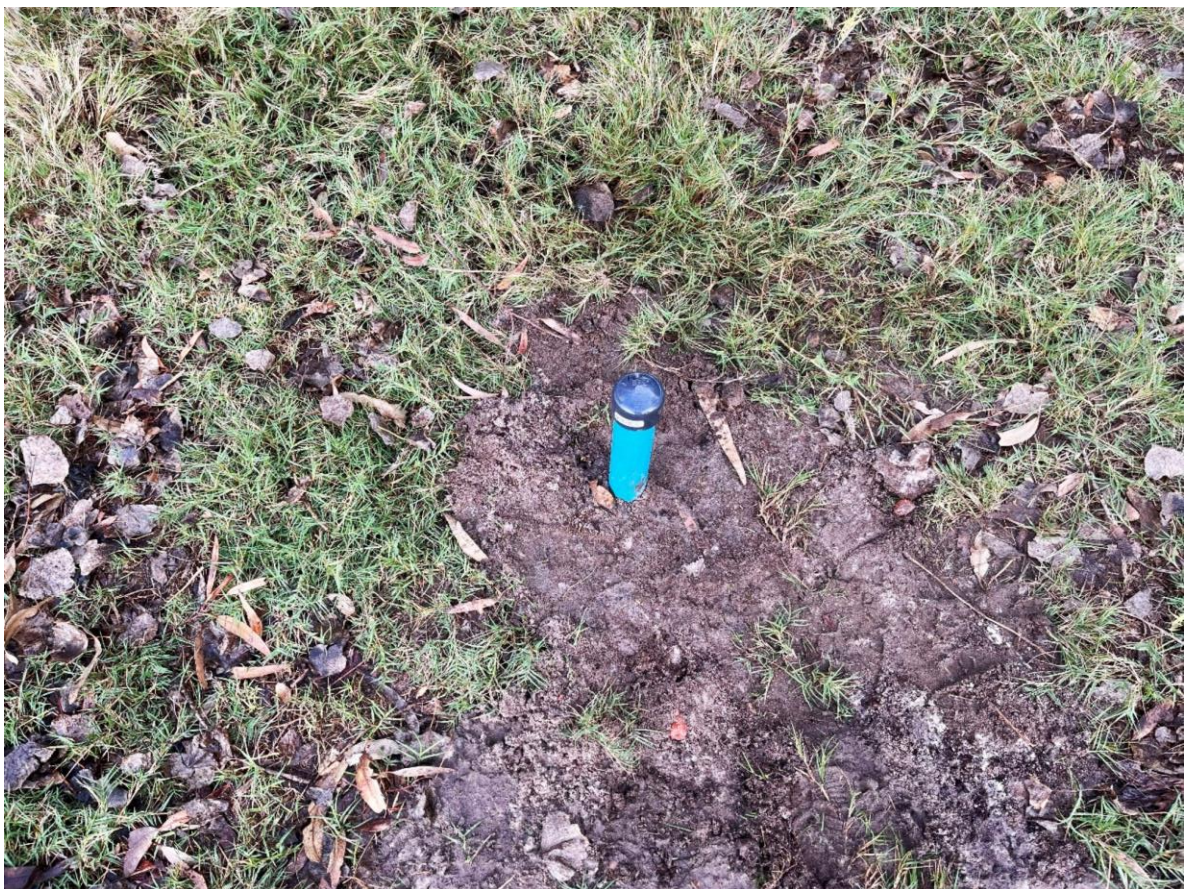
Photo 22: Piezometer 3 (PZ3)
