## *Groundwater Impact Assessment for the Proposed Extension of the Hout Bay Cemetery, Western Cape.*

GEOSS Report No: 2023/12-21

*20 December 2023*

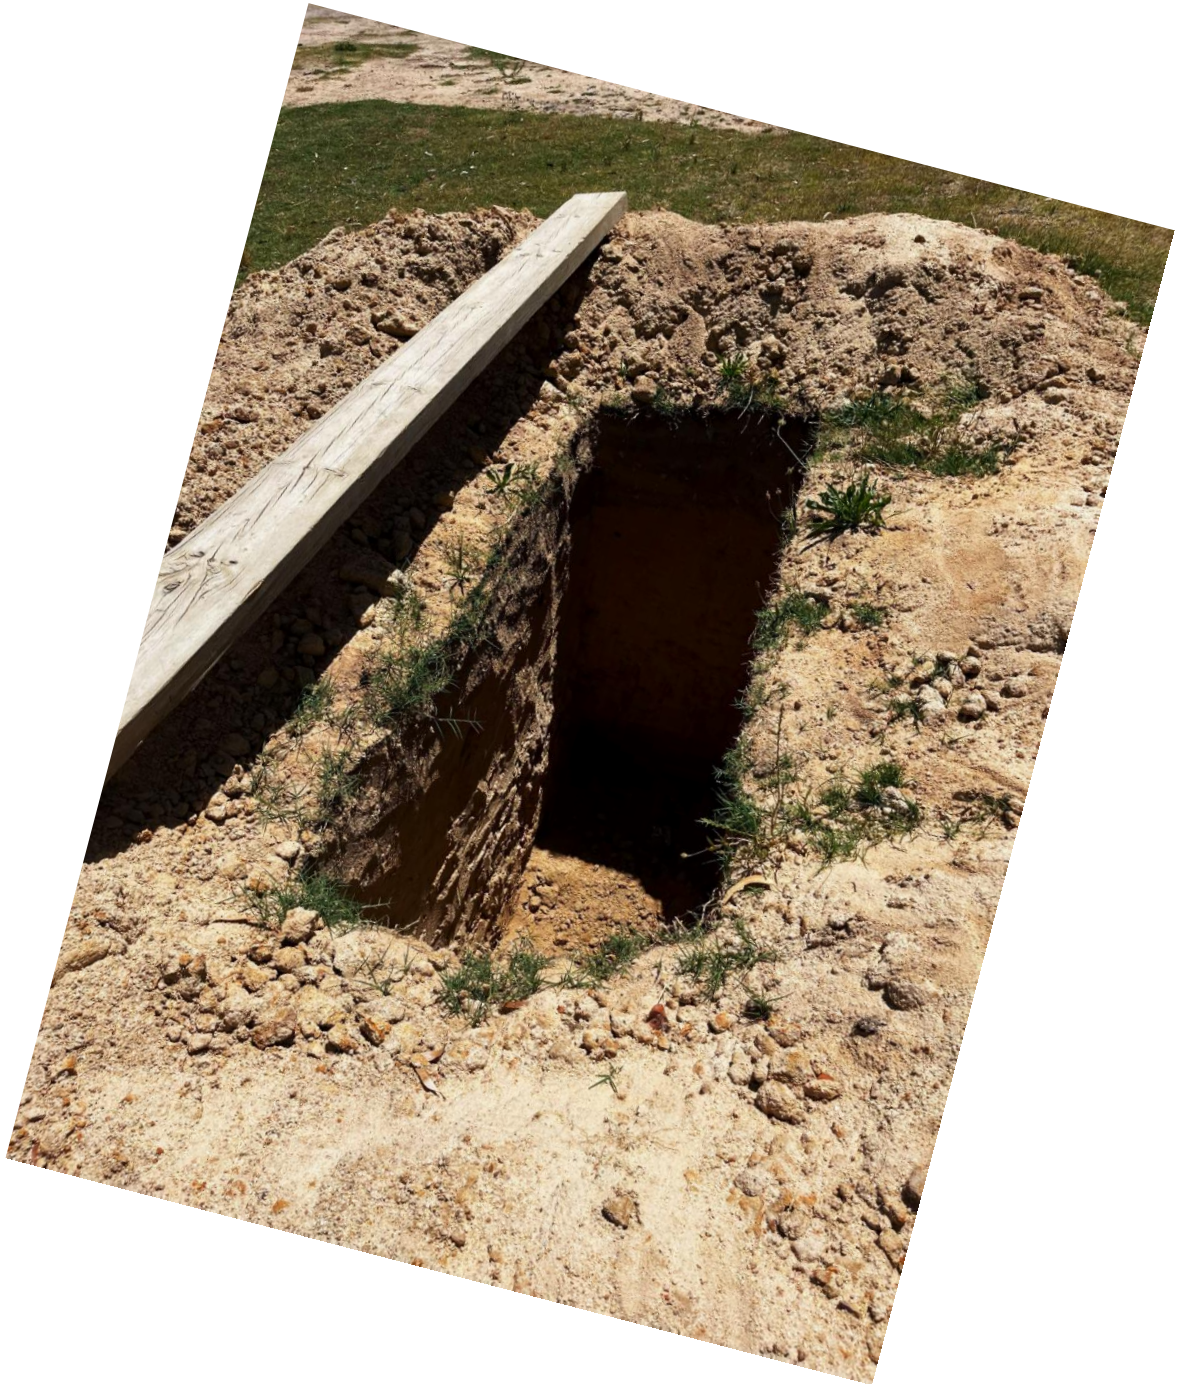
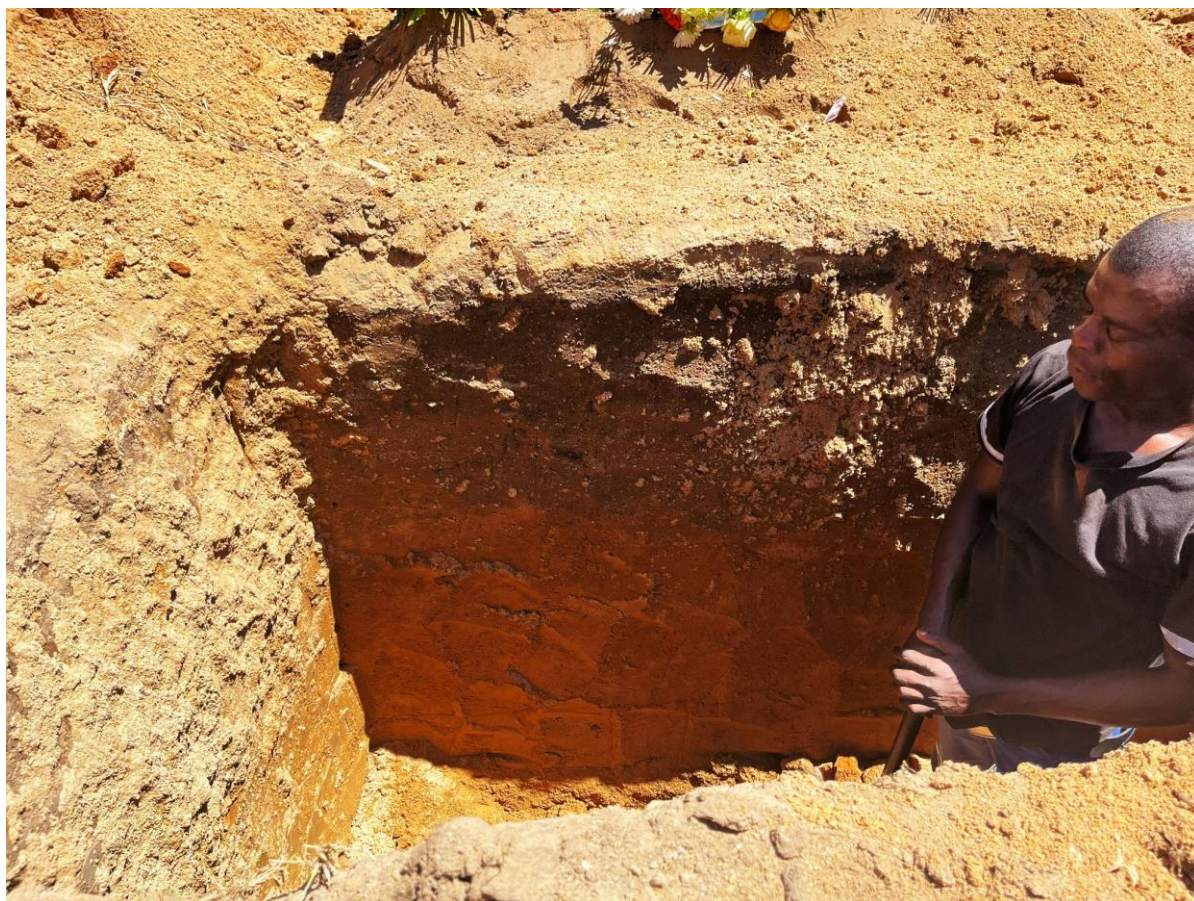
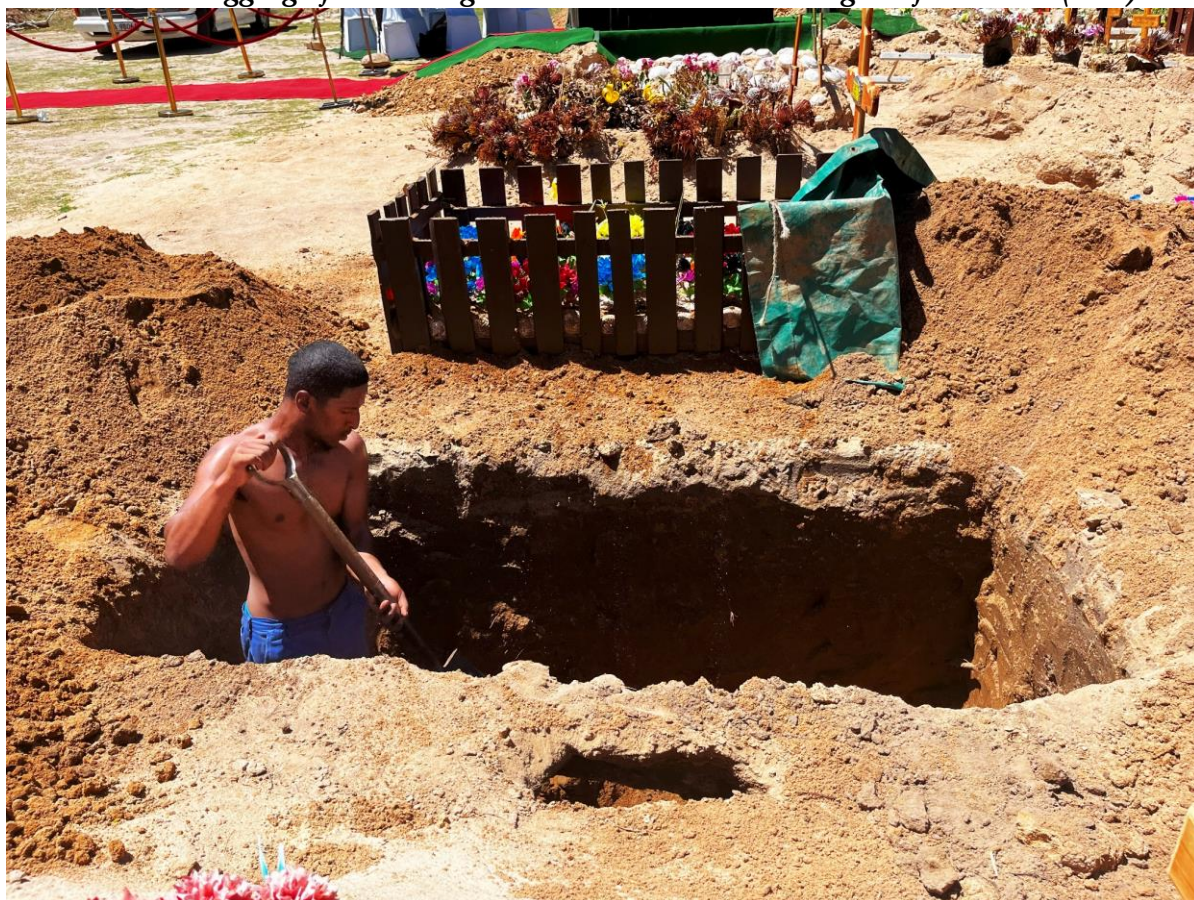
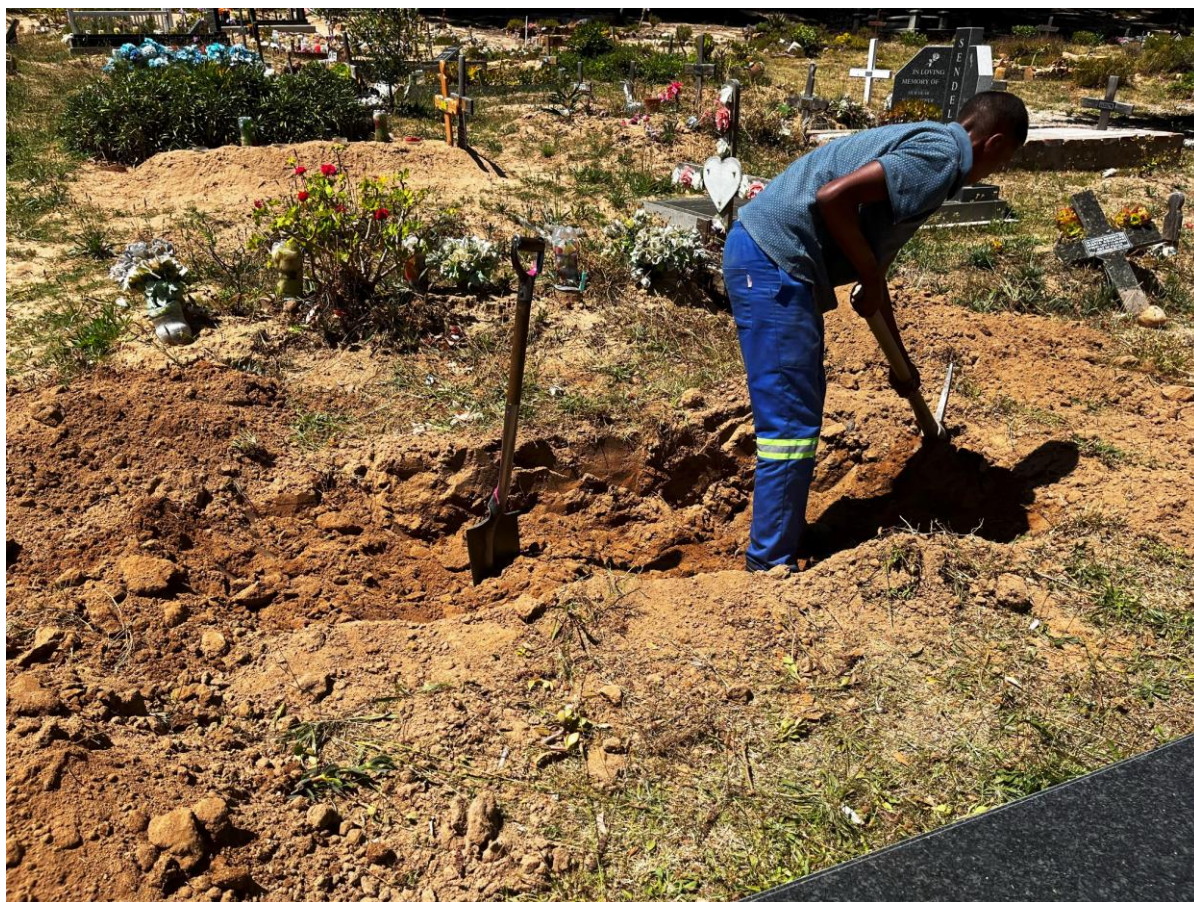
*Photo 5: Digging of a grave on site observed during the field work (GS1)*

*Photo 6: Digging of a second grave on site observed during the field work (GS2)*

*Photo 7: Digging of a third grave on site observed during the field work (GS3)*

*Photo 8: Digging of a fourth grave on site observed during the field work (GS4)*

During the site visit, however, four graves were being dug. These graves provided valuable information of the subsurface and further augering was deemed to be unnecessary. The graves were dug to a depth of 2 metres beneath the ground level at elevations ranging between 53 – 57 mamsl. All of the graves were observed to be dry. Communication with staff on site further confirmed that to the best of their knowledge, water has never been intersected during the digging of graves.

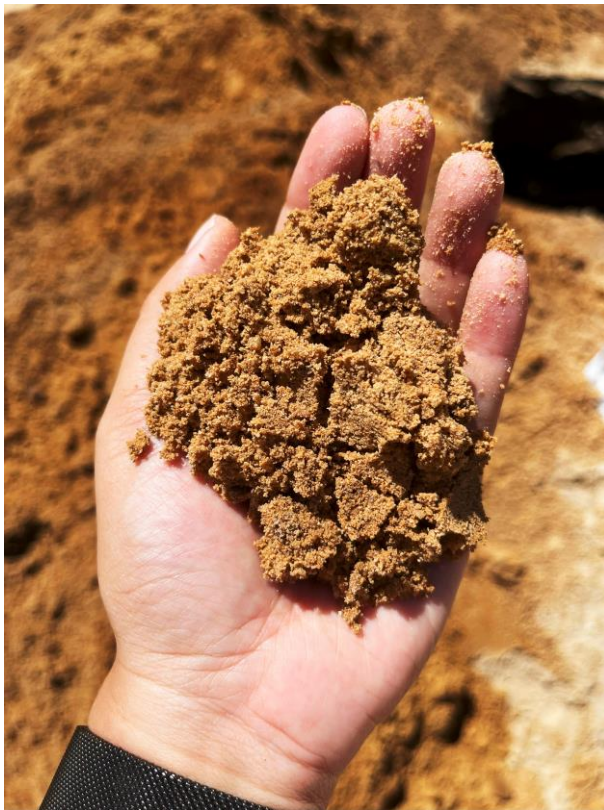
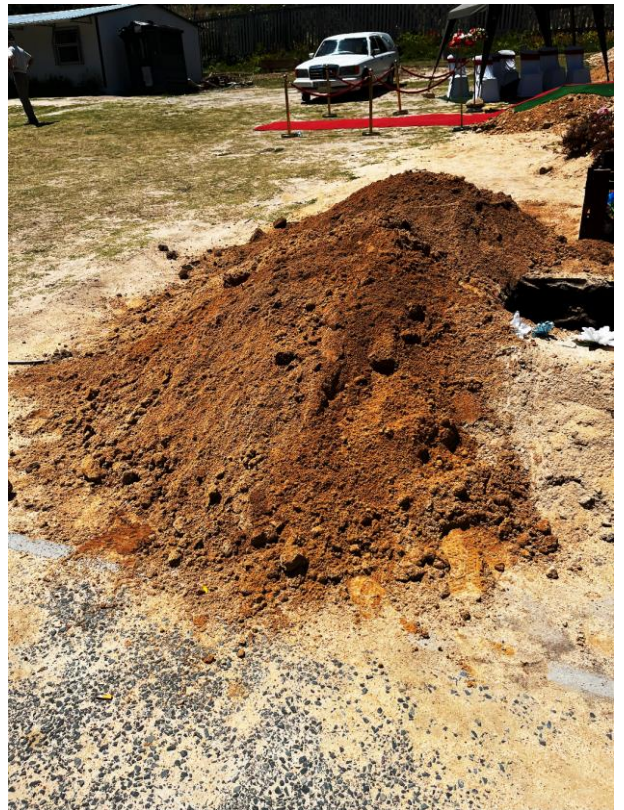
*Photo 15: Soil type observed on site*

*Photo 16: Soil type observed on site*

This site is dominated at the surface by a dry, unconsolidated, fine- to medium-grained, medium-brown sand. Small quartz grains (~1 – 2 mm) are present. Small roots may be present and this is regarded as the top soil layer. This soil type was observed at all of the grave sites which were dug to a depth of 2 metres below ground level.
