## BOTANICAL STATEMENT FOR PROPOSED REFURBISHMENT OF BASIN 6 AND BASIN 9, ATLANTIS

[Works Project No: BW-WP045 Atlantis Aquifer]

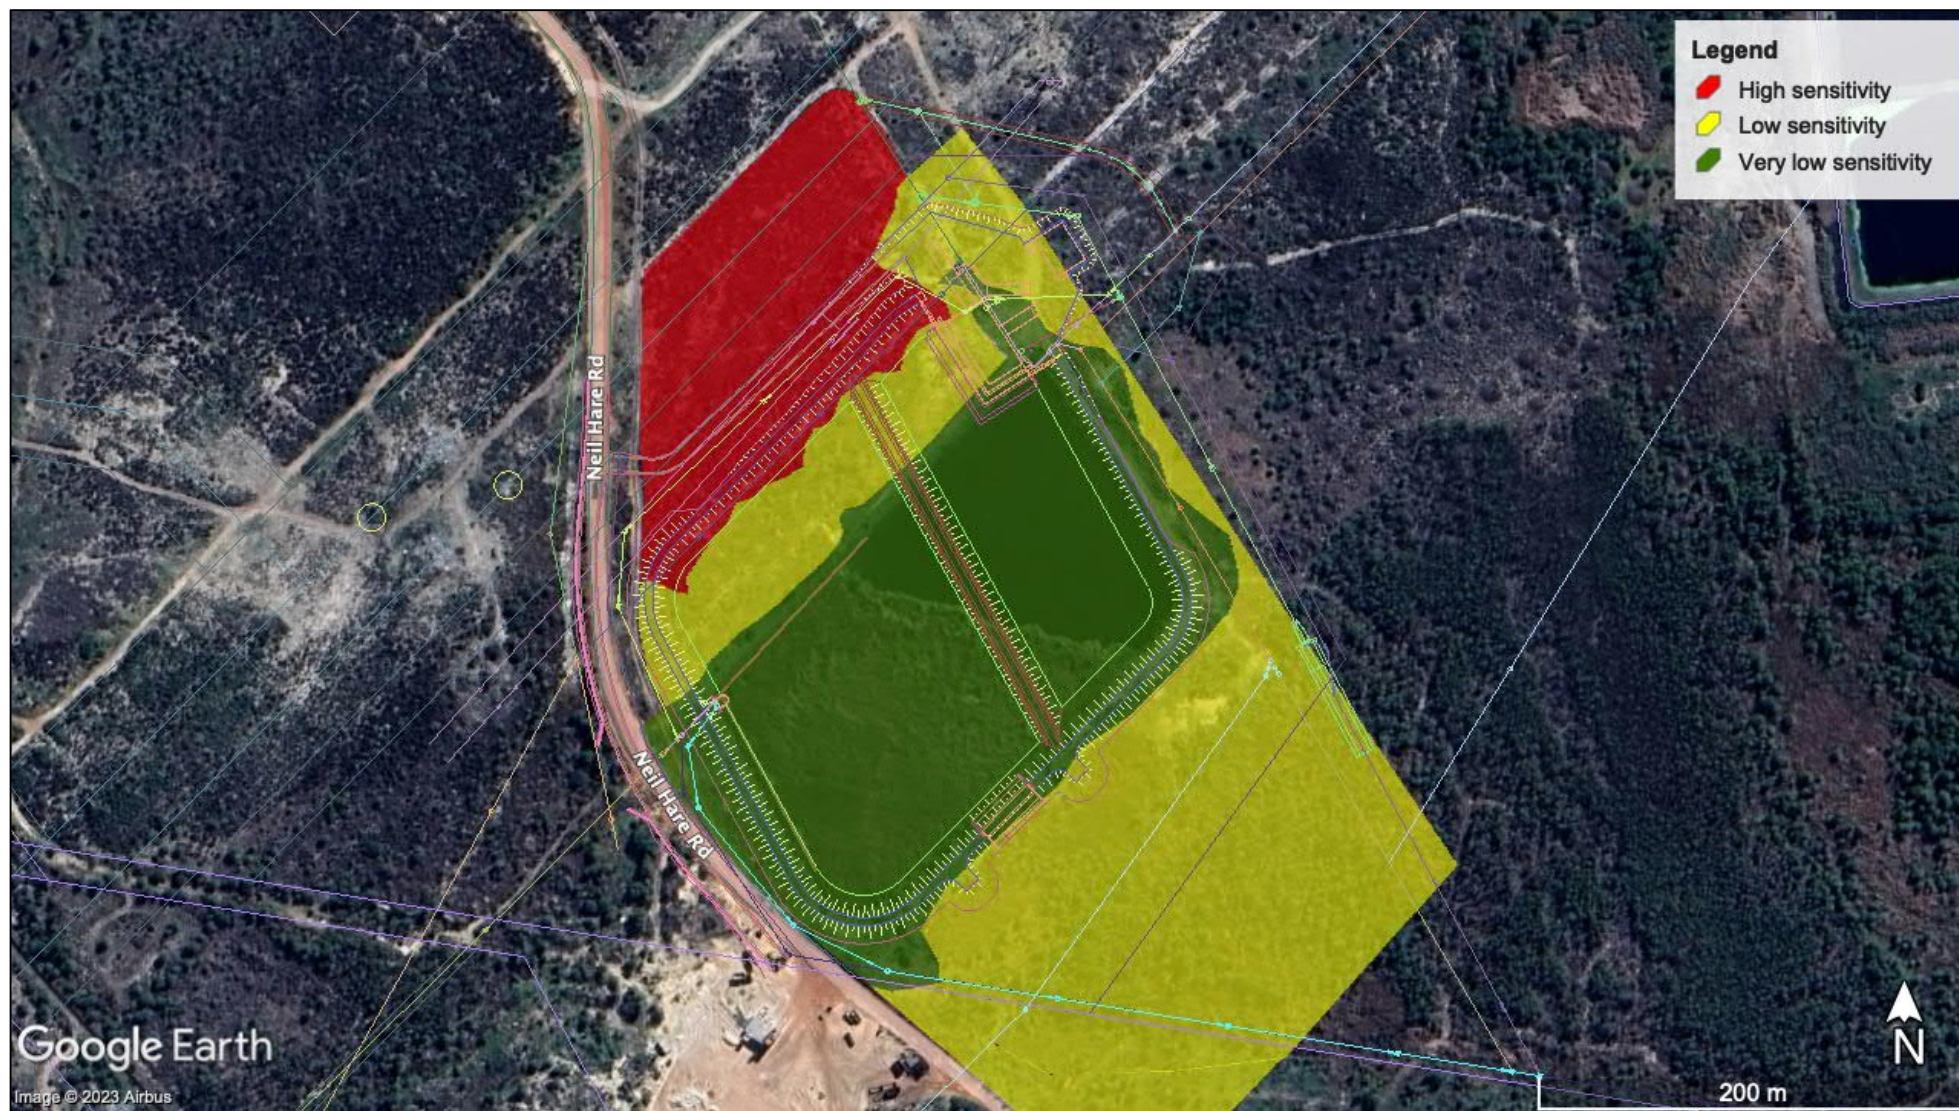
intact vegetation (Figure 2A). The semi-intact habitat is of high sensitivity due to (1) the endangered status of the vegetation type, (2) the presence of species of conservation concern (SCC) and (3) ecological connectivity to an adjacent and connected vegetation patch extending northwards (Figure 2B). It extends northwards to an Eskom servitude and beyond (Figure 3). The degraded and transformed habitats have low restoration potential and are of low sensitivity. The artificially wet areas on the southern side of the Basin are dominated by *Typha capensis* and very high density of Port Jackson willow.

Figure 2B. SENSITIVITY MAP: Basin 6 with footprint and sensitivity overlay represented on a Google Earth™ aerial image.

- If it is a feasible option the design should be amended to avoid the high sensitivity area shown in Figure 2B. This would involve shifting the footprint to the south and/or east away from the high sensitivity vegetation. The high sensitivity area would then need to be demarcated so that no activities impact this area.

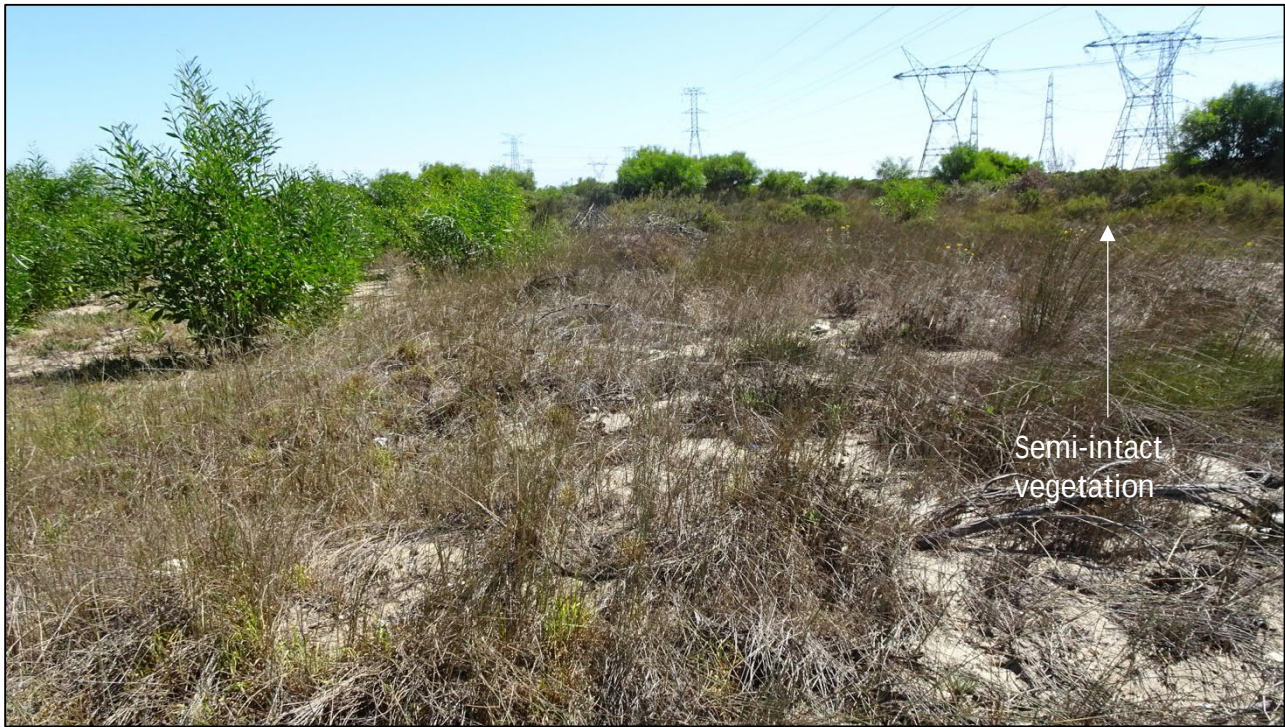
Figure 3. View of the transition from highly degraded to semi-intact remnant vegetation showing invasive Port Jackson willow on the edges. The Eskom servitude is visible in the background. The good quality vegetation continues northwards beyond the servitude.

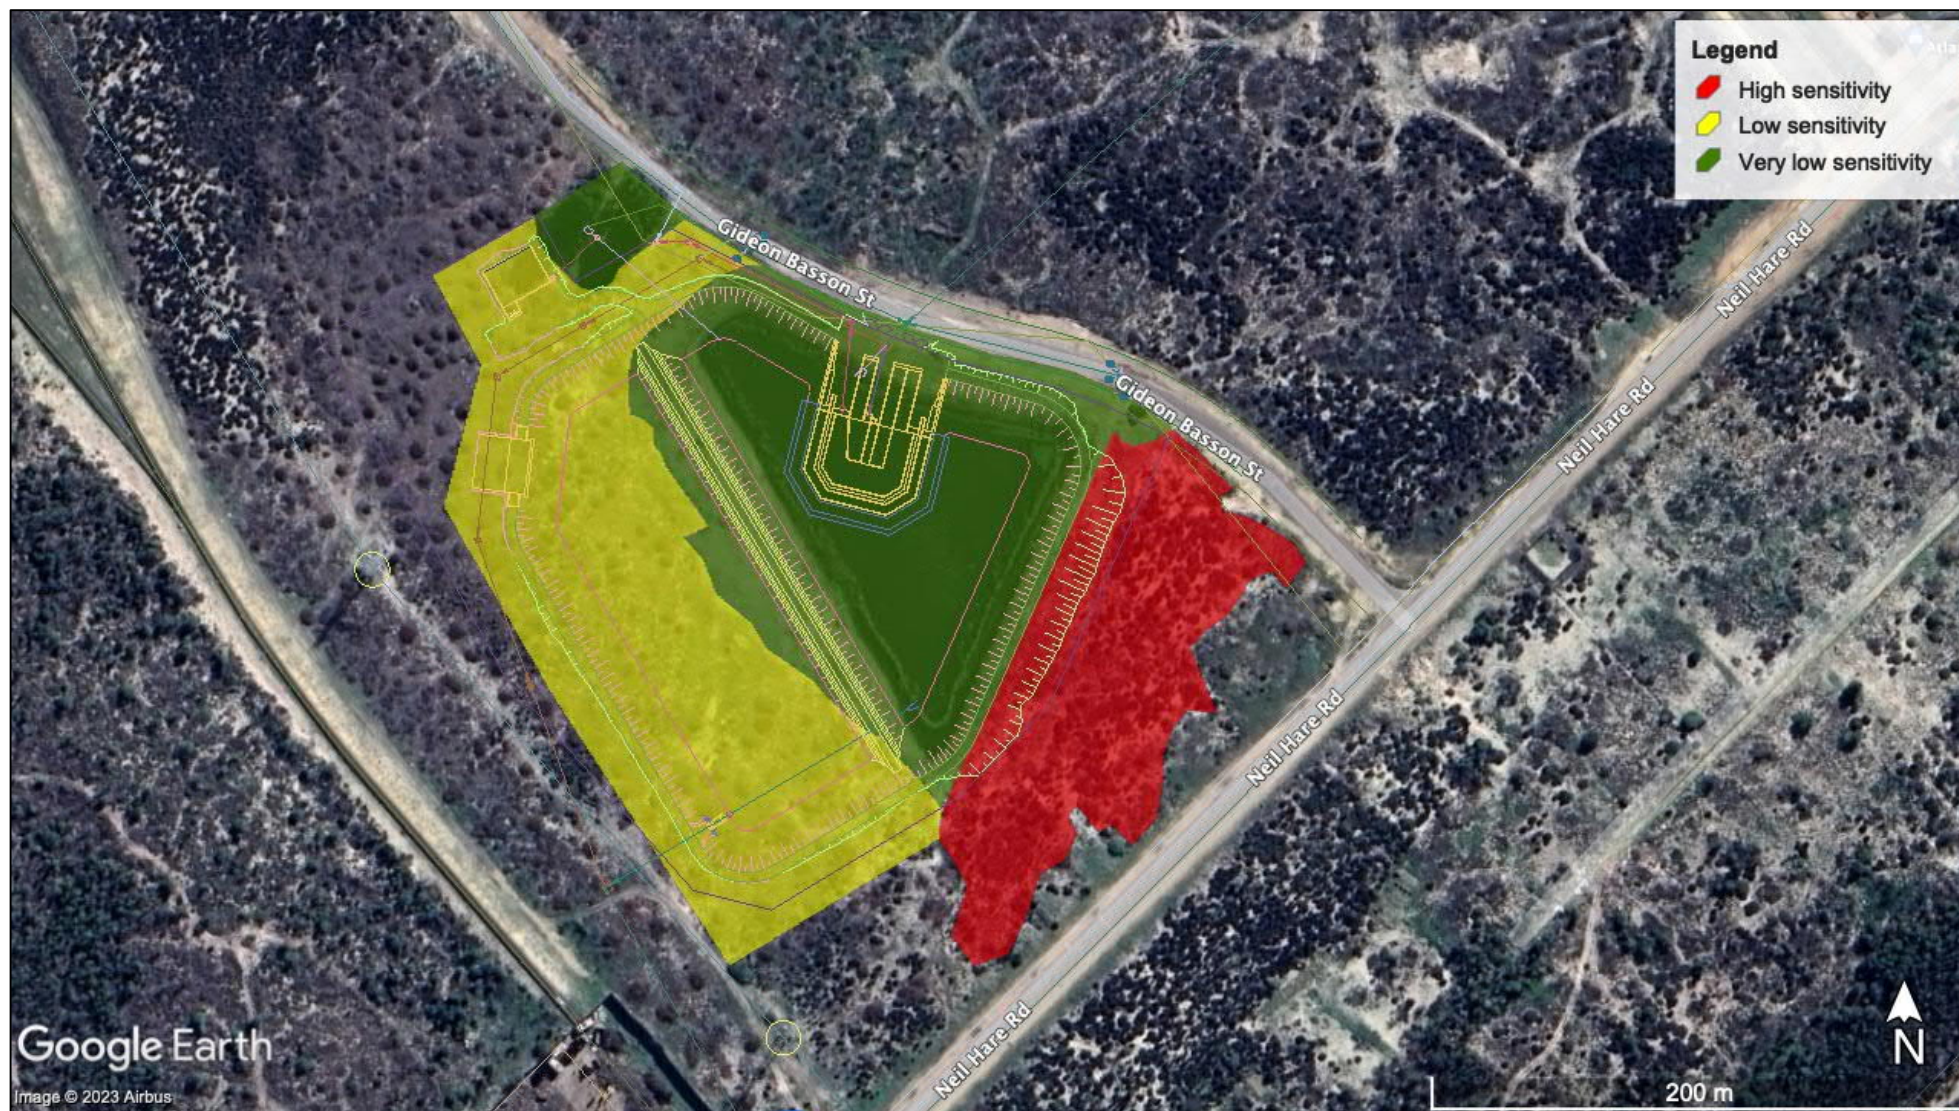
Figure 5B. SENSITIVITY MAP: Basin 9 with footprint and sensitivity overlay represented on a Google Earth™ aerial image.

- If it is a feasible option the design should be amended to avoid the high sensitivity area shown in Figure 5B. Since the vegetation to the north, east and west is highly degraded and transformed the severity of the impacts in terms of loss of vegetation and species would be lower if the footprint can be shifted into these areas. The high sensitivity area would then need to be demarcated so that no activity impacts this area.

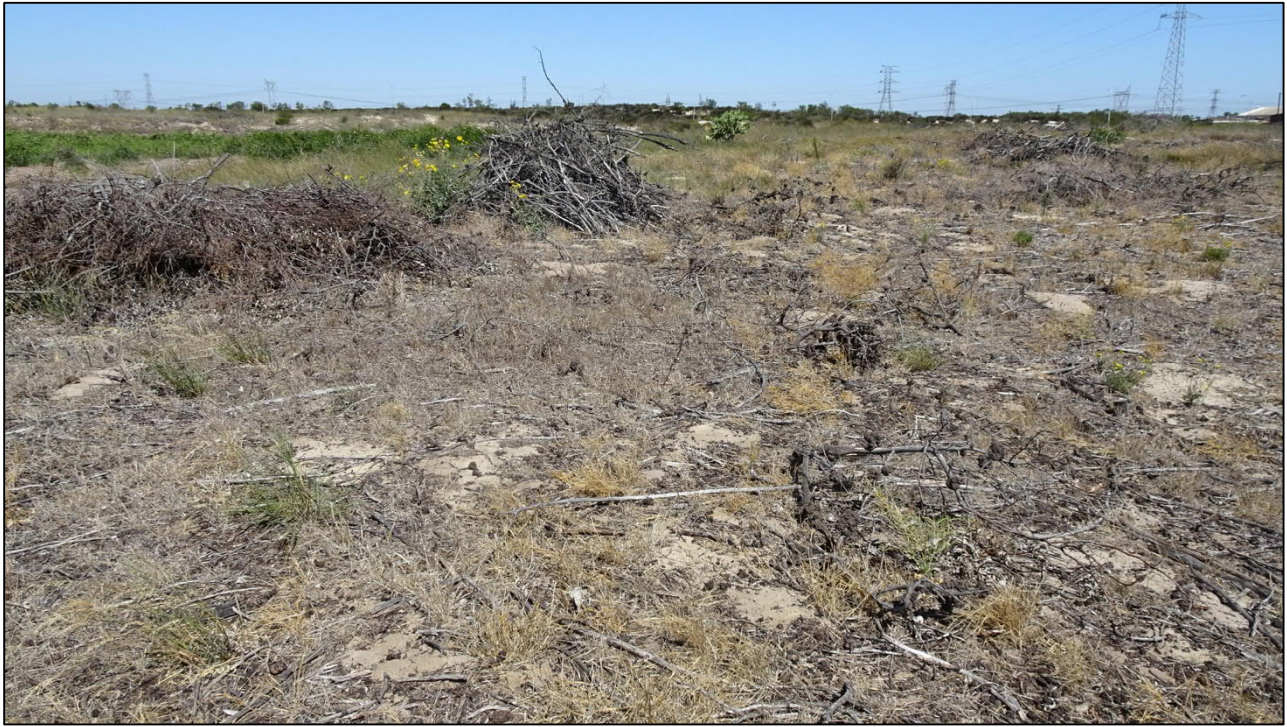
The vegetation within the footprint of Basin 9 supports transformed and highly degraded vegetation on the western and northern sides, and degraded to semi-intact vegetation on the southern side (Figures 5). The semi-intact vegetation is of high sensitivity due to (1) the endangered status of the vegetation type, (2) the possible presence of species of conservation concern (SCC), and (3) ecological connectivity to an adjacent and connected vegetation patch to the south up to Neil Hare Road (Figure 5B). The eastern side is formed by the road and contains mounds of dumped soil mixed with rubble. The highly degraded areas have low species diversity with low to medium restoration potential. Invasive Port Jackson willow *Acacia saligna* has been previously cleared from the highly degraded areas but has emerged at high densities immediately east of the existing basin following dredging/maintenance activities (Figure 6 and 7).

Figure 6. The eastern side of Basin 9 showing highly degraded habitat with previously cleared Port Jackson willow.

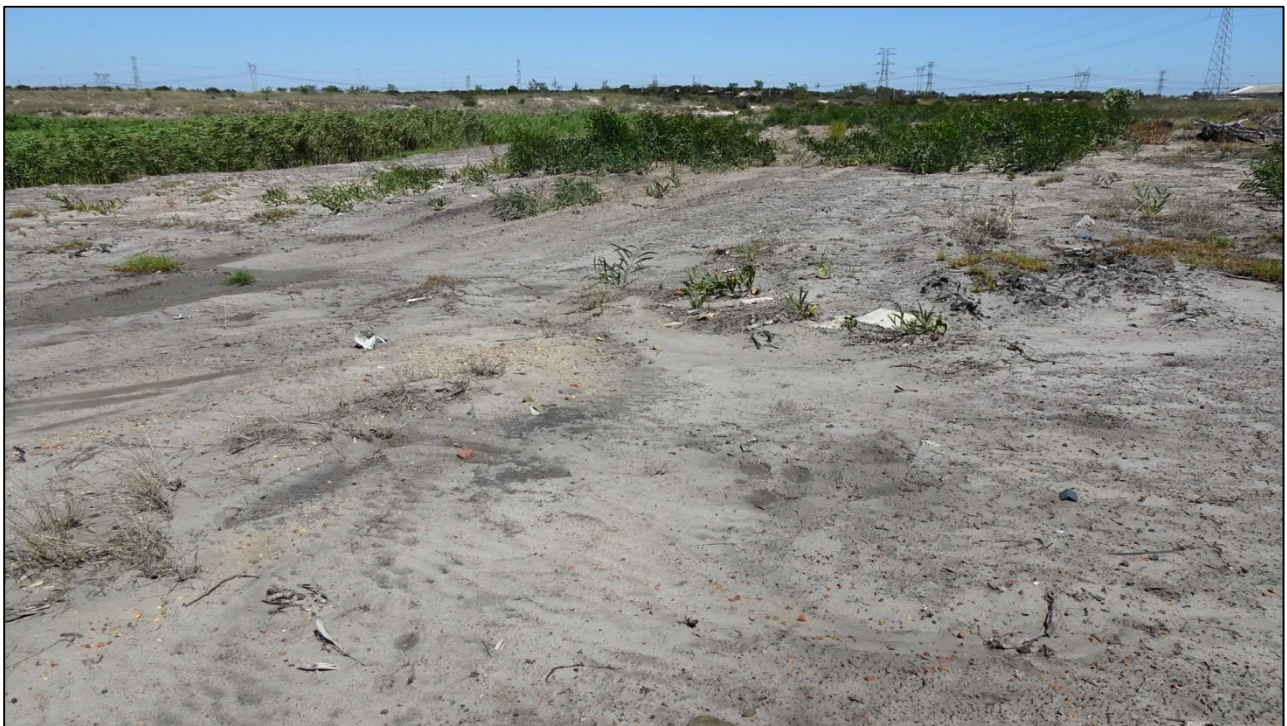
Figure 7. Transformed area on the eastern side of Basin 9 where regular pond maintained and dredging take place.

- Since it is anticipated that the areas surrounding the basins will be regularly disturbed due to dredging of sediment, kikuyu grass and Port Jackson willow are likely to become invasive along the edges. A hard surface should be considered around the edge of the basins since this would allow for easy vehicle access and would prevent the proliferation of weeds.
