# Atlantis Haul Road

## Terrestrial and Aquatic Sensitivity Assessment

1 February 2024

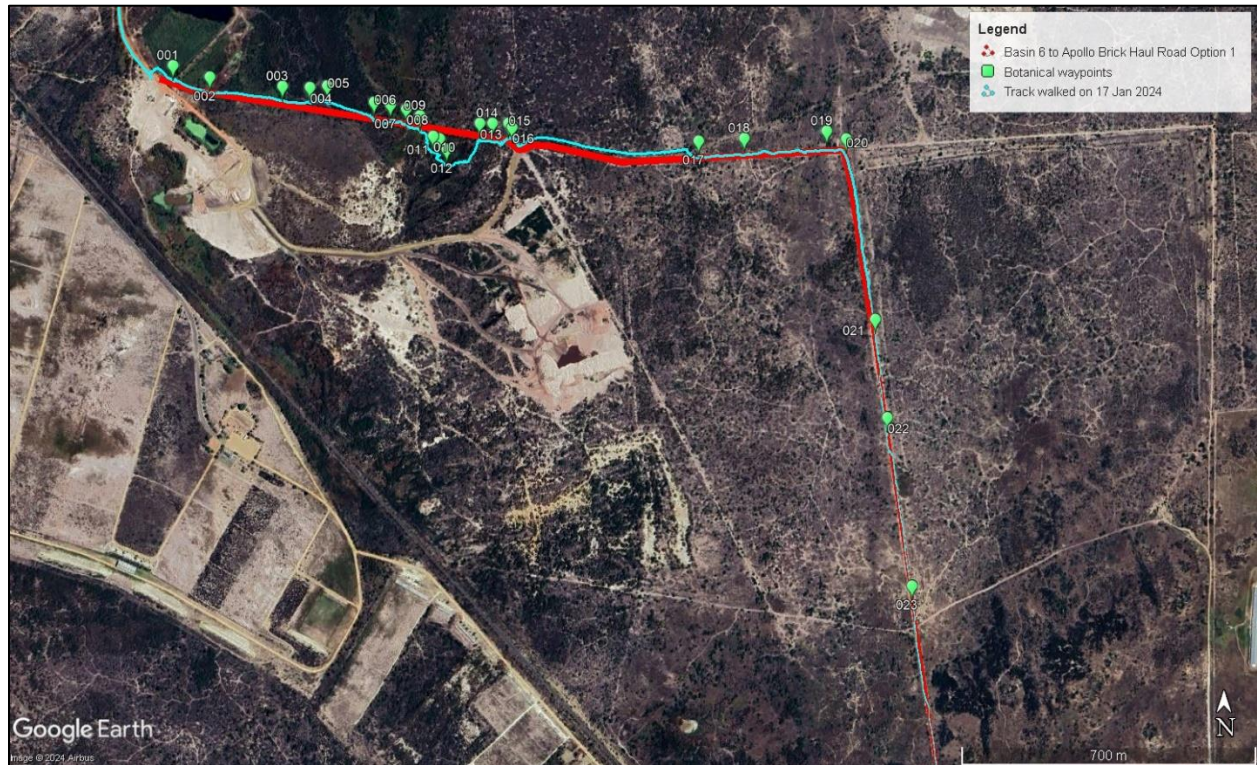
Figure 3.1 Waypoints relevant to the survey of botanical sensitivity of the haul road route.

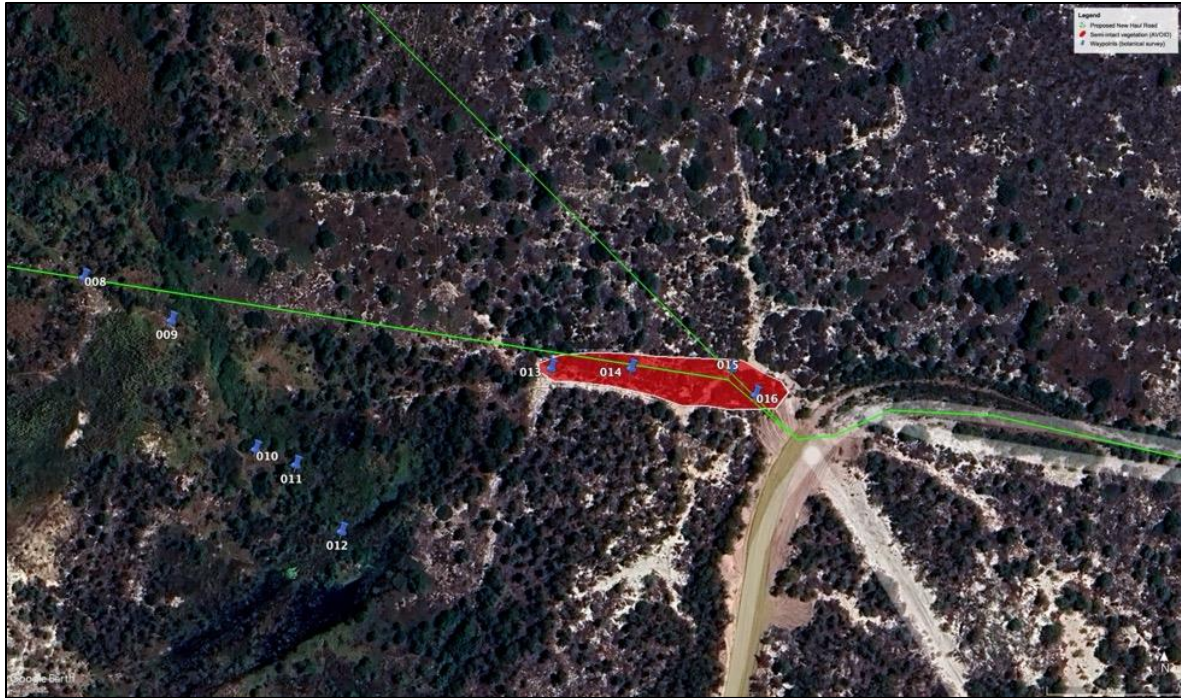
The main area of concern from a terrestrial point of view is highlighted in red in Figure 3.2, and is located between waypoint 013 and 016. This area supports semi-intact Atlantis Sand Fynbos – a critically endangered vegetation type (Figure 3.3). This area should be avoided by adjusting the road alignment south of this section. The habitat may support bulb species but due to summer dormancy this cannot be verified without a spring survey.

Figure 3.2 Area to be avoided between waypoints 013 and 016, shown on a Google Earth image.

- The low, very low, and no sensitivity areas along the haul road route do not need to be avoided, with minimal mitigation required.
- Mitigation measures required for the entire haul road route include:
  - The construction and operational footprint of the haul road must be kept to the minimum required;
  - The road must follow existing tracks or roads, wherever possible;
  - The land surrounding the construction footprint is no-go for construction workers and machinery;
  - Toilets on site must be regularly serviced and litter picked up regularly;
  - Management of stormwater on and upslope of the road must not lead to the creation of concentrated flowpaths, which may cause erosion of the surrounding landscape
- The medium sensitivity terrestrial area must be avoided by adjusting the road alignment south of this section, and the patch of *Euclea racemosa* at waypoint 019.

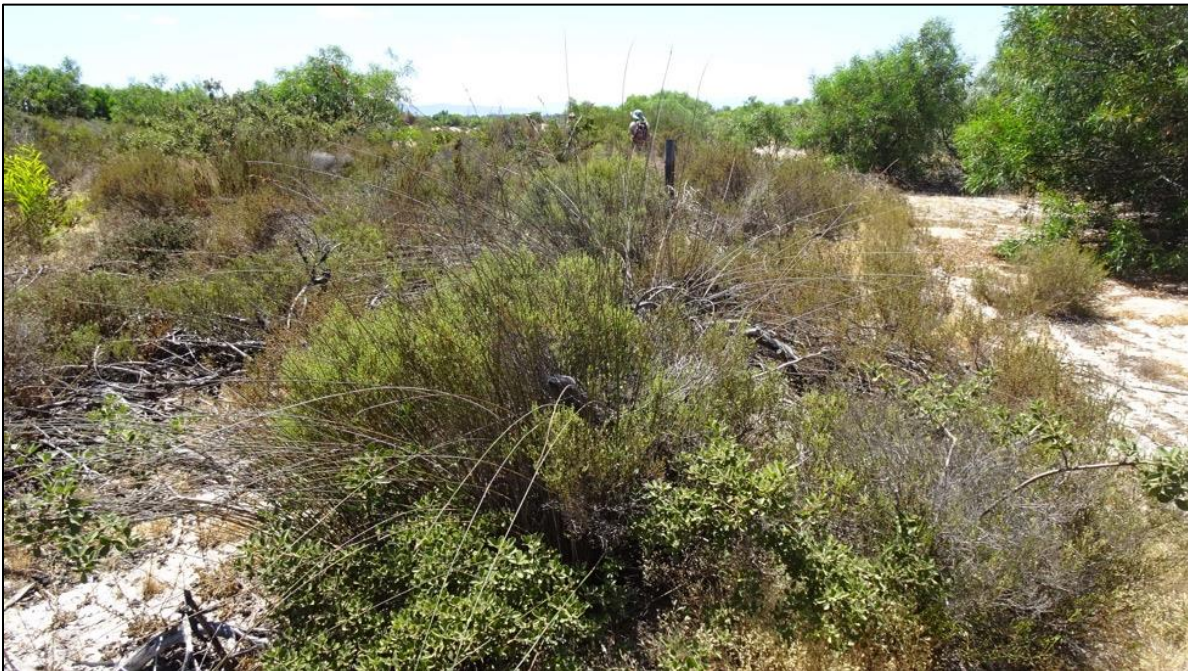
Species: *Agathosma imbricata*, *Cliffortia polygonifolia*, *Metalasia densa*, *Passerina corymbosa*, *Phyllica cephalantha*, *Anthospermum aethiopicum*, *Salvia africana*, *Searsia laevigata* var. *villosa*, *Thamnochortus* sp. and *Trichocephalus stipularis*.

Figure 3.3 Semi-intact Atlantis Sand Fynbos, located between waypoint 013 (33°36'56.21"S; 18°28'52.59"E) and 016 (33°36'56.53"S; 18°28'55.55"E). The road alignment should be adjusted to run along the cleared road visible on the right-hand side (south). The vegetation should be demarcated and should not be disturbed during the construction and operational phases.

- Mitigation measures required within the areas of medium terrestrial or freshwater sensitivity include:
  - The edge of the construction footprint must be marked or fenced, in order to demarcate the surrounding landscape as no-go areas;

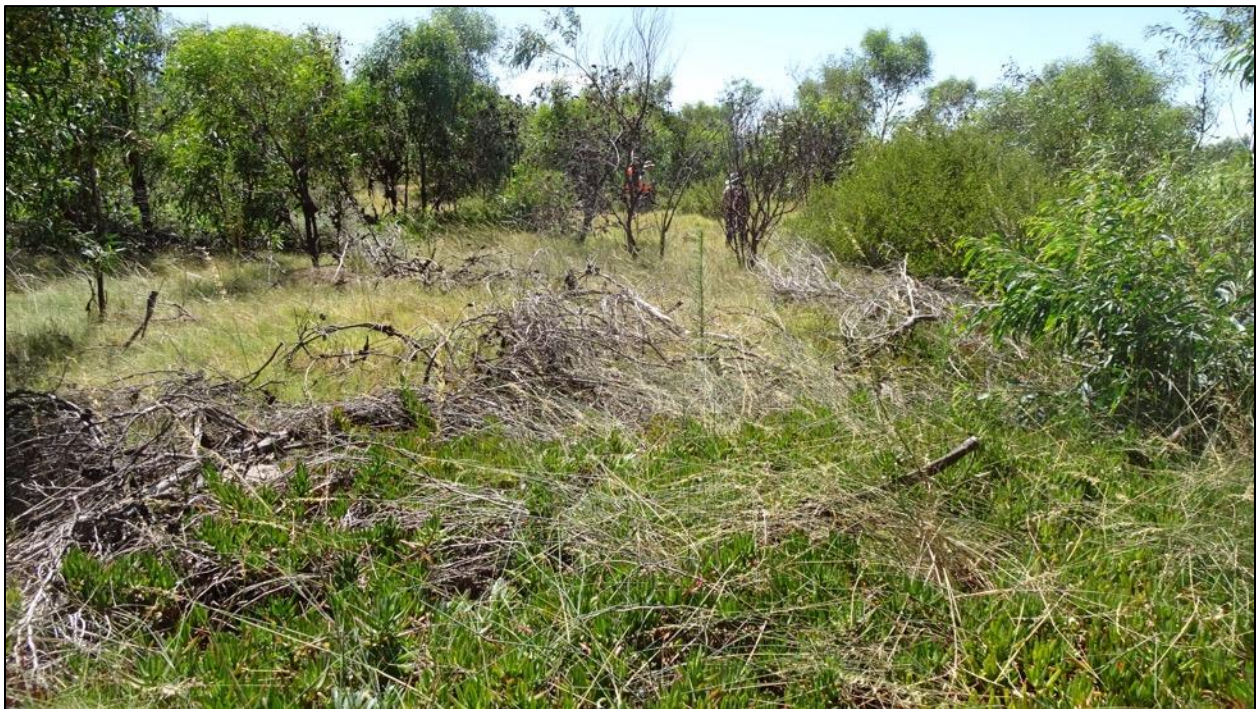
The low sensitivity habitat occurs from waypoint 006 (33°36'54.62"S; 18°28'42.91"E) to 013 (33°36'56.21"S; 18°28'52.59"E). This section supports degraded to highly degraded habitat, supporting a mix of grasses and scattered indigenous shrubs with medium density infestation of Port Jackson willow (*Acacia saligna*) (Figure 3.4). No mitigation is required since the affected habitats are too degraded to warrant the expense and effort of rehabilitation.

Species (\* = invasive): \**Acacia saligna*, *Aspalathus hispida*, *Asparagus capensis*, *Cliffortia polygonifolia*, *Conicosia pugioniformis*, *Ehrharta calycina*, *Helichrysum cf. revolutum*, *Lycium afrum*, *Osteospermum incanum*, *Pelargonium capitatum*, *Searsia lucida*, *Searsia glauca*, *Searsia laevigata* var. *laevigata* and *Searsia laevigata* var. *villosa*.

Figure 3.4 Degraded to highly degraded areas dominated by *Ehrharta calycina*, with occasional indigenous shrubs and tall Port Jackson willow. This section is located between waypoint 006 and 013.

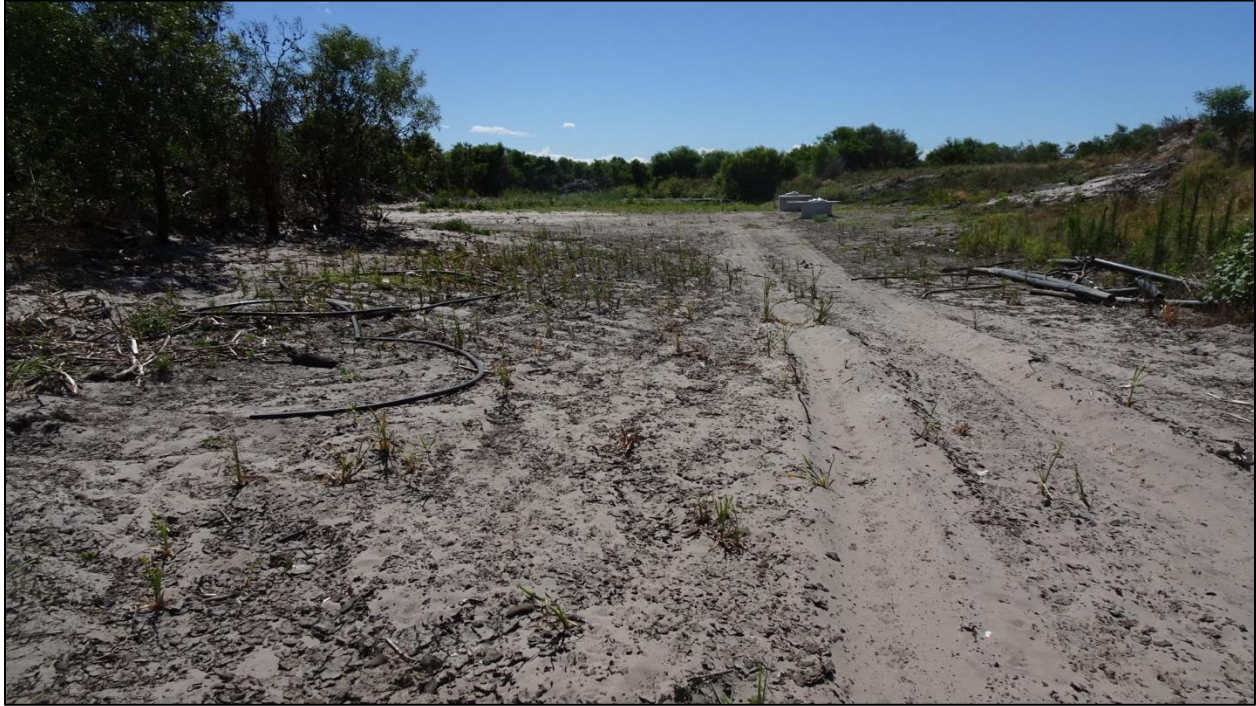
The section of haul road route from waypoint 001 to 003 has patches of terrestrial habitat that occur within an artificial wetland dominated by recently cleared *Phragmites australis* (Figure 3.5). The cleared areas have been colonized by weedy species such as *Cynodon dactylon*, *Datura stramonium*, *Pennisetum clandestinum* and *Raphanus raphanistrum*. Recently created artificial

Figure 3.5 Recently cleared section at waypoint 002 showing emerging *Phragmites australis*.

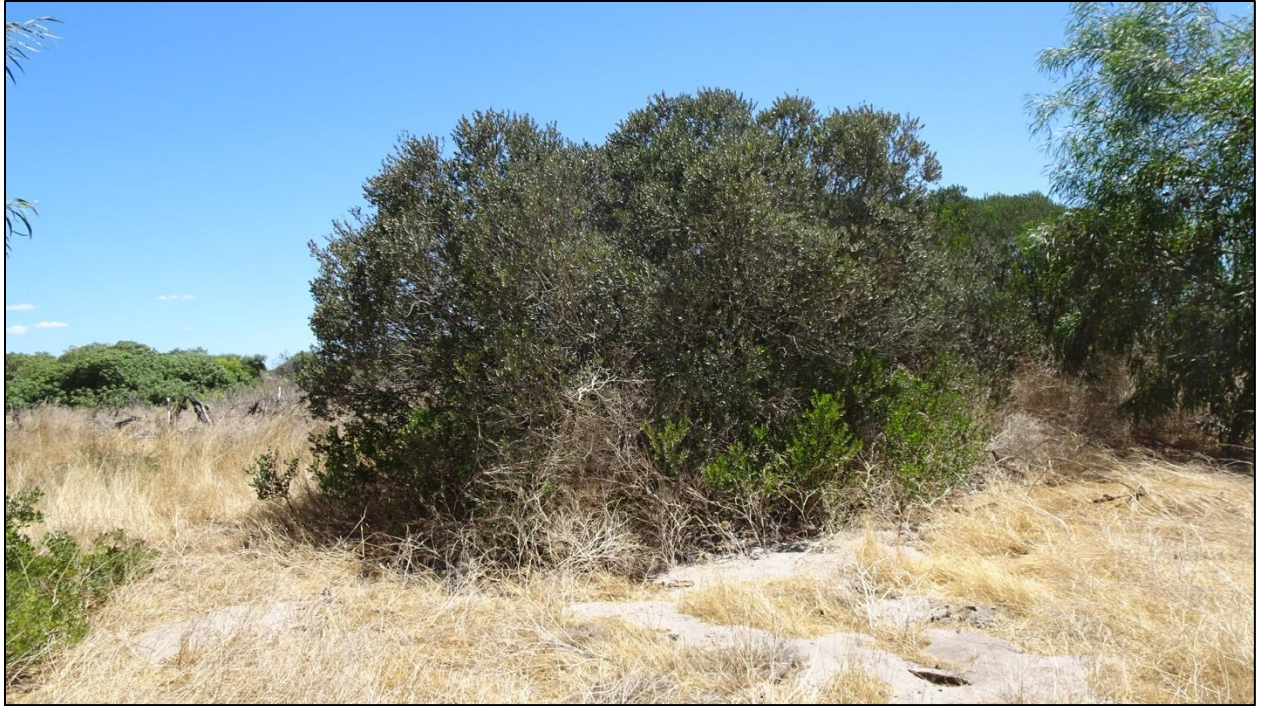
This section of the proposed road alignment from waypoint 016 to the Apollo Brick Factory is highly degraded to transformed, and also considered to be of very low sensitivity from a terrestrial perspective. The habitat is dominated by alien grasses with the occasional indigenous shrub and some patches of sour fig *Carpobrotus edulis*. A clump of the indigenous shrub *Euclea racemosa* was found at waypoint 019 (33°36'56.76"S; 18°29'24.42"E) (Figure 3.7). This clump of about 3 individuals should be avoided.

*Figure 3.6* This *Euclea racemosa* clump located at waypoint 019 (33°36'56.76"S; 18°29'24.42"E) should be avoided.

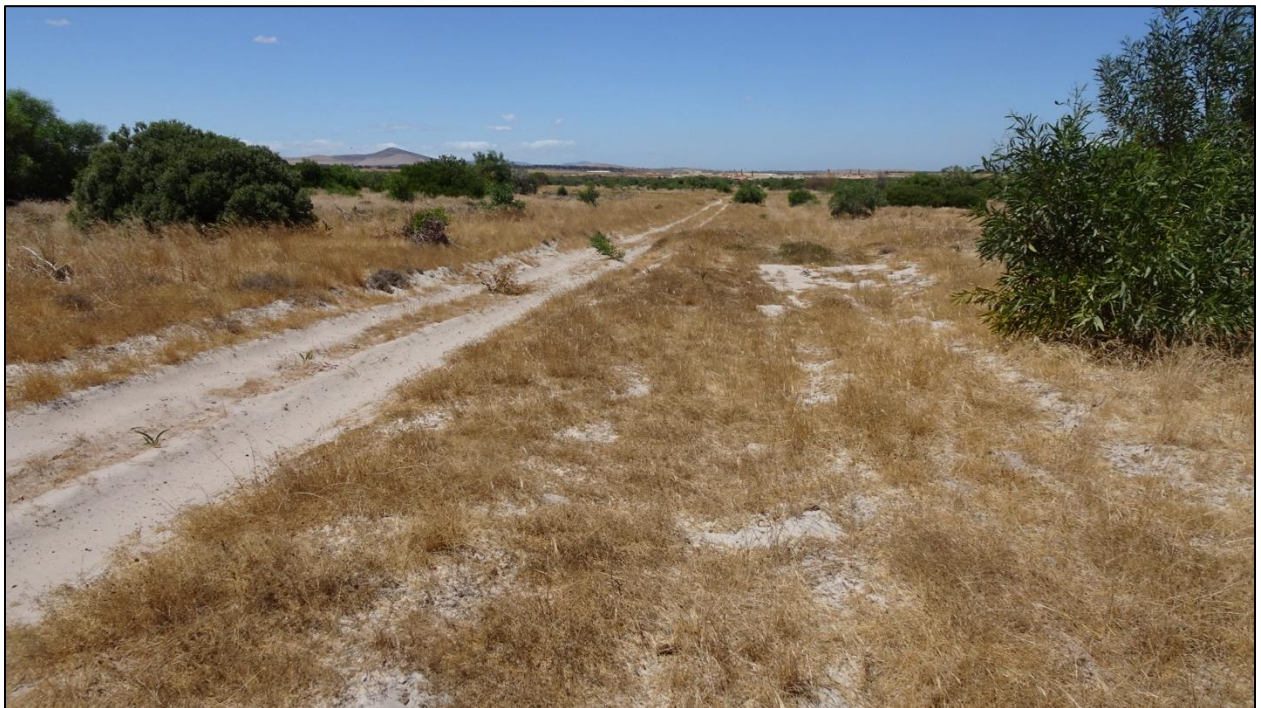
*Figure 3.7* Transformed section extending from waypoint 021 southwards towards the Apollo Brick Road and brick factory.

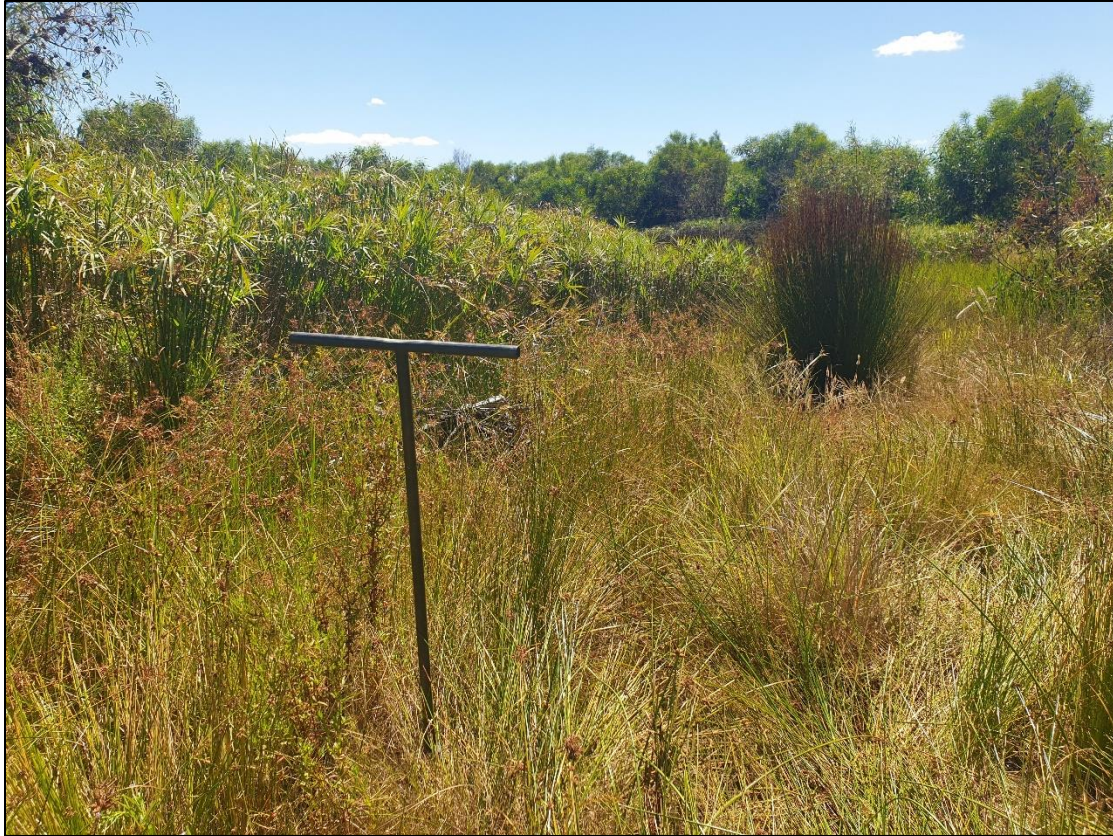
- Water retention in the soils;
- Provision of wetland habitat and biodiversity, for instance a diverse patch of indigenous obligate and facultative wetland plants was recorded at waypoint 005 (Figure 4.1 and Figure 4.2).

Figure 4.2 A diversity of wetland plants was recorded here (waypoint 028), including *Cyperus textilis*, *Elegia tectorum*, *Bolboschoenus maritimus* and *Ficinia nodosa*.

- The area occupied by the wetland is considered to be of medium sensitivity, but the proposed haul road route currently avoids the diverse patch of wetland plants, so the current route is acceptable, with mitigation.

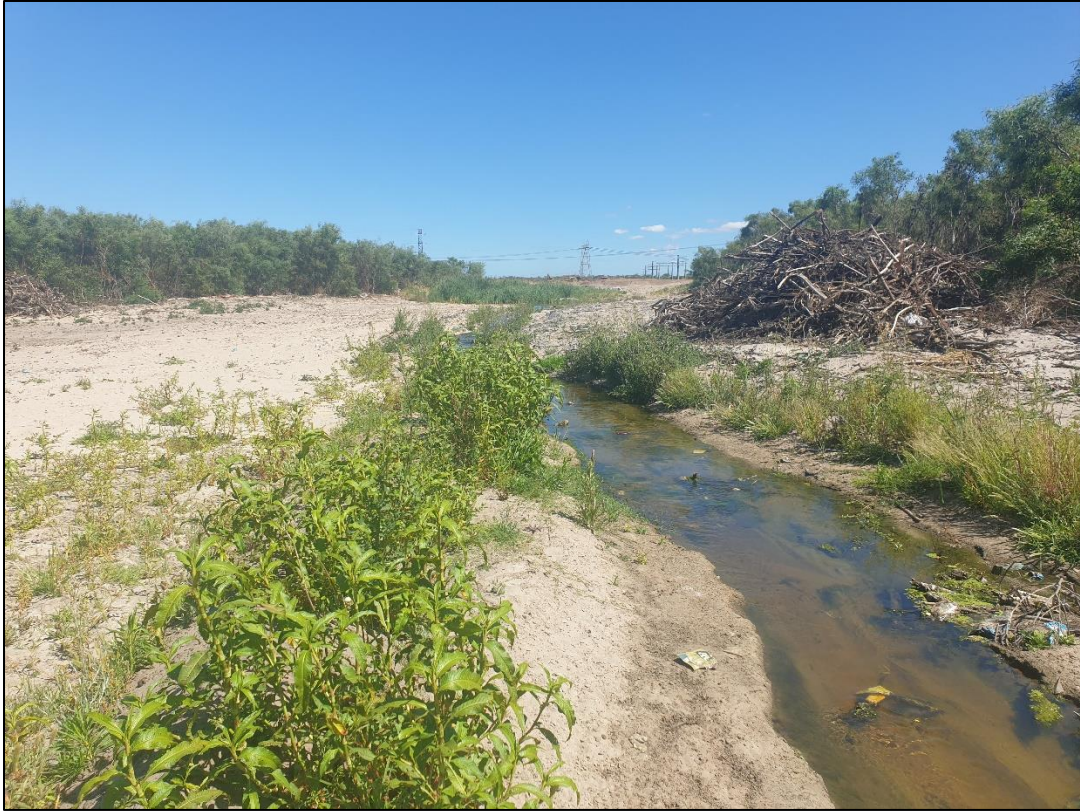
The other aquatic feature affected by the haul road route is the recently constructed artificial stormwater channel, which crosses the route at aquatic waypoint 024 (Figure 4.1 and Figure 4.3). The margins of the channels support *Persicaria cf lapathifolia* (not indigenous, but considered naturalised to South Africa) on the channel margins, and *Lemna* sp. and filamentous green algae on open water. All of these species are tolerant of poor water quality, and are not considered sensitive. The channels do not supply natural or desired aquatic habitat, and are thus considered to be of very low sensitivity.

Figure 4.3 Artificial stormwater channel that crosses the haul road route at aquatic waypoint 024. Dominant species include *Persicaria* cf. *lapathifolia* on the channel margins, and *Lemna* sp. and filamentous green algae on open water.

- All construction machinery must be supplied with adequate drip trays and banded where necessary, to avoid pollution from oils and fuels;
  - Where stormwater is directed away from the road through the use of earth berms (as proposed), this water should not be concentrated into one or two pipes or culverts, which may lead to erosion, but should be discharged through numerous pipes on the downslope side of the road. Discharge points must be stabilised;
