# Steenbras: Site photographs

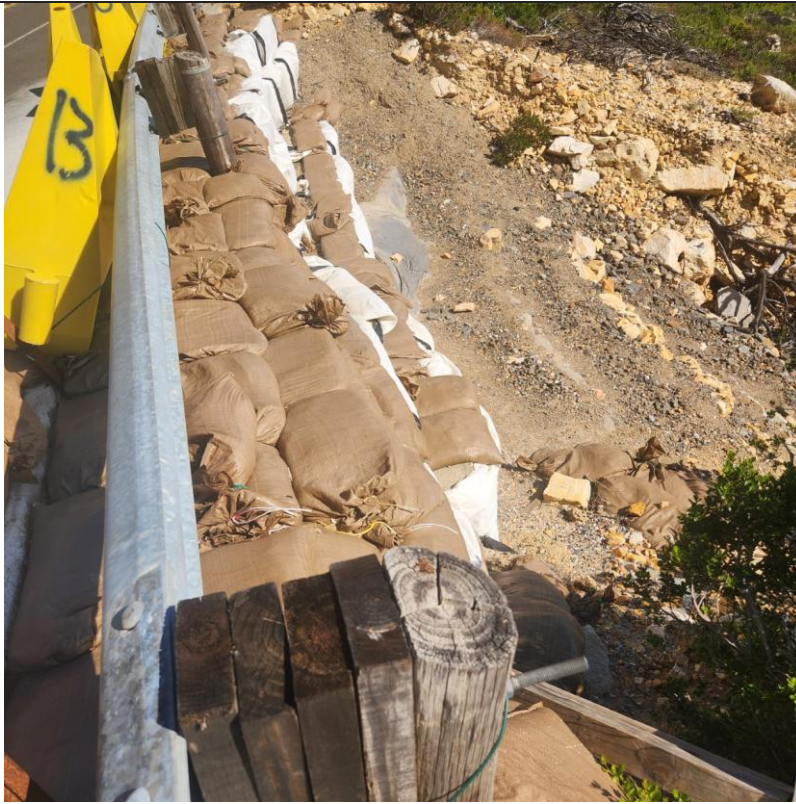
Temporary roadside reinforcement using sandbags and barriers to prevent further erosion of slope 1 along the Steenbras WTP access road

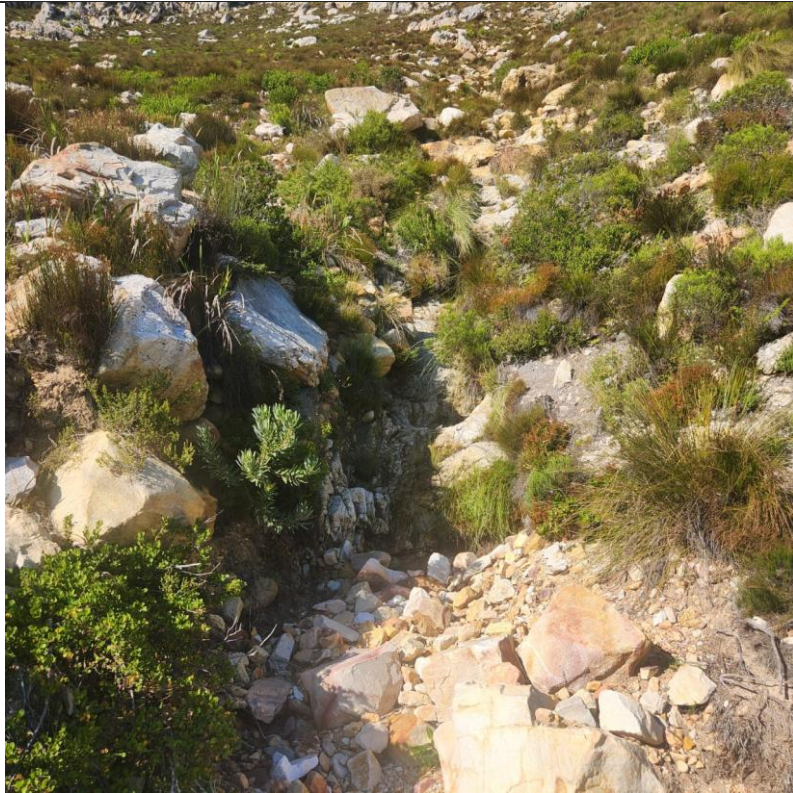
Natural water channel within the rocky terrain and dense fynbos vegetation within the proposed slope 1 rehabilitation area

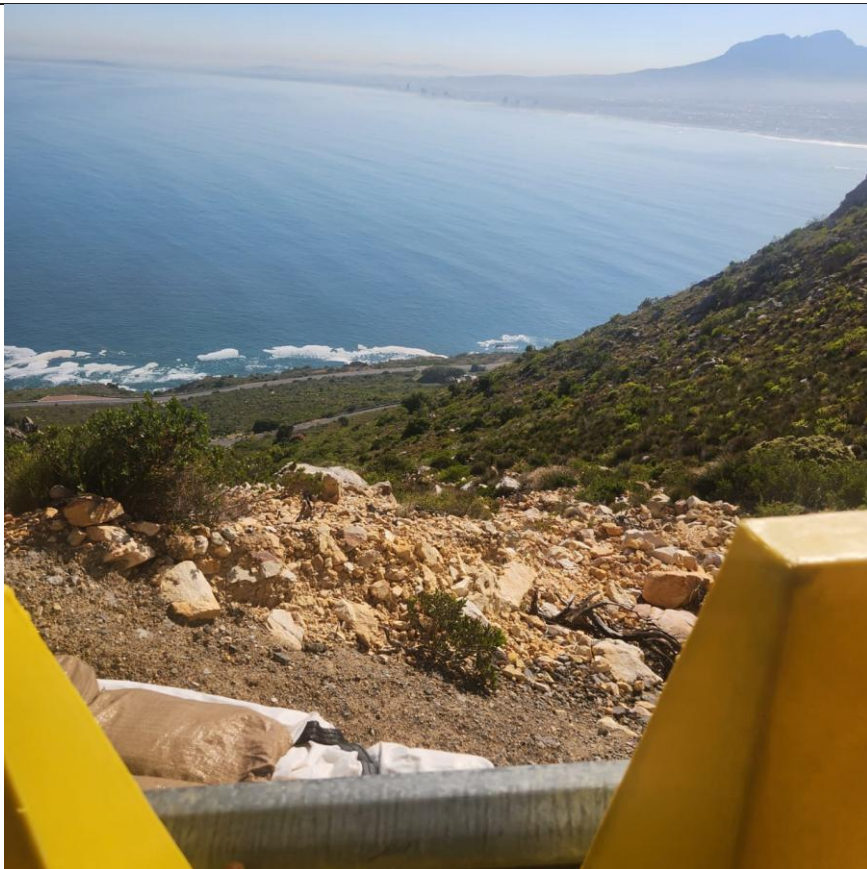
Evidence of slope instability and erosion on slope 1 and views of the vegetation in the area (Kogelberg Sandstone Fynbos)

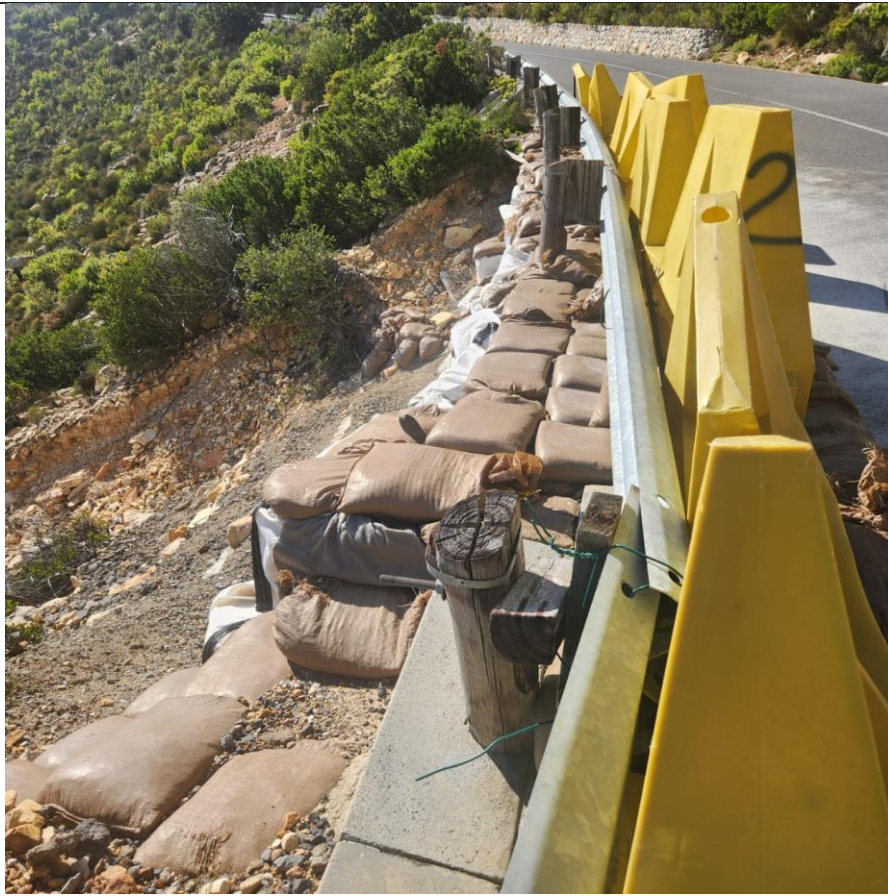
Temporary roadside reinforcement using sandbags and barriers to prevent erosion and support slope stability on the proposed rehabilitation area

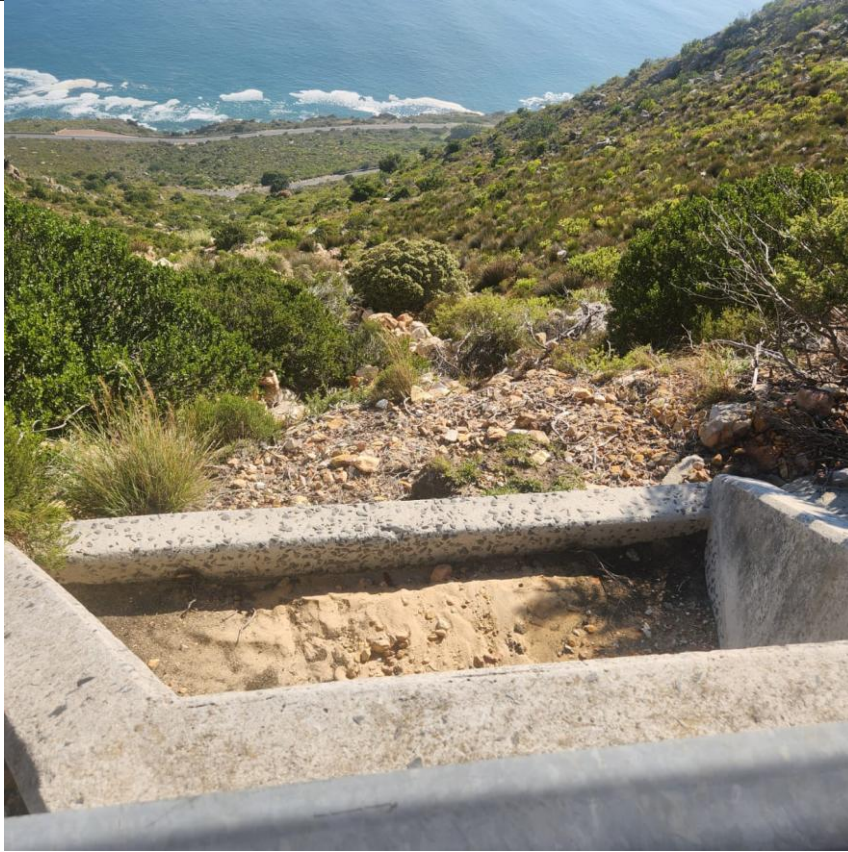
Example of the blocked culvert and Kogelberg Sandstone Fynbos on the proposed slope 1 rehabilitation area

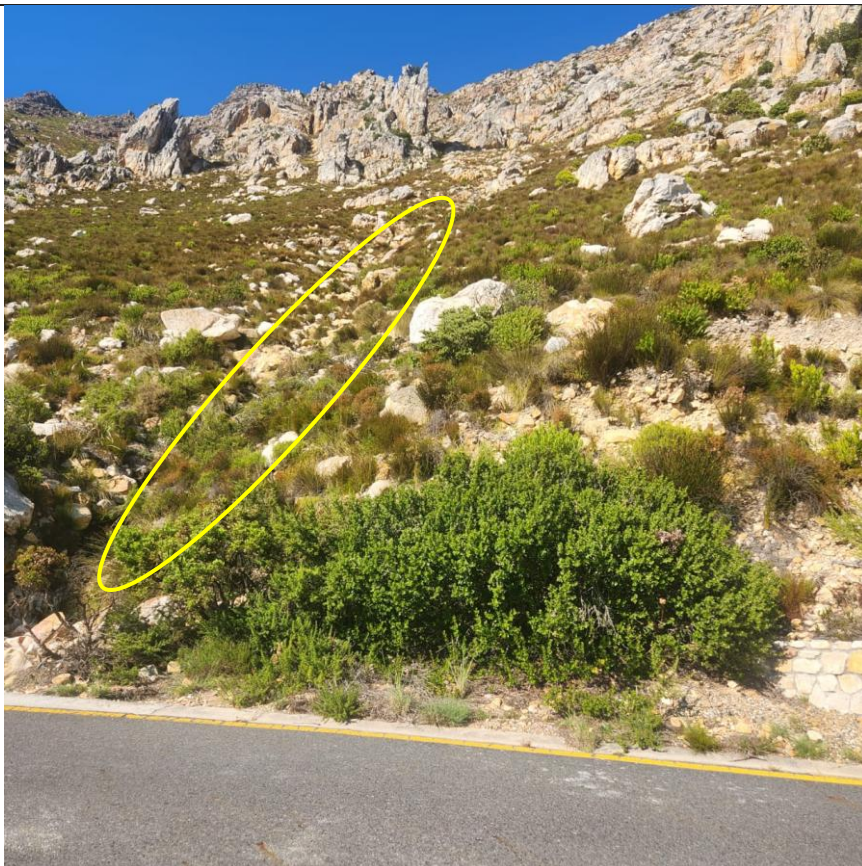
Dense Kogelberg Sandstone Fynbos vegetation in a mountainous landscape (proposed slope 1 rehabilitation area near the tar road). Natural water channel (encircled in yellow)

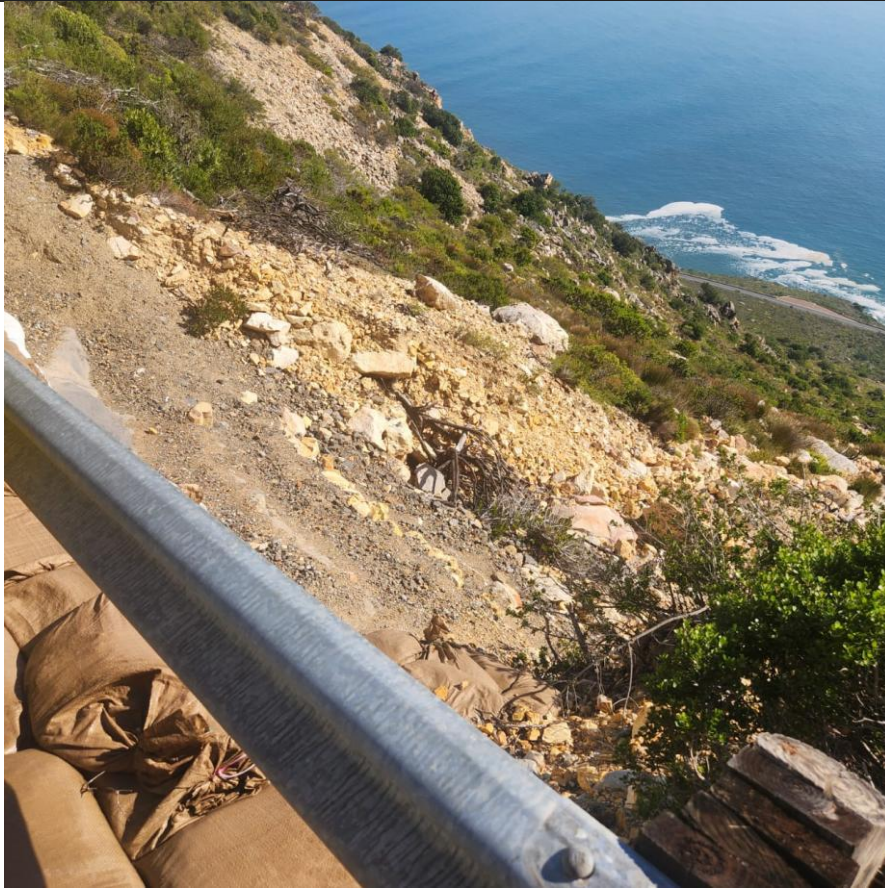
View of the Kogelberg Sandstone Fynbos and the damage to the slope 1 area
