**BOTANICAL ASSESSMENT FOR THE PROPOSED  
REHABILITATION OF THE STEENBRAS WATER  
TREATMENT PLANT ACCESS ROAD, CITY OF CAPE  
TOWN**

PAUL EMMS

FEBRUARY 2026

ZUTARI

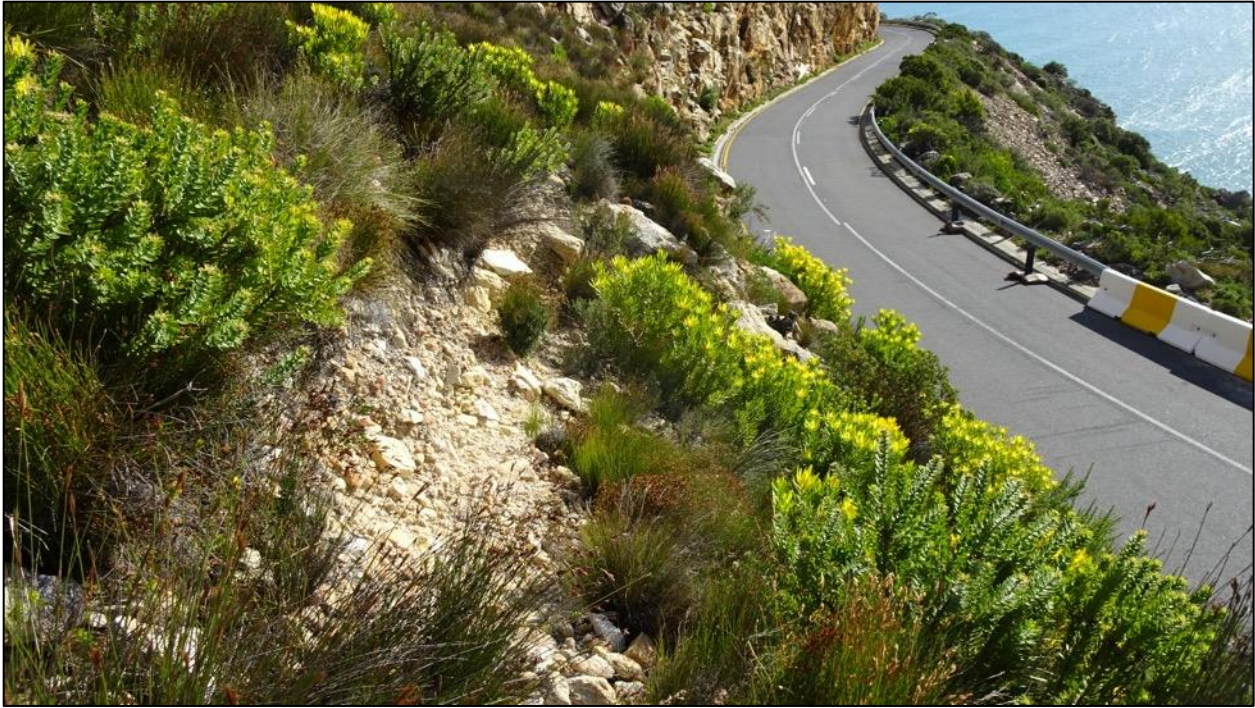
**Figure 15.** Some erosion with very loose substrate just upslope from the road at waypoint 010 (34°10'38.46"S; 18°50'18.26"E).

A small eroded area with very loose substrate was observed close to the road at waypoint 10 (34°10'38.46"S; 18°50'18.26"E) (**Figure 15**).

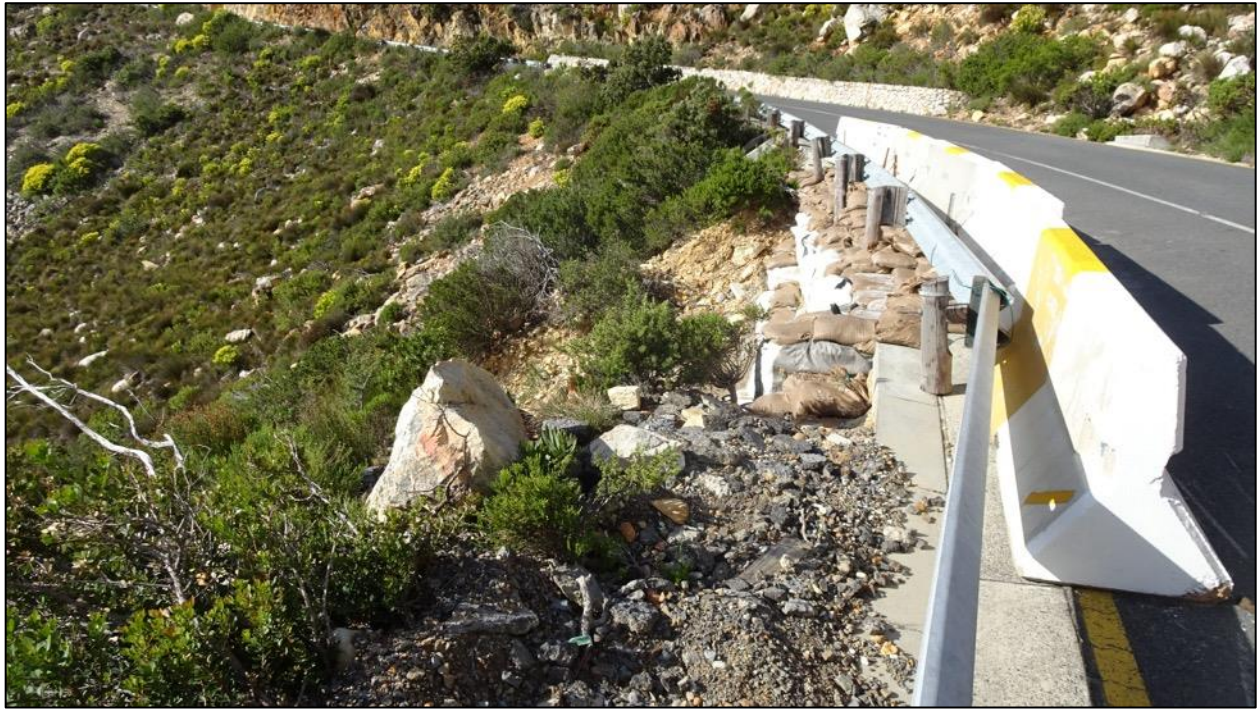
**Figure 17.** The upper limit of the erosion zone along the road edge.

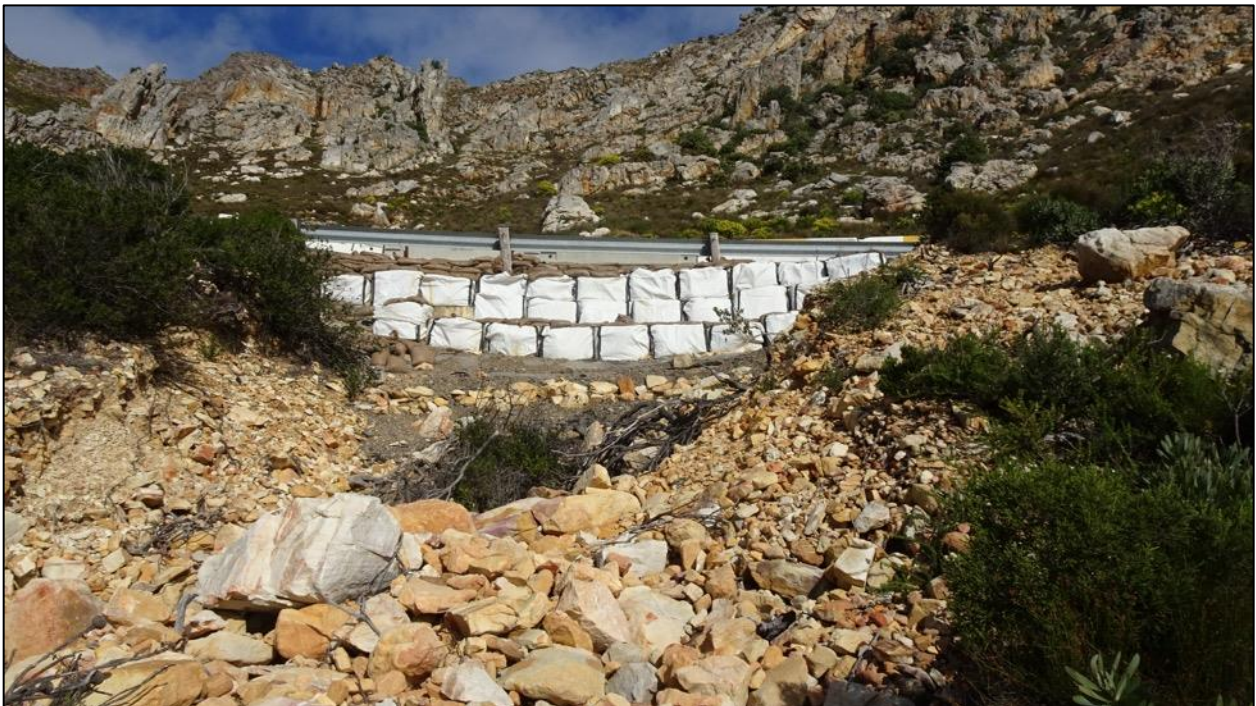
**Figure 19.** Sand bags used to temporary repair the built the eroded road edge.
