*Aquatic Biodiversity Compliance Statement and Risk Assessment:  
Proposed Repairs to the Steenbras Water Treatment Plant Access  
Road in Gordon's Bay, Cape Town in the Western Cape  
March 2026*

Prepared By:  
Toni Belcher and Dana Grobler  
BlueScience (Pty) Ltd  
Cell: 082 883 8055  
Email: [toni@bluescience.co.za](mailto:toni@bluescience.co.za)

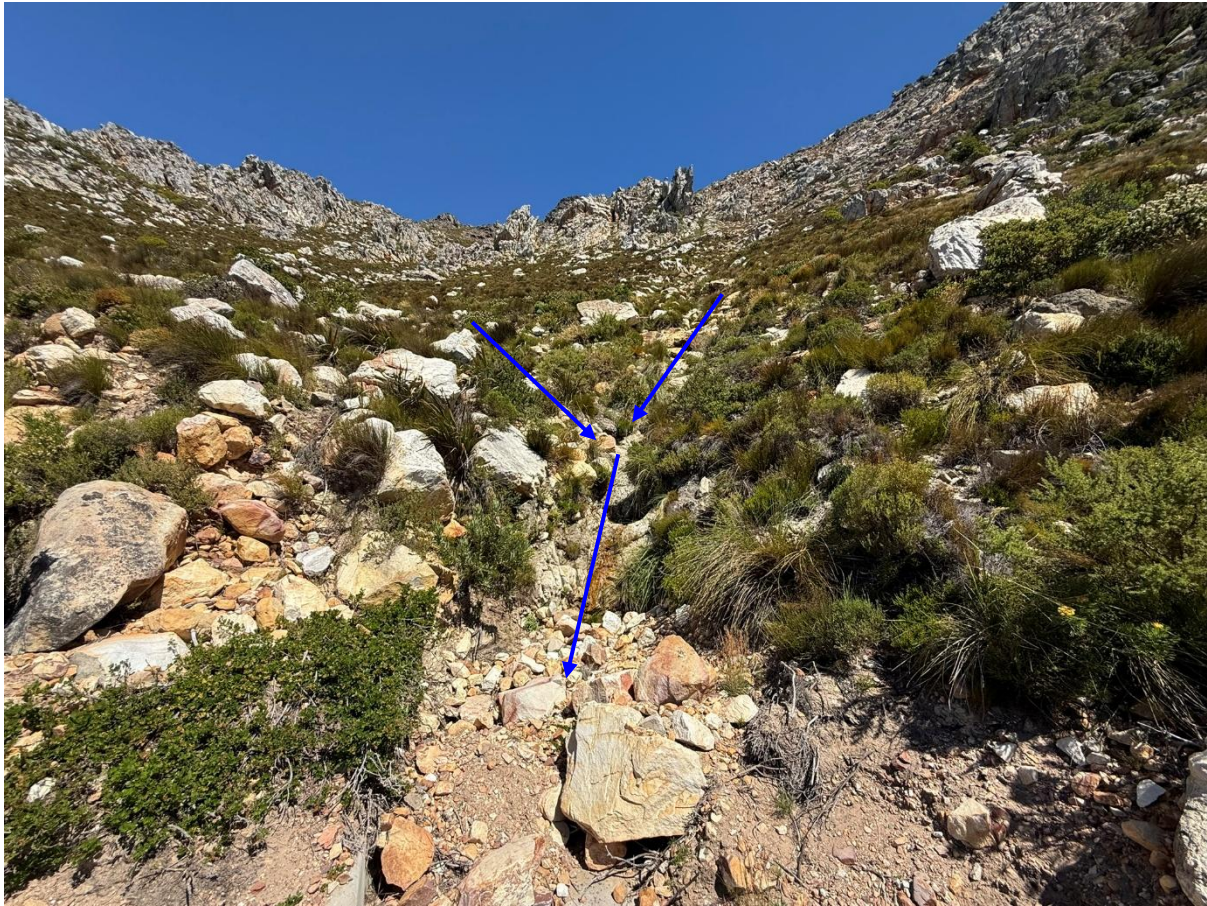
**Figure 3. View of the watercourse at Slope 1, upslope of the Steenbras WTP access road.**

vegetation and mostly resemble the surrounding terrestrial areas, with only a defined channel in places (Figure 3). The slope of the watercourse at the two sites is about 40%. The erosion potential of the watercourse channels at these sites is thus very high as they are on steep slopes, with little soil or vegetation cover.

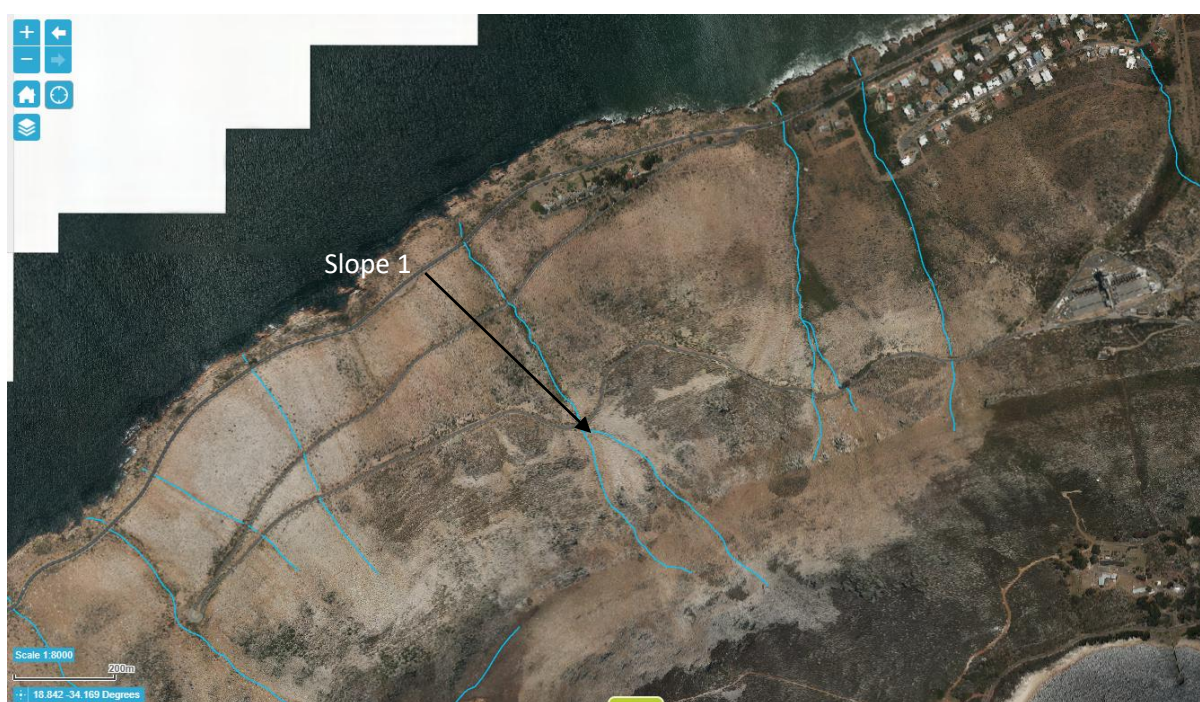
Figure 5. Aerial image of the site and surrounding area, taken in 1968 ([City of Cape Town Map Viewer](#), 2025)

Figure 5 (bottom image) provides an image of the site, taken in January 2019, during the recent drought. There has also been a recent fire that had burnt the cover vegetation in the area. From the 2019 imagery (Figure 5, bottom image), one can clearly see where groundwater contributes to flow in these watercourses and associated seep and wetland vegetation. Neither of the watercourses has any associated wetland habitat visible at or upstream of the proposed working area. There is some wetland habitat visible on the larger stream, about 60 m downstream of the working area for Slope 1. The most significant wetland areas are visible on the two streams directly east of this watercourse. These wetland areas are included in the City Wetland layer as well as the National Wetland Map (Versions 5 and 6 beta).

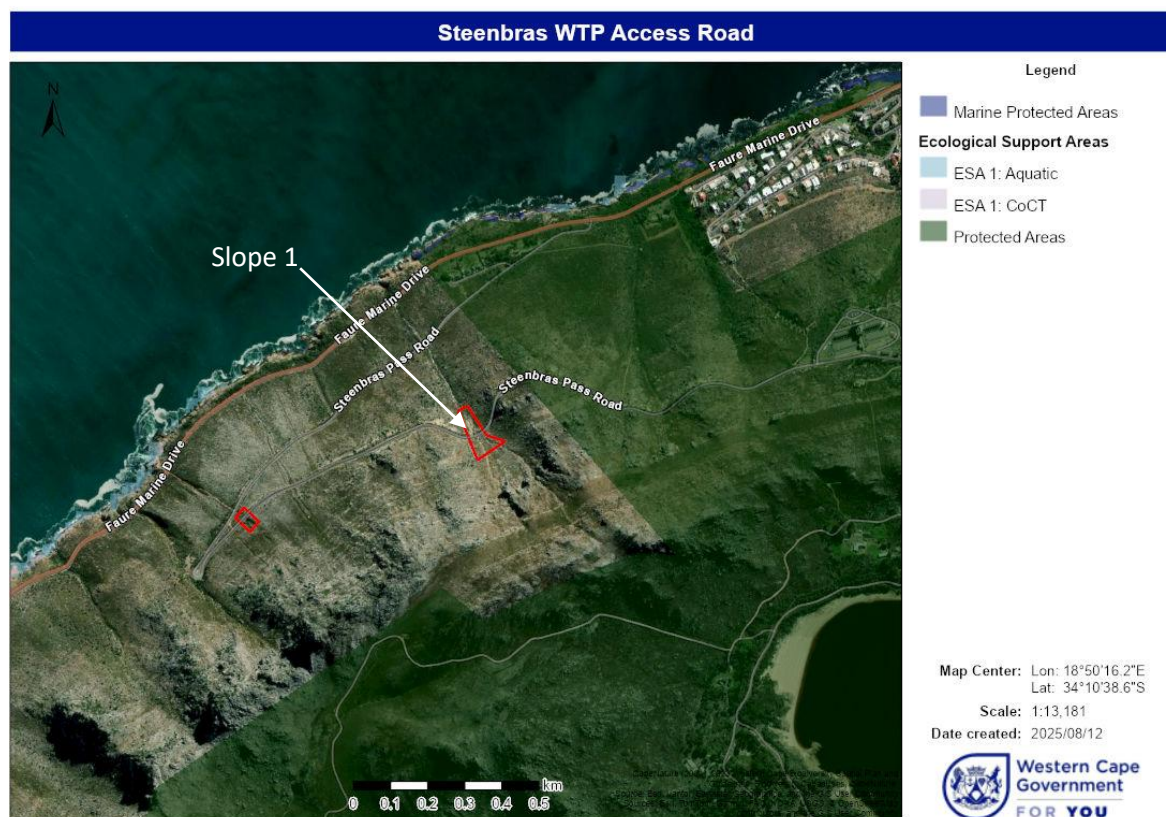
Figure 9. 2023 Western Cape Biodiversity Spatial Plan for the area (CapeFarmMapper, 2025)

In the 2023 Western Cape Biodiversity Spatial Plan (Figure 9), the area to the east of the site is within the formally protected Steenbras Nature Reserve and Hottentots-Holland Mountain Catchment Area. There are, however, no features mapped along the watercourse at Slope 1.

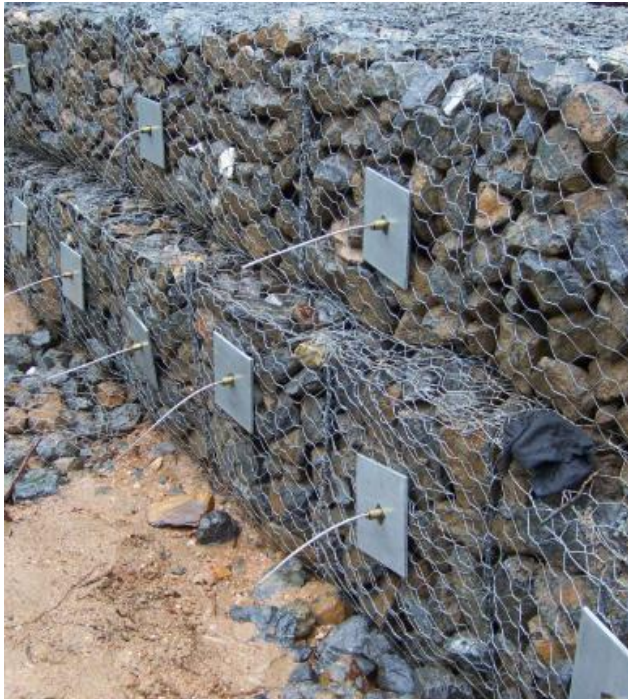
**Figure 12. Example of an anchored gabion wall**

Based on the site conditions and constraints, the anchored gabion wall has been identified as the preferred alternative for the rehabilitation/repair works. The anchored gabion wall alternative that allows for capturing of soil and growth of cover vegetation over time is also a more acceptable alternative from an aquatic ecosystem perspective. An example of the anchored gabion wall is shown in Figure 12.
