**TERRESTRIAL ANIMAL ASSESSMENT FOR THE  
PROPOSED REHABILITATION OF THE STEENBRAS  
WATER TREATMENT PLANT ACCESS ROAD, CITY  
OF CAPE TOWN**

25 May 2025

**REPORT PREPARED FOR  
ZUTARI**

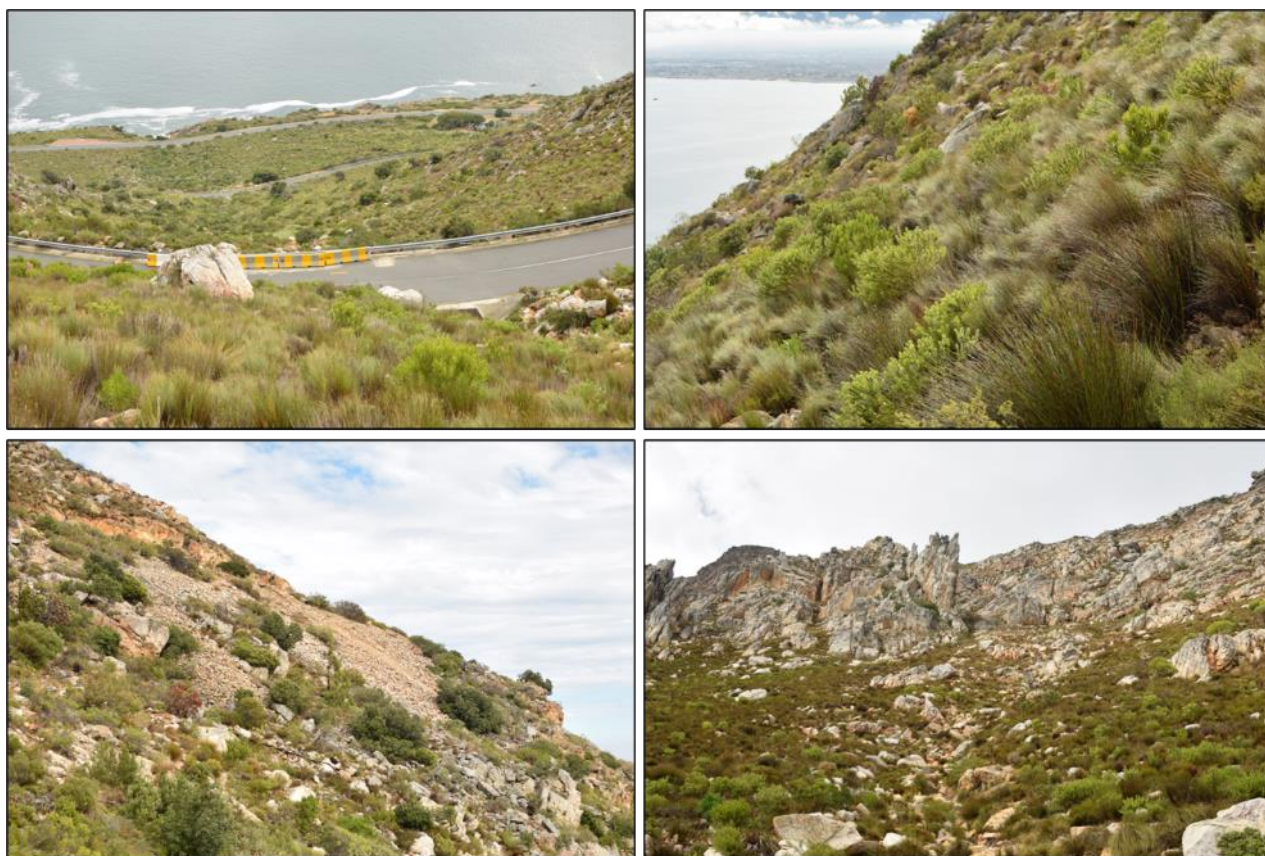
**Figure 4.** (*top left*) image from slope above Steenbras Pass, looking down to Faure Marine Road/R44; (*top right*) Steep slopes supporting intact Kogelberg Sandstone Fynbos; (*bottom left*) Unconsolidated scree below the Steenbras Pass Road; (*bottom right*) Non-perennial watercourses that converge at the Steenbras Pass Road.

The Steenbras Water Treatment Works Access Road is located on the west facing slope of the Hottentots-Holland mountains, above the suburb of Gordons Bay, City of Cape Town. The surrounding area is largely untransformed, consisting of steep sand stone slopes (35 degrees) (Figure 4, *top right*) supporting intact Kogelberg Sandstone Fynbos. The access road is a two-lane road that runs from the R44/Faure Marine Drive up to the Steenbras Water treatment Works. Downslope of the road there are areas of rock scree/unconsolidated material below the Steenbras Pass Road, left over from construction of the pass; these areas have not yet been significantly colonised by extant vegetation (Figure 4, *bottom left*). The section of road to be rehabilitated is located at the confluence of two non-perennial watercourses (Figure 4, *bottom right*); it is due to damage caused during intense precipitation events that these water courses flooded and caused significant erosional damage to the road.

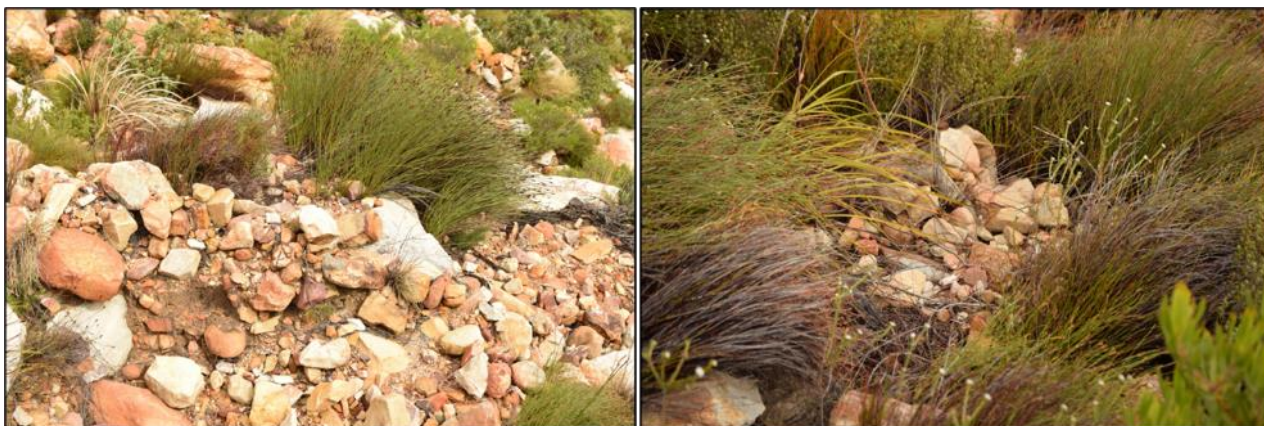
**Figure 7.** Very coarse, gravelly substrate found across the site. Soil depth is thin to non-existent.

The site area is moderately to very steep, with a slope of 35 degrees. Located on the west facing slopes of the Hottentots Holland mountain range, the underlying geology of the site consists of sandstones belonging to the Table Mountain Group. The soils across most of the site are extremely thin or non-existent, consisting primarily of coarse gravel and cobbles (Figure 7). Acidic lithosol soils derived from Ordovician sandstones of the Table Mountain Group (Cape Supergroup). Kogelberg Sandstone Fynbos is described as having “*Deep sandy blankets (whitish, nutrient-poor acidic sand) develop in depressions and on slopes resisting erosion. Land types mainly 1c, 1b and Gb*” as per Rebelo *et al.*, in Mucina & Rutherford, 2006. A small shale band runs south-east, upslope of the site however this appears to have limited to no effect on the geology of the site area.

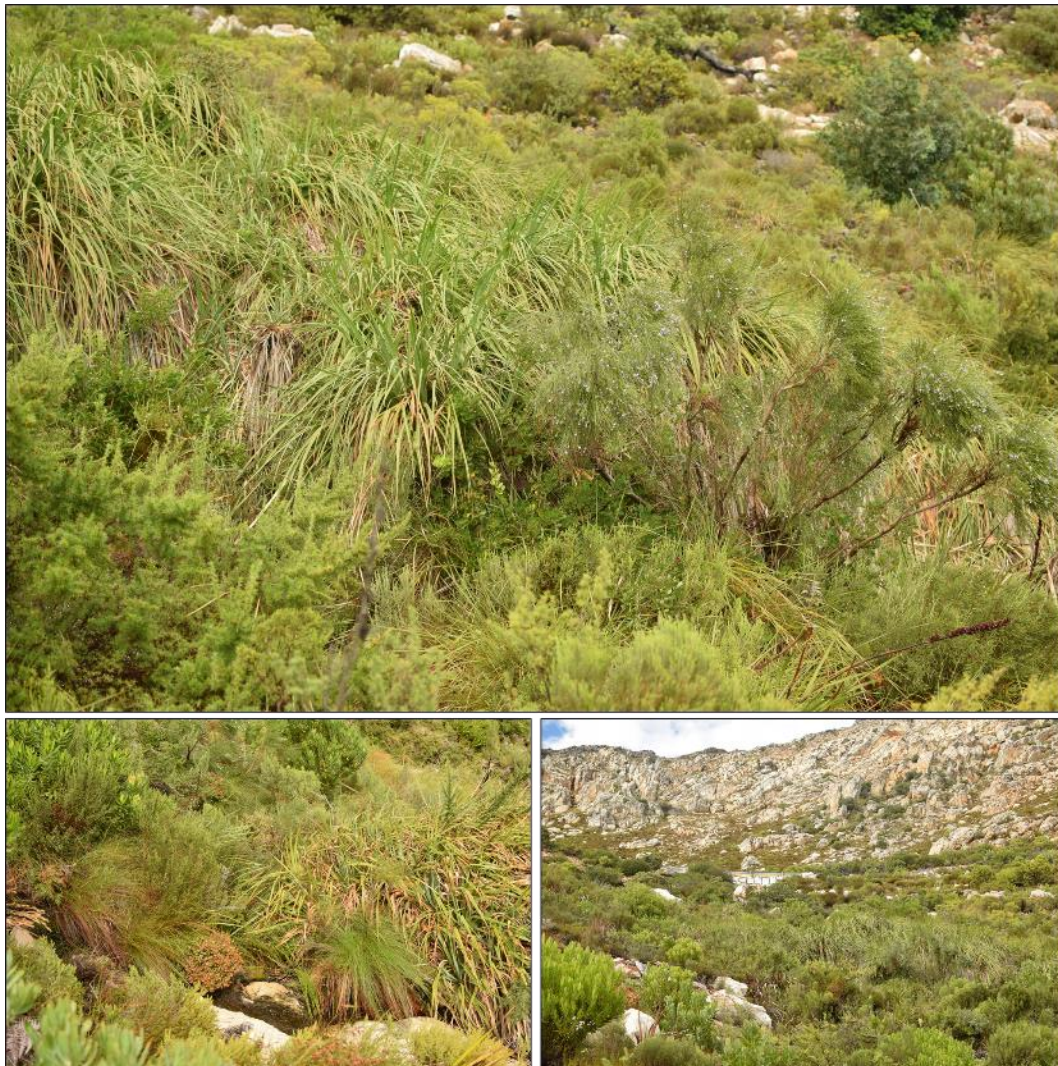
**Figure 13.** Palmiet wetland located downslope of Steenbras Pass Road. Dominated by *Pronium serratum*, this habitat contains many microhabitats, including seeps and pools, which support amphibian species, as well as bird and mammal species.

Downslope of the Steenbras Pass Road, and below the erosion field, the watercourse enters a Palmiet dominated riparian zone/wetland habitat (Figure 13). Approximately 380m<sup>2</sup> in extent, this Palmiet *Pronium serratum* community strongly indicates the presence of a perennial stream. Other mesophilic and hydrophilic species found in this habitat include *Psoralea uncinata*, *Ficinia brevifolia*, *Capeochloa cincta*, *Erica distorta*, *Morella serrata*, and *Cliffortia ruscifolia*. Amongst the dense vegetation are numerous seeps, mossy microhabitats, and small to medium sized pools. These conditions provide optimal habitat for many amphibian species such as Clicking Stream Frog *Strongylopus grayii*, Banded Stream Frog *Strongylopus bonaespei*, Cape River Frog *Ametia fuscigula*, and De Villier's Moss Frog *Arthroleptella villiersi*. This habitat may be able to support Striped Flufftail *Sarothrura affinis*.

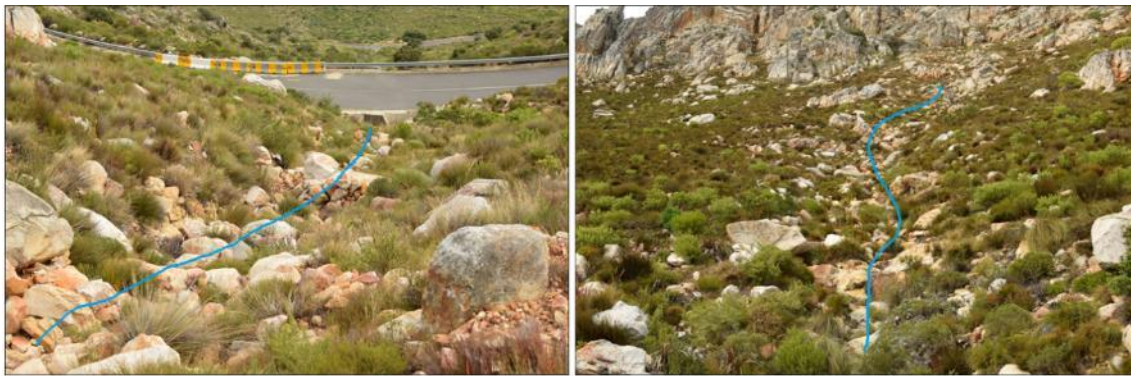
**Figure 14.** Non-perennial watercourses upslope of the Steenbras Pass Road. The riparian vegetation is particularly narrow, almost non-existent on the eastern drainage line.

Upslope of the Steenbras Pass Road there are two non-perennial watercourses (Figure 14). The north-eastern drainage line appears to be the drier of the two, likely only flowing during intense precipitation events whereas the south-western drainage line appears to contain water for a greater part of the year. During the site visit the lowest portion of the drainage line contained pools and moist habitats that support amphibian species (Figure 15). The species assemblage surrounding these drainage lines is very similar to the intact mountain fynbos described below, with more mesic or hydric areas supporting species such as *Capeochloa cincta*, *Erica distorta*, and *Ficinia brevifolia*.

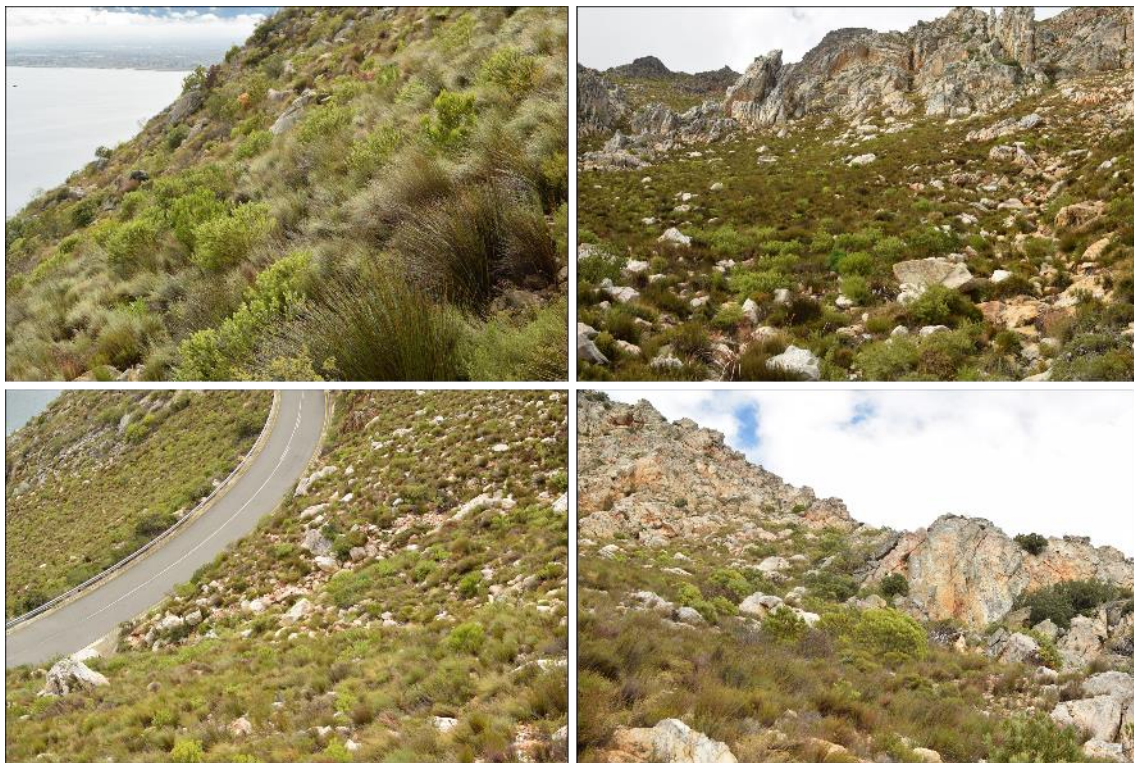
**Figure 16.** Intact Kogelberg Mountain Fynbos across the majority of the site. Open slopes are dominated by graminoid species, with larger shrubs such as *Heeria argentea* and *Protea repens* located in fire refugia amongst sandstone boulders.

Found both above and below Steenbras Pass Road, outside of drainage lines and riverine/wetland habitat, the site supports intact Kogelberg Sandstone Fynbos (Figure 16). The vegetation contains many graminoid species (primarily restios like *Elegia stipularis*, *Hypodiscus* cf. *argenteus*, and *Restio capensis*) interspersed between ericoid shrubs (*Cliffortia carinata*, *Erica serrata*, and larger shrub species such as *Protea laurifolia* and *Heeria argentea*). These species grow in and amongst medium to large sandstone boulders with larger sandstone outcrops located upslope of the site. The abundance of exposed rocks is ideal for species such as Ground Woodpeckers *Geocolaptes olivaceus* and Cape Rock Jumper *Chaetops frenatus* whereas with the sandstone outcrops form optimal habitat for species such as Dassies/Rock Hyrax *Procavia capensis* (the preferred prey item for Verreaux's Eagle *Aquila verreauxii*). Amphibian species such as Cape Mountain Rain Frog *Breviceps montanus* and reptiles such as Cape Crag Lizards *Pseudocordylus microlepidotus* are likely to occur. The high density of *Protea*, *Leucospermum*, and Restiod species also provides significant foraging for SCC such as Protea Canaries *Crithagra leucoptera*.

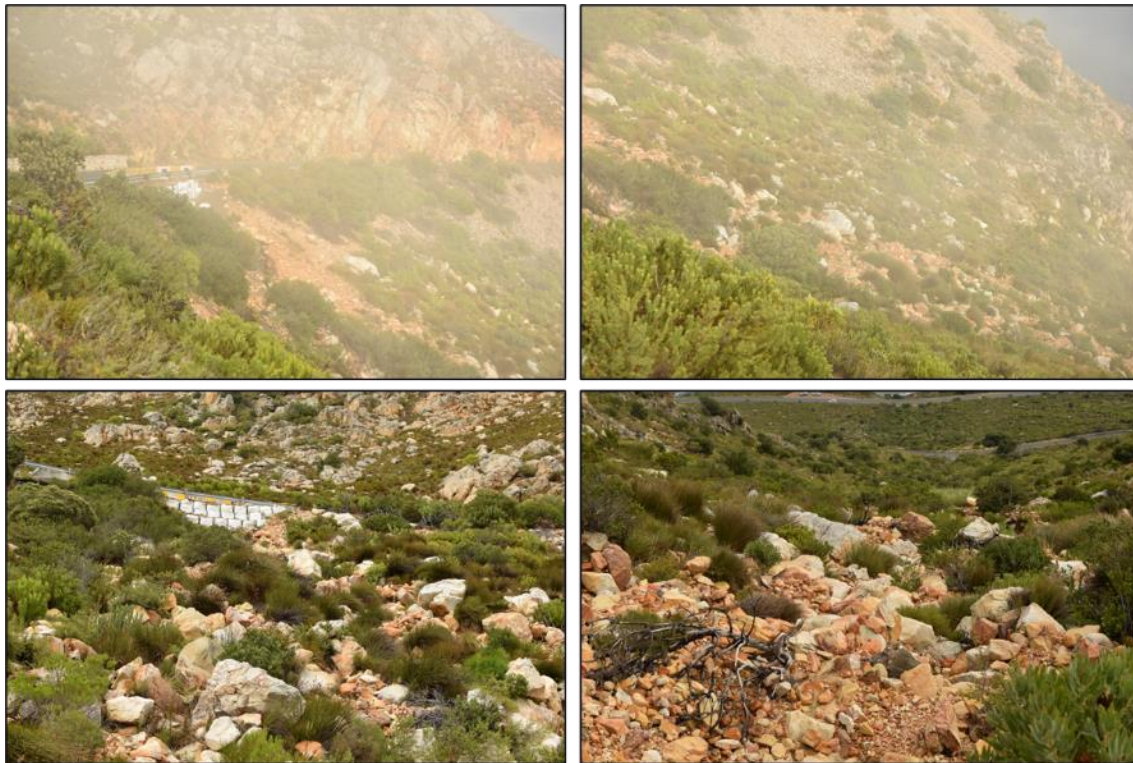
**Figure 17.** Images showing the erosion field downslope of the Steenbras Pass Road. (*top*) shows the extent of the erosion, with cobbles extending approximately 50m down the slope. (*bottom*) Sparsely vegetated in contrast to the rest of the site, supporting robust shrubby species resistant to erosion.

Approximately 1000m<sup>2</sup> in extent, the erosion field sites directly below the Steenbras Pass Road. Dominated by large cobbles and unconsolidated scree, only robust shrub species and newly grown restios are present within this habitat, whilst the margins host intact Kogelberg Sandstone Fynbos (Figure 17). Directly downslope of the road, the slope has been stabilised using sandbags (Figure 18); historic erosion is also visible, with undercutting of gabions used to protect the road also visible. It should be noted that despite the significant disturbance caused by the intense flood event, these erosional processes are natural occurrences on steep mountain fynbos slopes, reshaping watercourses, creating fire refugia, and provide numerous habitat niches as part of a dynamic system. Thus, in the absence of significant anthropogenic pressures, this habitat is not considered to be degraded.
