## Rehabilitation of the Steenbras Water Treatment Plant (WTP) Access Road Repair

Site Sensitivity Verification Report (SSVR)

**City of Cape Town**

Document number: R00001008882-00-ZUT-REP-NM-0001-Site  
Sensitivity Verification-00

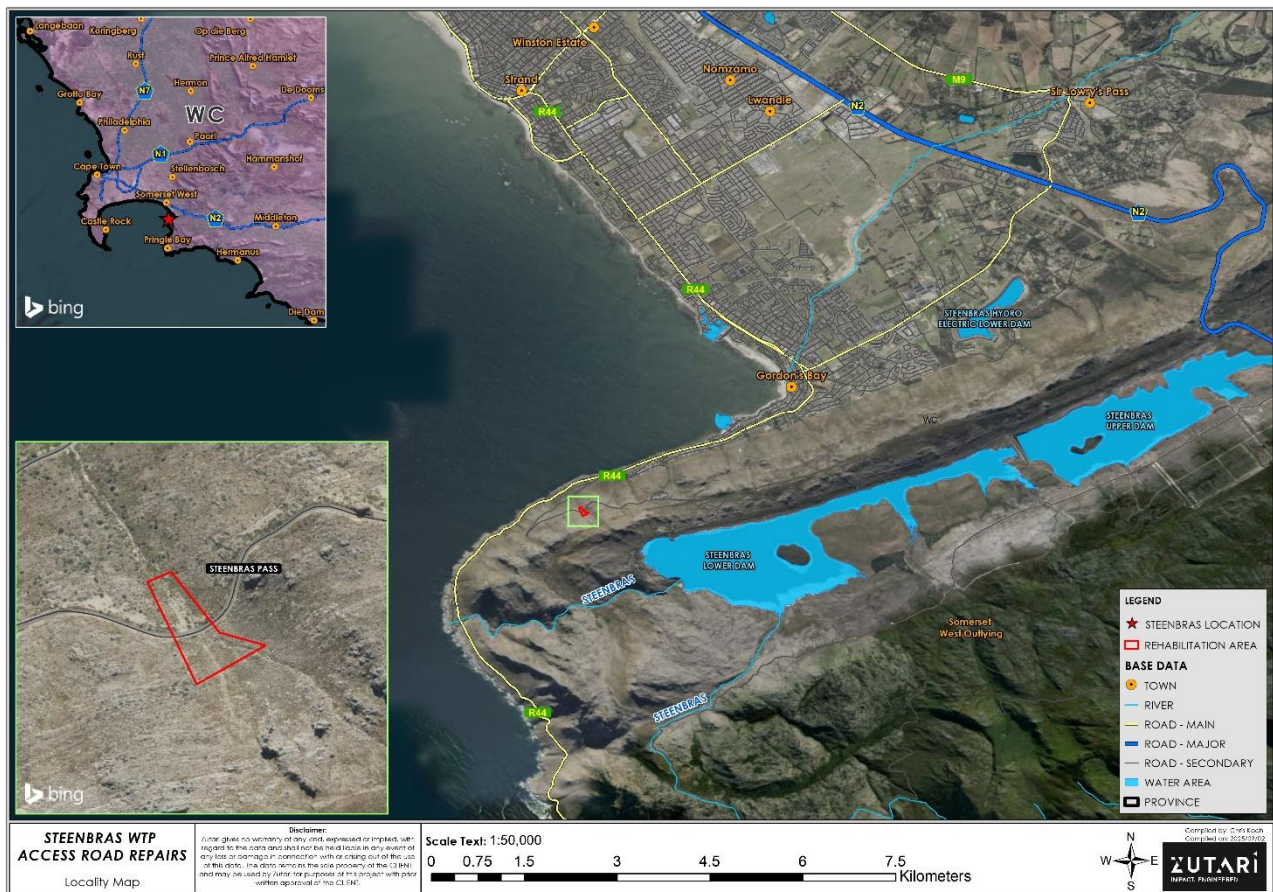
Figure 1: Steenbras WTP Access Road rehabilitation area (Red)

The City of Cape Town (CoCT) proposes the rehabilitation of a section (referred to as “Slope 1”) of the Steenbras Water Treatment Plant (WTP) access road (Steenbras Dam Road). Slope 1 is located on Farm Faure Marine Drive (RE/933). The locality of the proposed rehabilitation area is shown in Figure 1 below.

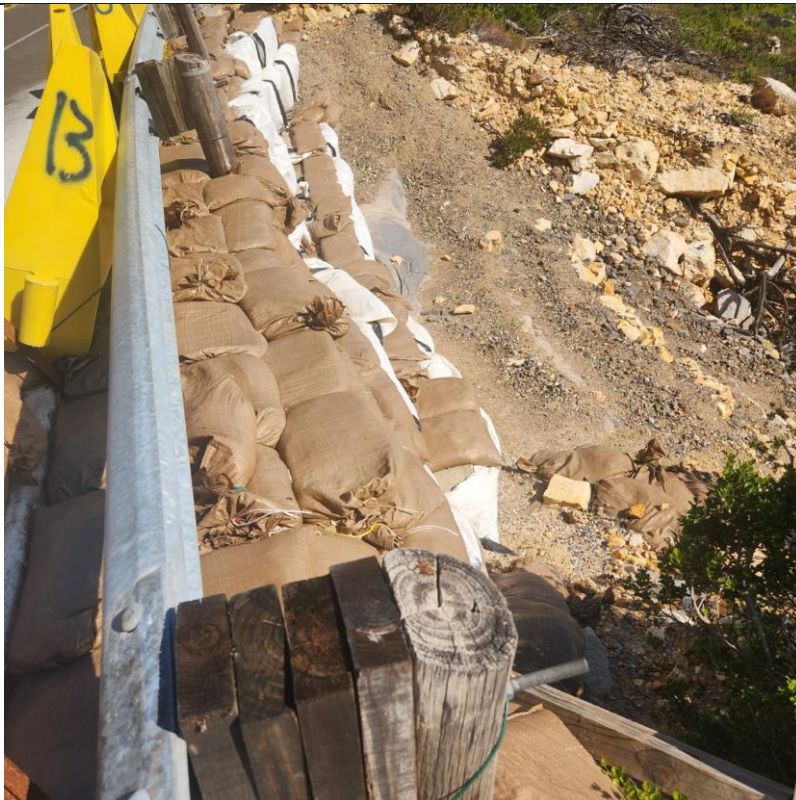
Temporary roadside reinforcement using sandbags and barriers to prevent further erosion of slope 1 along the Steenbras WTP access road

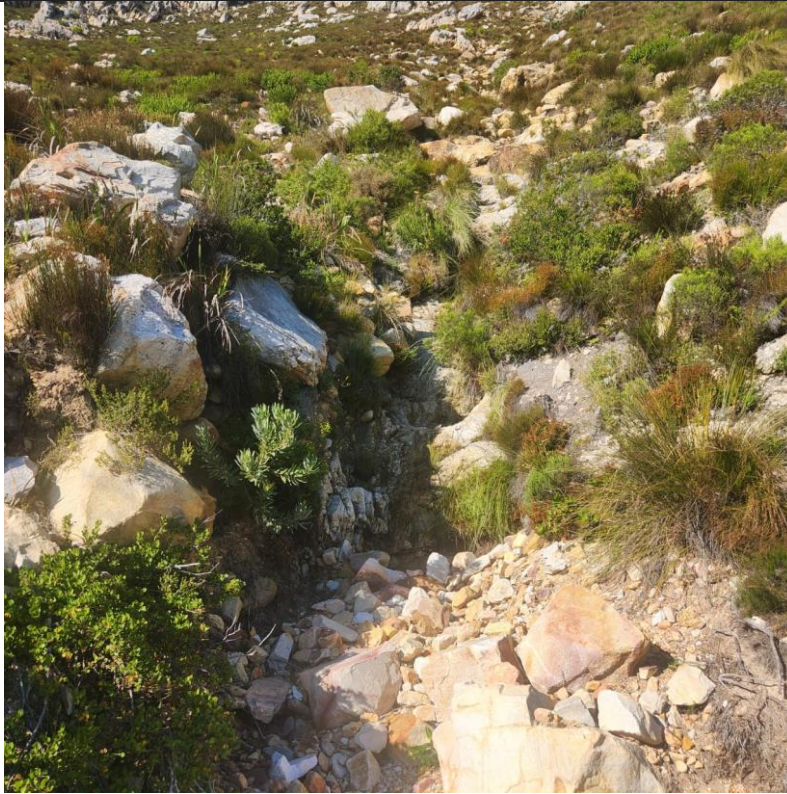
Natural water channel within the rocky terrain and dense fynbos vegetation within the proposed slope 1 rehabilitation area

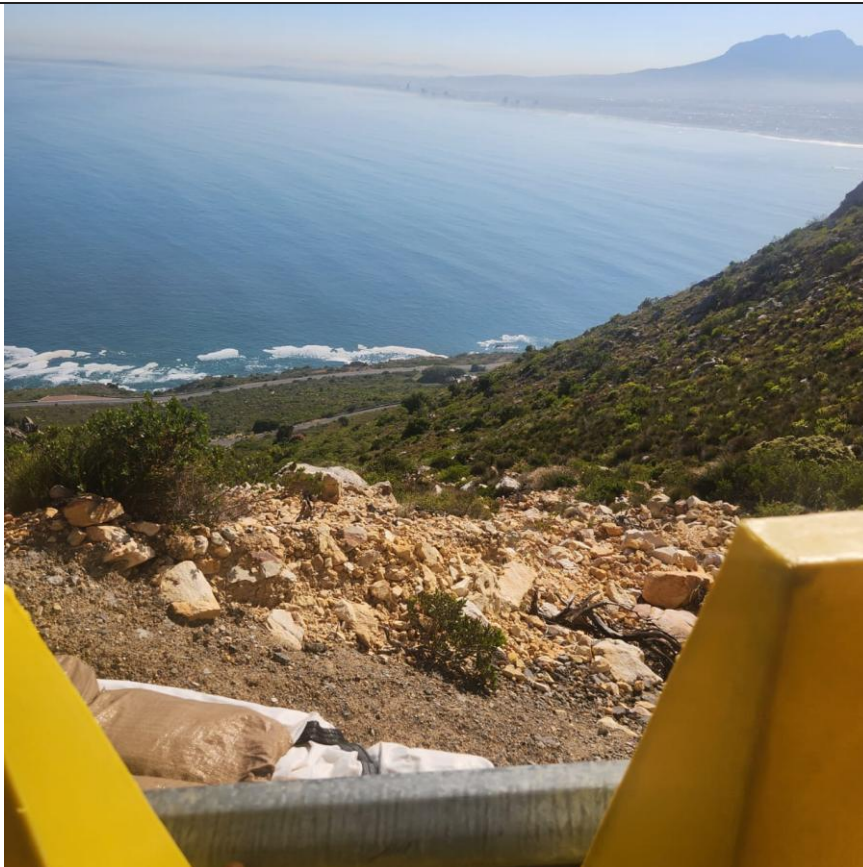
Evidence of slope instability and erosion on slope 1 and views of the vegetation in the area (Kogelberg Sandstone Fynbos)

The City of Cape Town (CoCT) proposes the rehabilitation/repair of a damaged section “Slope 1” of the Steenbras Water Treatment Plant (WTP) Access Road on Farm Faure 933, where the slope instability occurred as a result of flood damage. To address the slope damage, two slope stabilisation methods have been considered for the repair/rehabilitation of Slope 1: the Anchored gabion wall and Terramesh retaining wall. The purpose of assessing these methods is to determine the most environmentally and technically feasible for the proposed repair of Slope 1. The locality of the rehabilitation area is shown in Figure 1.

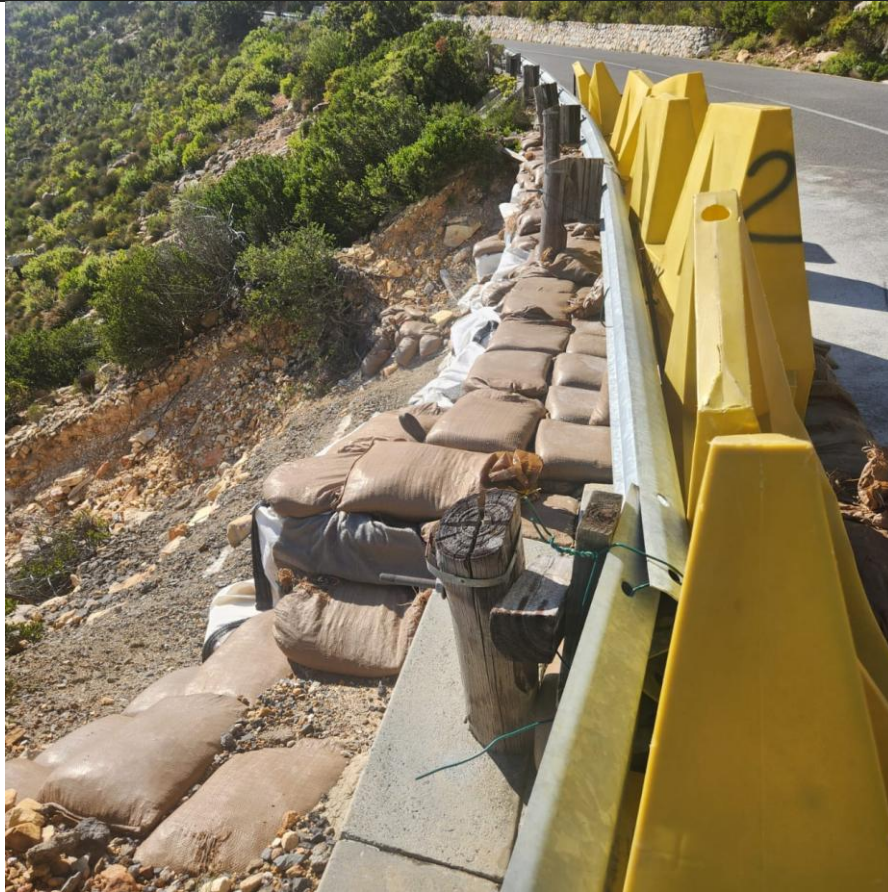
Temporary roadside reinforcement using sandbags and barriers to prevent erosion and support slope stability on the proposed rehabilitation area

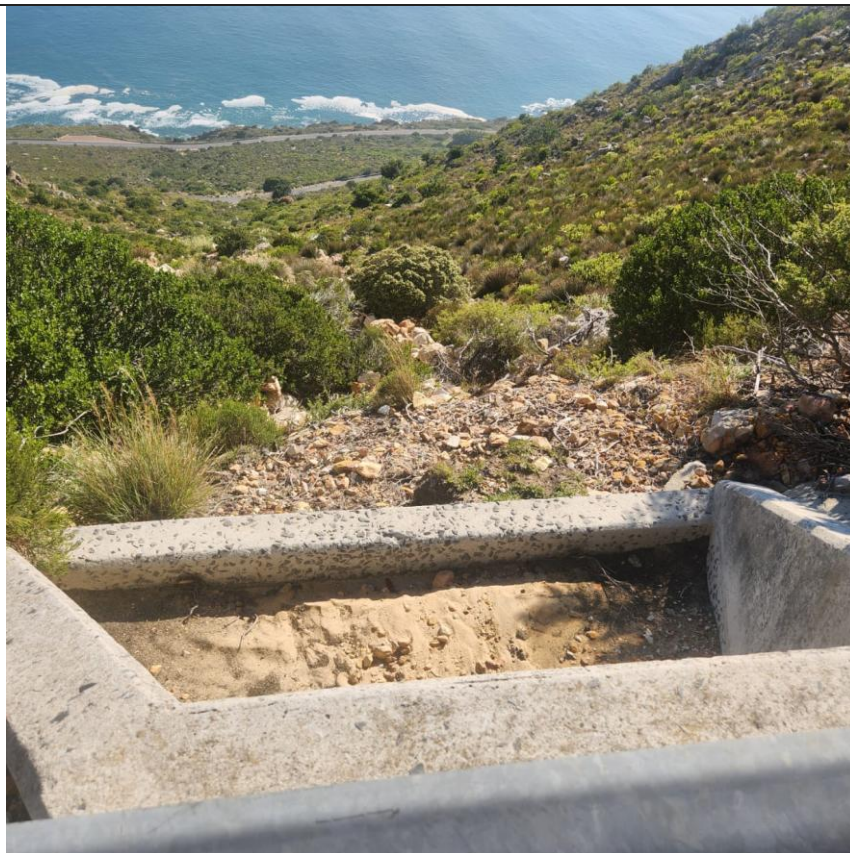
Example of the blocked culvert and Kogelberg Sandstone Fynbos on the proposed slope 1 rehabilitation area

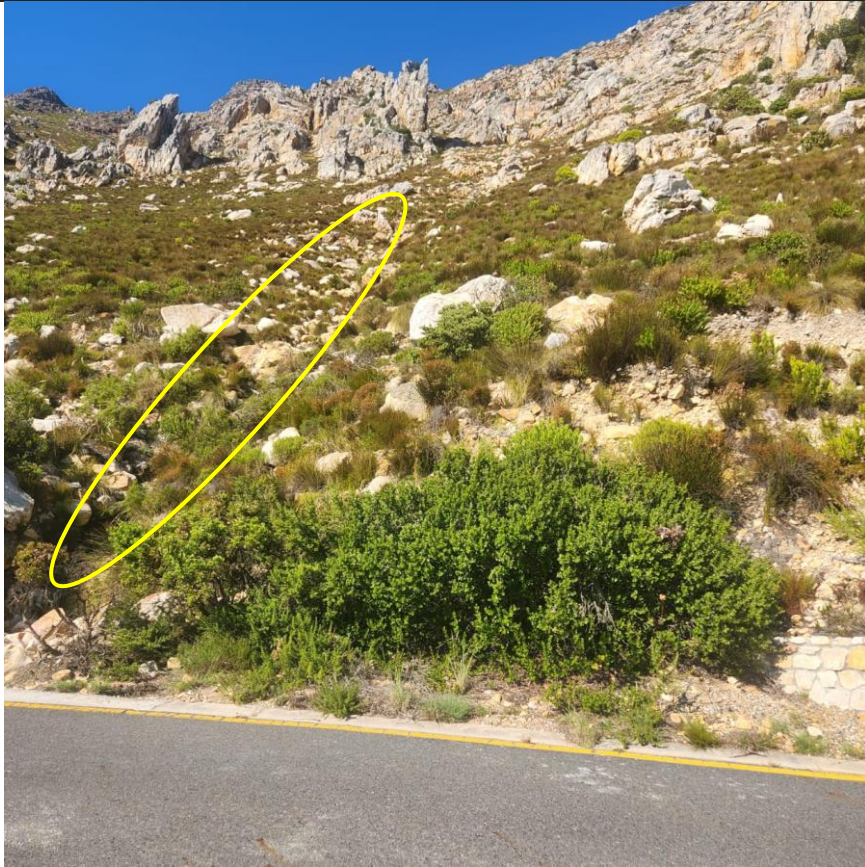
Dense Kogelberg Sandstone Fynbos vegetation in a mountainous landscape (proposed slope 1 rehabilitation area near the tar road). Natural water channel (encircled in yellow)

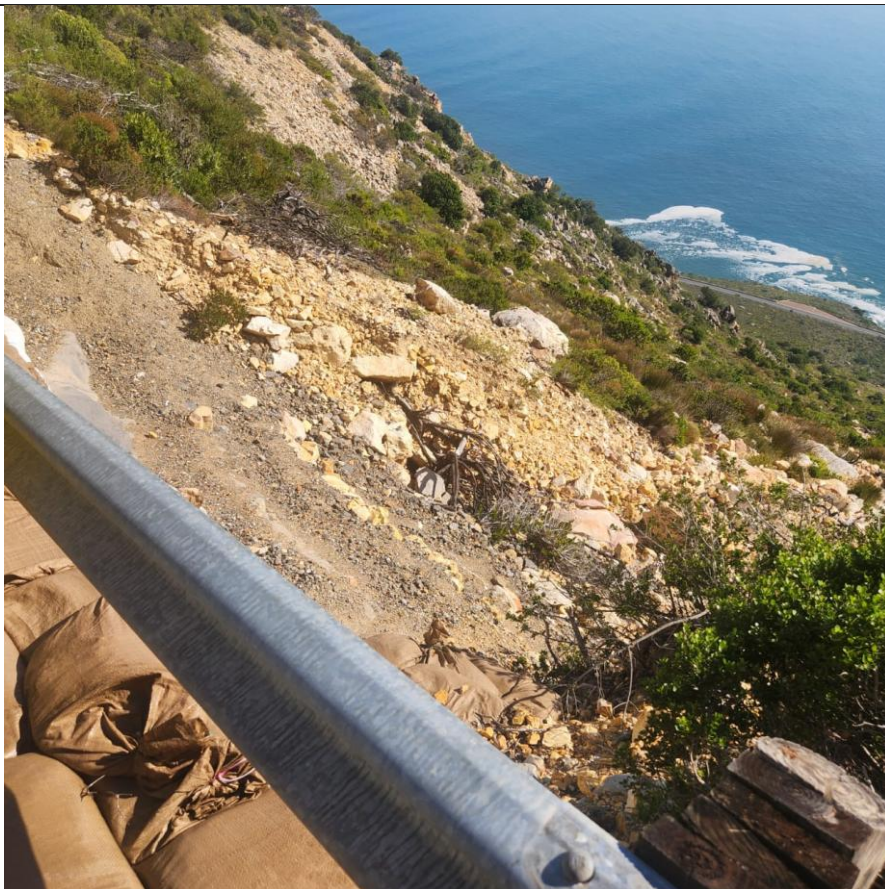
View of the Kogelberg Sandstone Fynbos and the damage to the slope 1 area

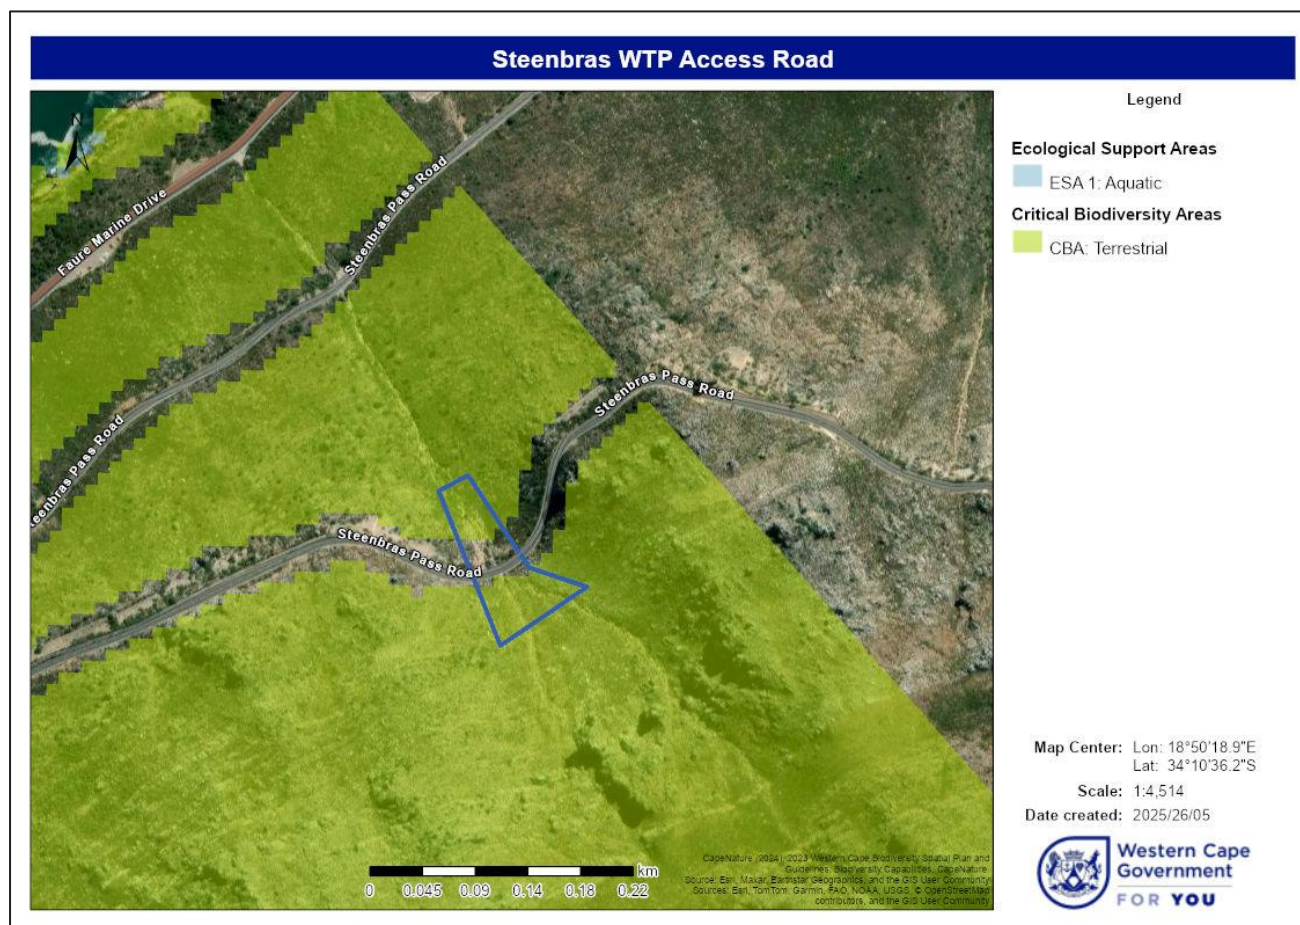
Figure 2: Critical Biodiversity Areas (CBA)s.

According to the 2023 Western Cape Biodiversity Spatial Plan (WCBSP, 2023), there are Critical Biodiversity Areas at the site. There is no Ecological Support Area (ESA) on the site. (Figure 2) The site is located within CoCT conservation area (Not formally protected under the Protected Areas Act). The rehabilitation area also falls within the Kogelberg Biosphere Reserve

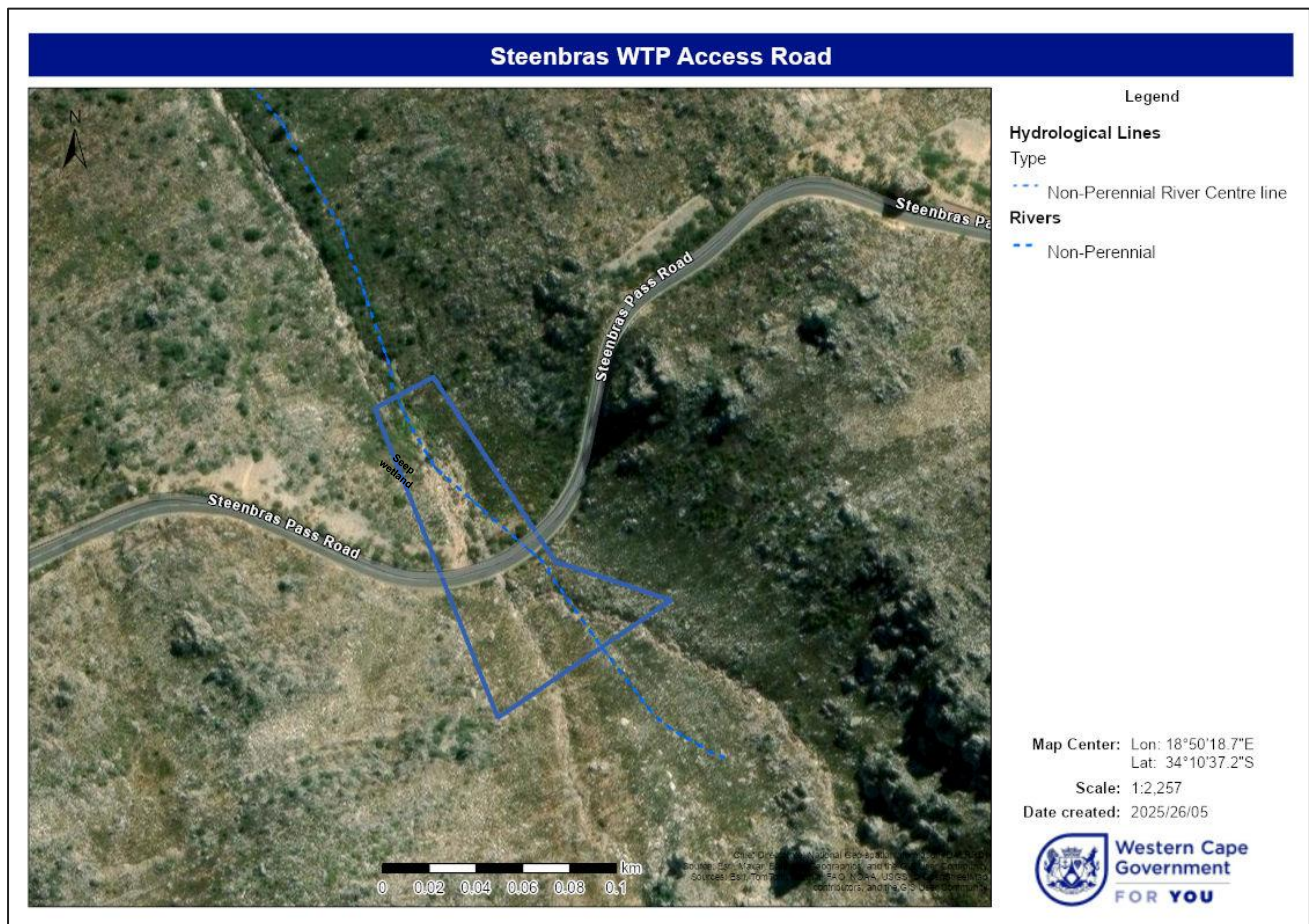
Figure 3: Aquatic Resources

The National Wetlands Map indicates that there is a seep wetland located approximately 450m east of the rehabilitation area (not shown in Figure 3 below). There is also a non-perennial river passing through the middle of the proposed slope 1 rehabilitation area (see blue dotted line in Figure 3). The intersection of the rehabilitation area and the non-perennial river triggers the need to register a water use, as identified in the National Water Act, with the Department of Water Affairs (DWS).
