## ADDENDUM

**PROJECT:** Baseline Assessment of Ecosystems Potentially Impacted by the well-field development at Steenbras:

Freshwater and Botanical Specialist Report (March 2019)

**CLIENT:** City of Cape Town

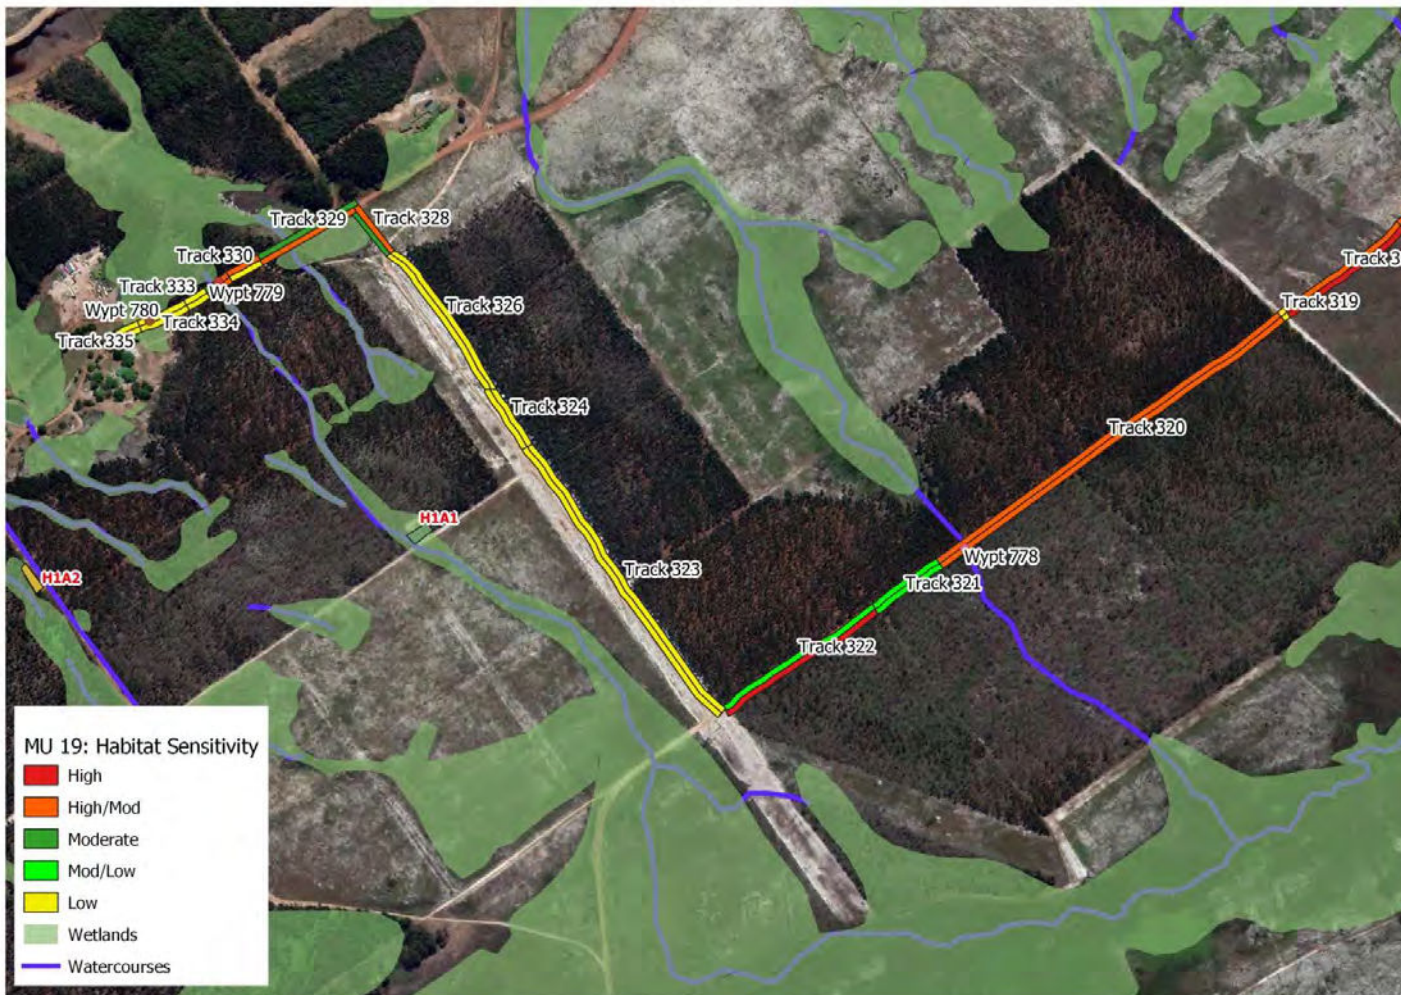
**Figure A3b** Management Unit 19: Habitat Sensitivity between the firebreak and the Steenbras offices

Tracks 323 to 326 represent the pipeline route through the firebreak adjacent to the existing plantation (Figure A3a). Due to constant ploughing and clearing below the Eskom pylons through this area, the habitat is completely altered. Changes in saturation of the sandy substrate suggest that this area is a mosaic of wetland and dry land, but severe disturbance rendered mapping of wetland impossible. Because of its poor condition and continued disturbance, the Ecological Sensitivity of this area is considered low (Table A1b and Figure A3b).

Despite disturbance to wetlands at the northern extent of the firebreak, this habitat still supports natural wetland habitat that attenuates runoff and discharges into relatively natural wetland north of the main road into Steenbras (Tracks 328 and 329). This area is considered to be of moderate to high Ecological importance with a high sensitivity to disturbance (Figure A3b and Table A1b).
