**BOTANICAL INPUTS FOR THE ATLANTIS WATER  
RESOURCE MANAGEMENT SCHEME ENVIRONMENTAL  
MAINTENANCE MANAGEMENT PLAN, CITY OF CAPE  
TOWN**

DECEMBER 2024

REPORT PREPARED FOR  
ZUTARI (PTY) LTD

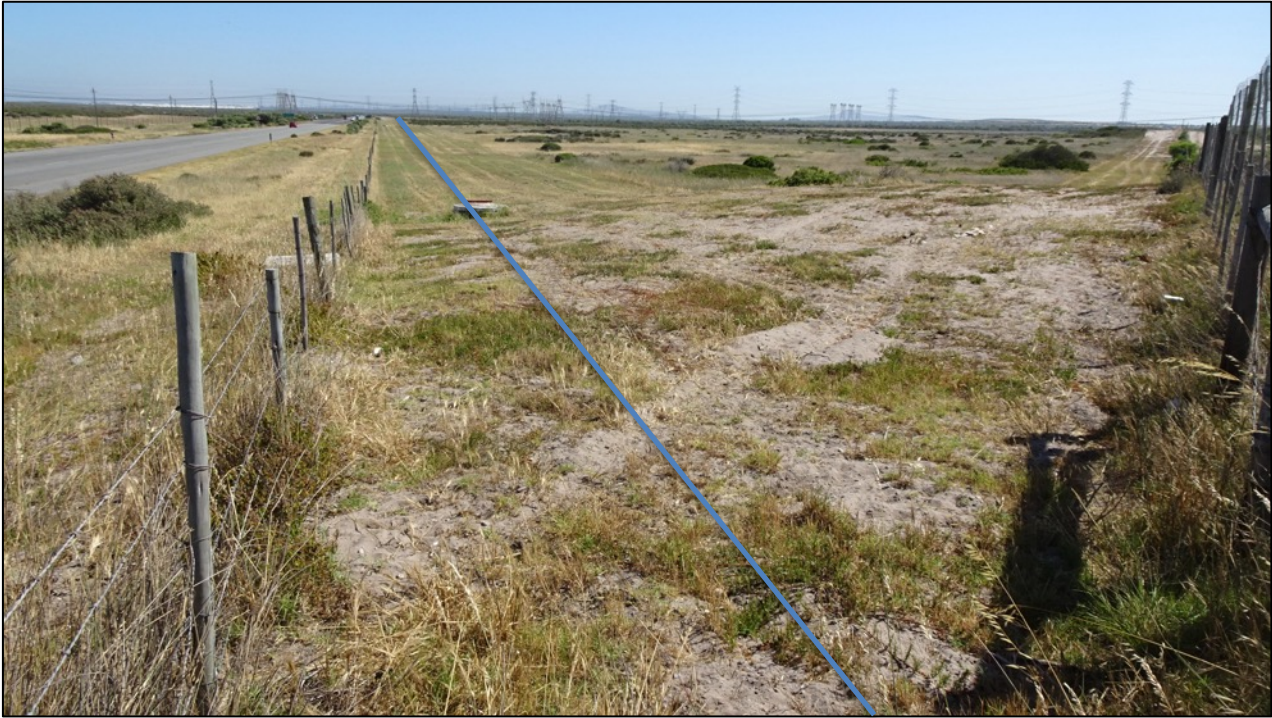
Figure 7. Transformed land adjacent to the R27. The blue line represents the pipeline.

Species diversity is typically higher in the most intact areas, declining with increasing levels of disturbance. The most transformed areas, ranging from (1) built-up or recently cleared areas with no vegetation present to (2) brush-cut or heavily impacted sites, may only support a few species, often dominated by exotic species. Figures 4 to 7 provide examples of the varying levels of disturbance.

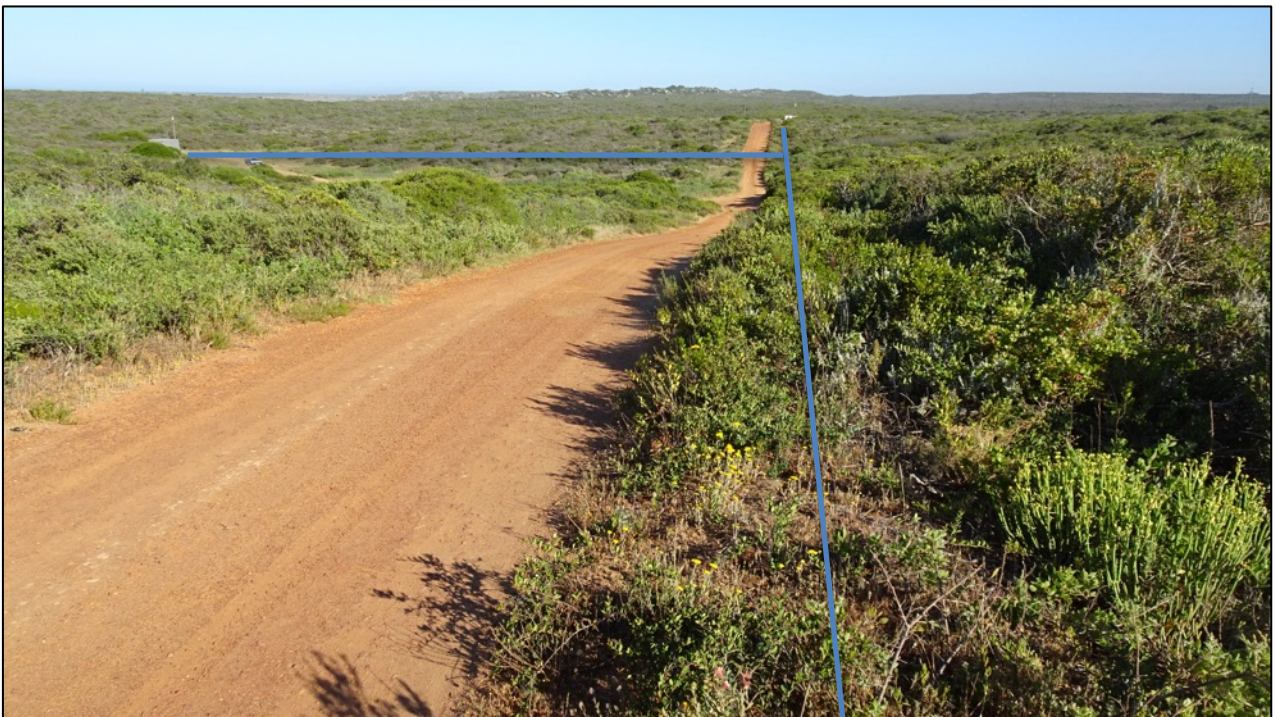
Figure 8. Intact Cape Flats Dune Strandveld at Silwerstroom. The blue line represents the pipeline.

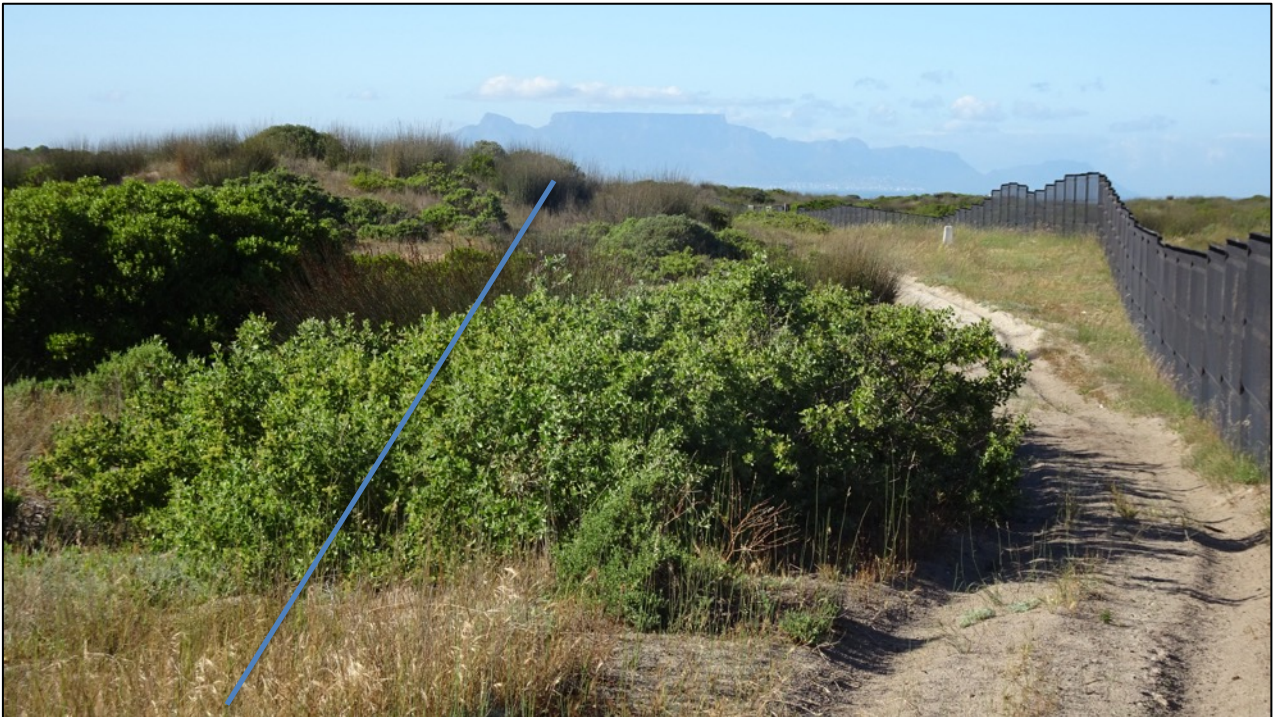
Figure 9. Intact CFDS within the pipeline route within the road reserve immediately adjacent to the Witsands Aquifer Nature Reserve. The blue line represents the pipeline.

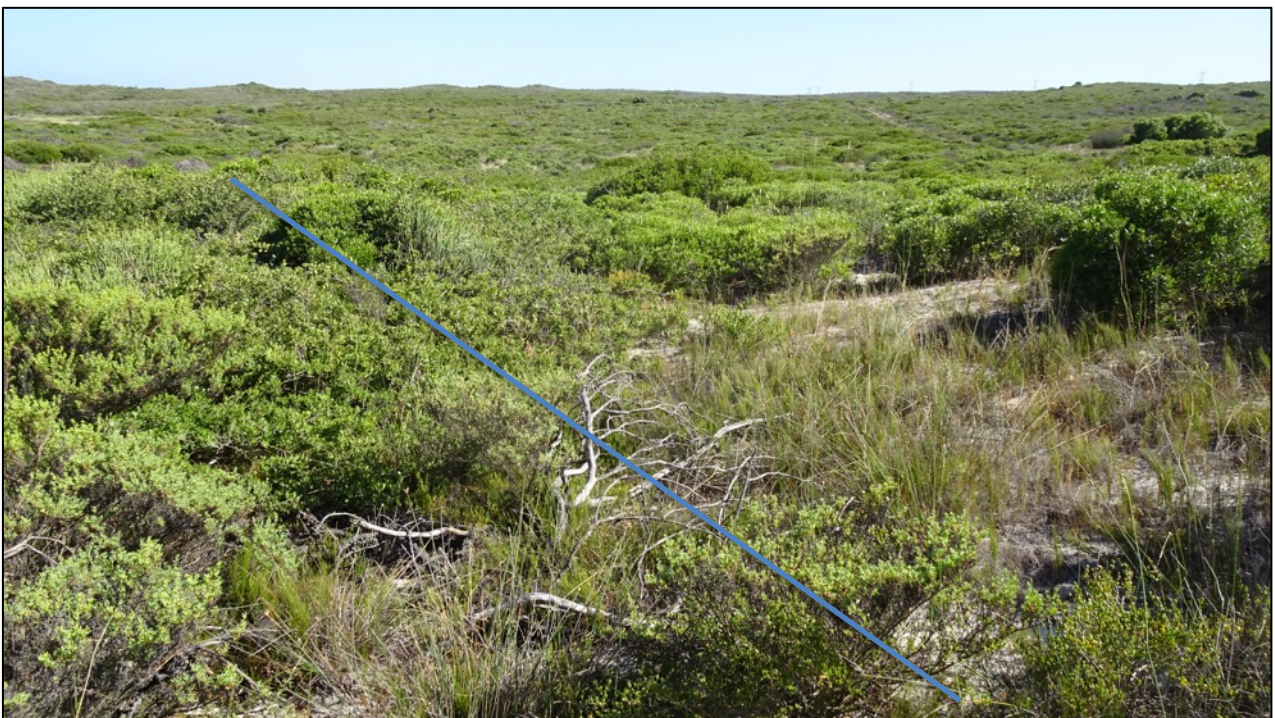
Figure 10. A patch of dune olive *Olea exasperata* that has reestablished along the pipeline east of Basin 7. The blue line represents the pipeline.

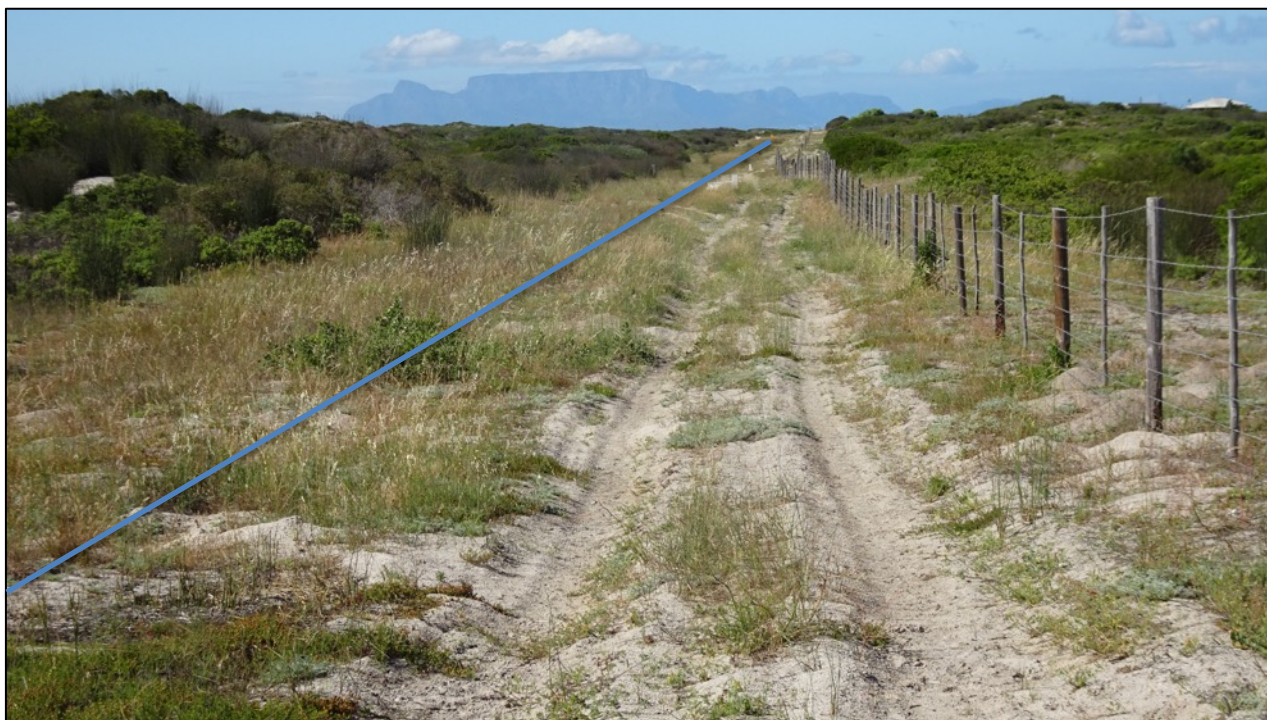
Figure 11. Degraded CFDS within the pipeline route adjacent to Intact CFDS left within the road reserve immediately adjacent to the Witsands Aquifer Nature Reserve. The blue line represents the pipeline.

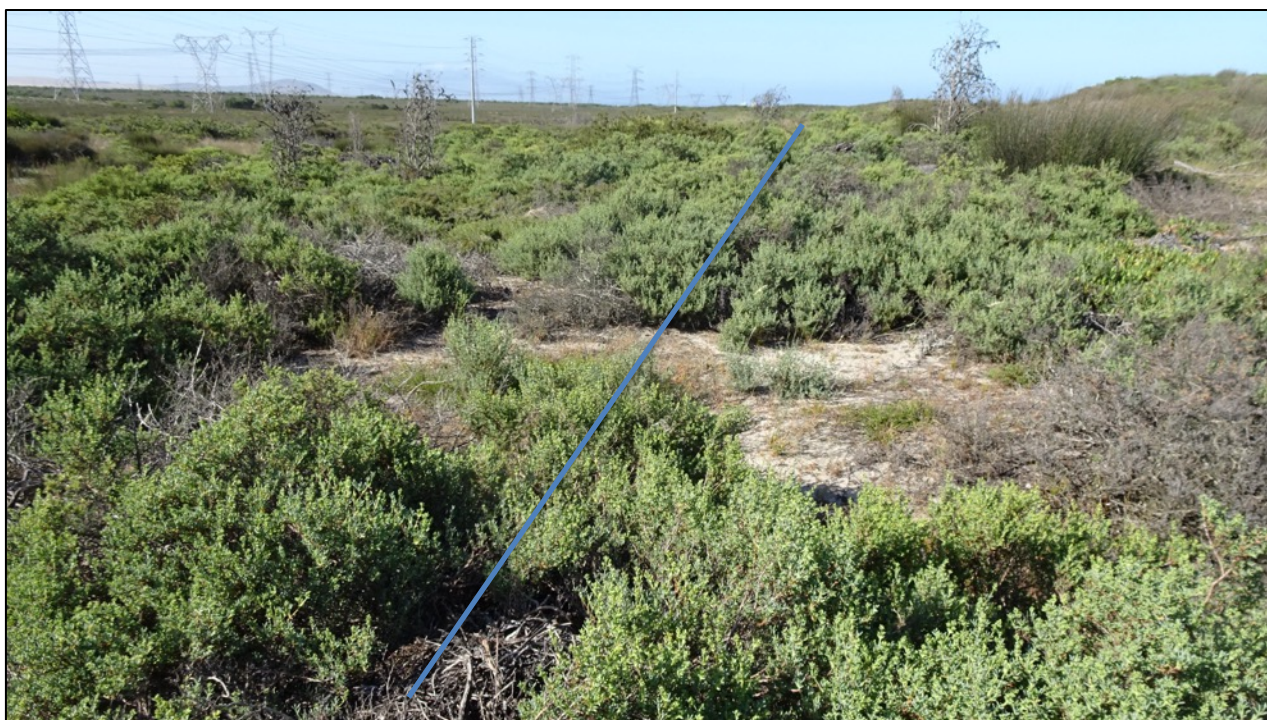
Figure 12. Degraded Cape Flats Dune Strandveld dominated by *Ruschia misera*. This species is dominant along the previously disturbed section of pipeline within strandveld and is key ecological species in that it establishes readily, forming an important role in natural rehabilitation. However, it is unknown for how long the species dominates the landscape. The blue line represents the pipeline.

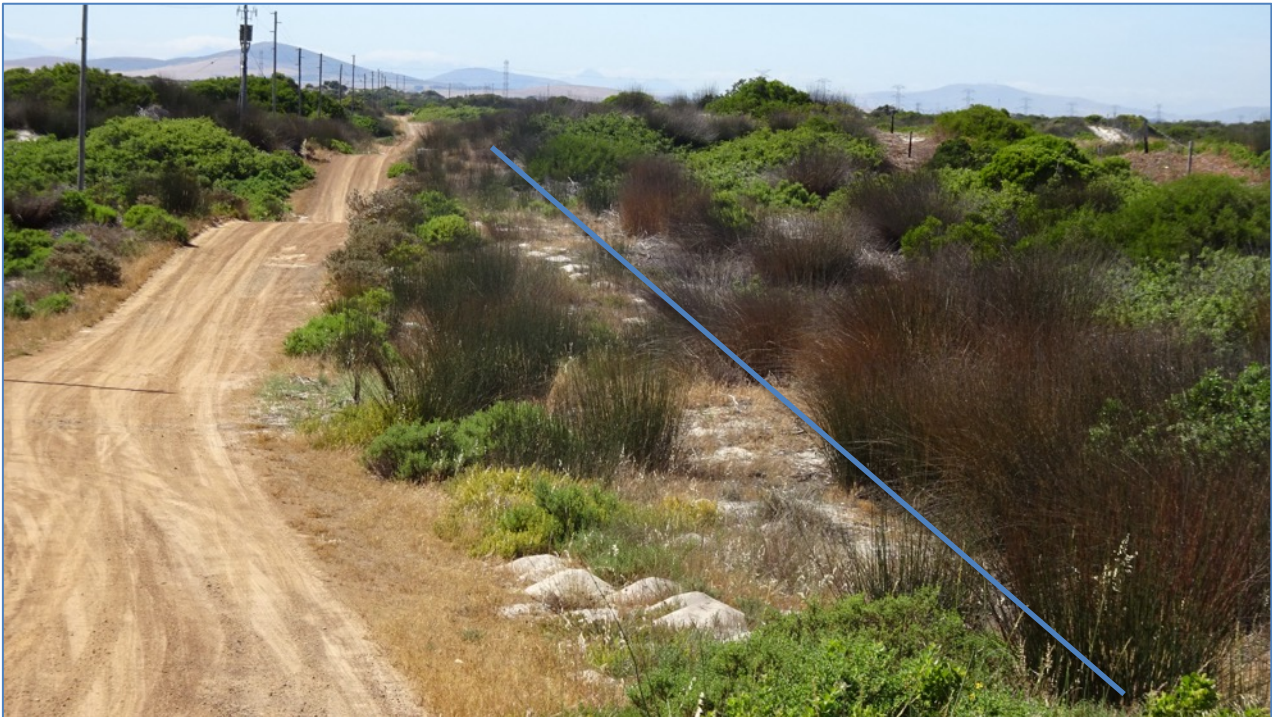
Figure 13. Pipeline disturbance footprint visible (blue line) in the Witsands Aquifer Nature close to the R27 showing degraded CFDS. The blue line represents the pipeline.

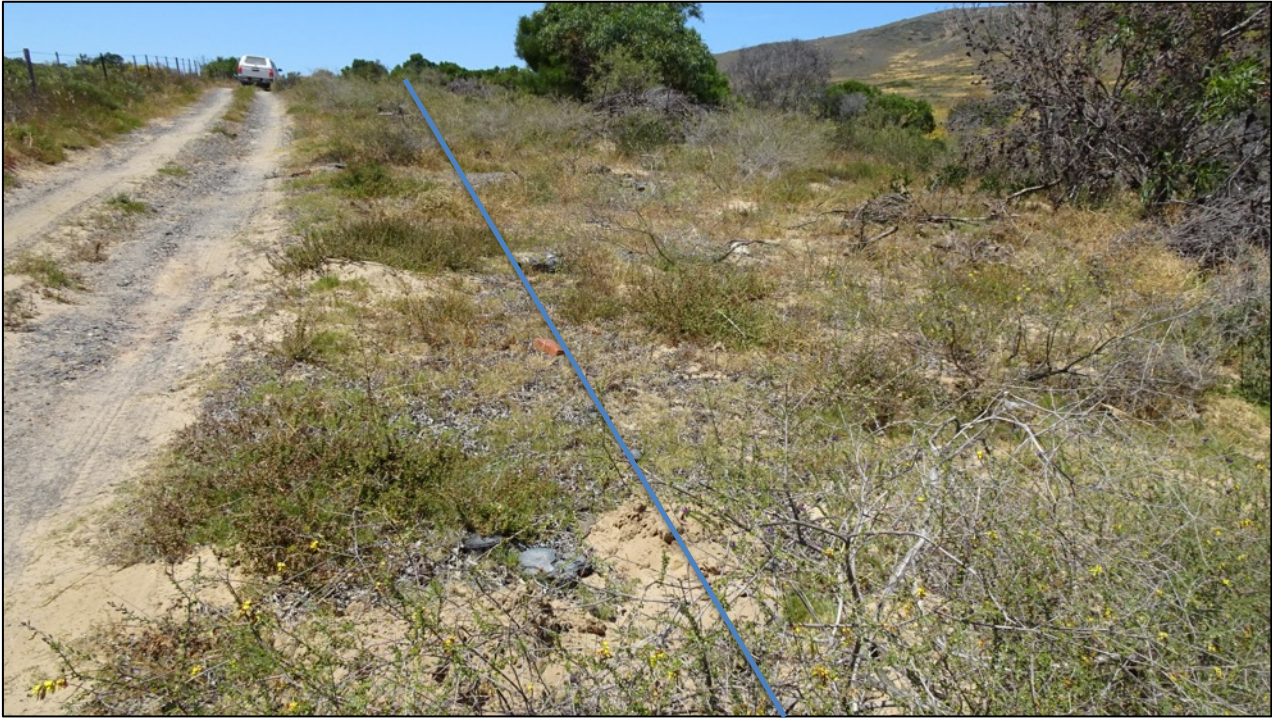
Figure 15. Degraded Atlantis Sand Fynbos-Swartland Shale Renosterveld ecotone on the lower slopes of Blouberg Hill near the Blouberg reservoir. The blue line represents the pipeline.
