# Archival Review and Interpretation Report

EVALUATION OF THE HERITAGE SENSITIVITY OF TWO  
SITES IDENTIFIED DURING A ROUTINE HIA ON THE  
FARM ARMOEDE 823 LR, MOKOPANE, LIMPOPO  
PROVINCE.

**Site name and location:** Proposed Solar Development on the Farm Armoede 823 LR, Mokopane, Limpopo Province.

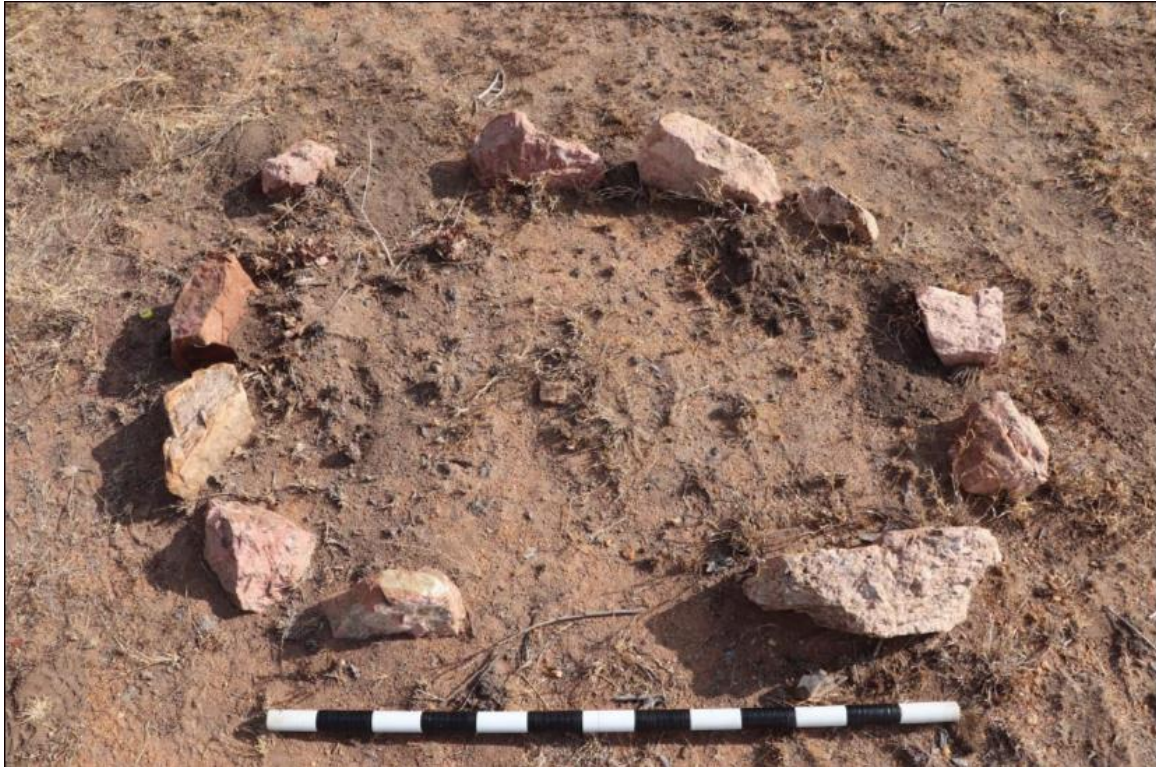
During the fieldwork undertaken for the Heritage Screening Assessment (Birkholtz, 2019), an oval, loosely packed stone-lined feature was identified and included in that report as site **MGSP 3**. The site was defined as a possible grave. During the fieldwork undertaken for the Heritage Scoping Assessment (Birkholtz & De Bruyn, 2020), no evidence for the stone feature identified the previous year could be found. However, a formal grave with a granite dressing and headstone was identified in close proximity to the place where the stone feature had been observed in 2019. As such, it seems likely that the family of the deceased replaced the stone feature with a formal grave dressing in the period between the fieldwork trips of 2019 and 2020. The grave was included in the Heritage Scoping Assessment as site **MGSP 8**. The site was again recorded during the fieldwork undertaken for the Heritage Impact Assessment. It was given the site number **MGSP 35**.

*Figure 22 – The stone-lined feature identified as a possible grave in 2019. The scale is in 10cm increments.*

The original stone circle photographed during the site scoping has several characteristics that makes the likelihood of it being a grave less. The packed stone circle seems of recent origin as can be seen from the lack of subsiding of the rocks into the ground as well as the limited plant and insect activity around them. When these circles indicate a grave, they are usually packed around a mound of earth and as time goes by this mound subsides to the top level of the stones. It seems likely that this stone circle was recently packed to indicate the possible location of a lost grave or merely to look like a grave until further steps could be taken. This circle can therefore be seen as a temporary marker to indicate a possible location of a lost grave. The sudden occurrence of the new granite grave dressing in the same area corroborates this idea especially since it is illegal without the correct permits to bury a person anywhere outside of a registered municipal cemetery and therefore it is unlikely that it would represent a new burial.

There is further uncertainty caused by the site size description in the HIA report. It gives the site size as 10m x 10m. One hundred square metres is a very unlikely size for a single grave.

The site variously attributed the number MGSP 003 as well as MGSP 008 should be treated as a burial site even though there are uncertainties as to its origin. Since the placement of the new grave dressing was done recently it is obvious that there are motivations behind this that is not yet clear at this stage. Legally the onus is with the developer to prove that it is not a grave and not for the family to prove the opposite. Until further investigations the sites therefore need to be regarded as having high heritage significance.

It is recommended that the claimant, Mr. Molekana be contacted by a social liaison officer to discuss the origin of the grave site. Since the site was recently upgraded it is fair to assume that the family have close ties to the deceased and they would therefore be in possession of a death certificate and could direct the investigators to other more senior members of the family who could corroborate the claim. It would be worthwhile (even if it is refused) to request permission from the family to perform a ground penetrating radar investigation into the likelihood of this being a grave. This is a non-intrusive investigation and refusal will give an indication of the legitimacy of the claim.

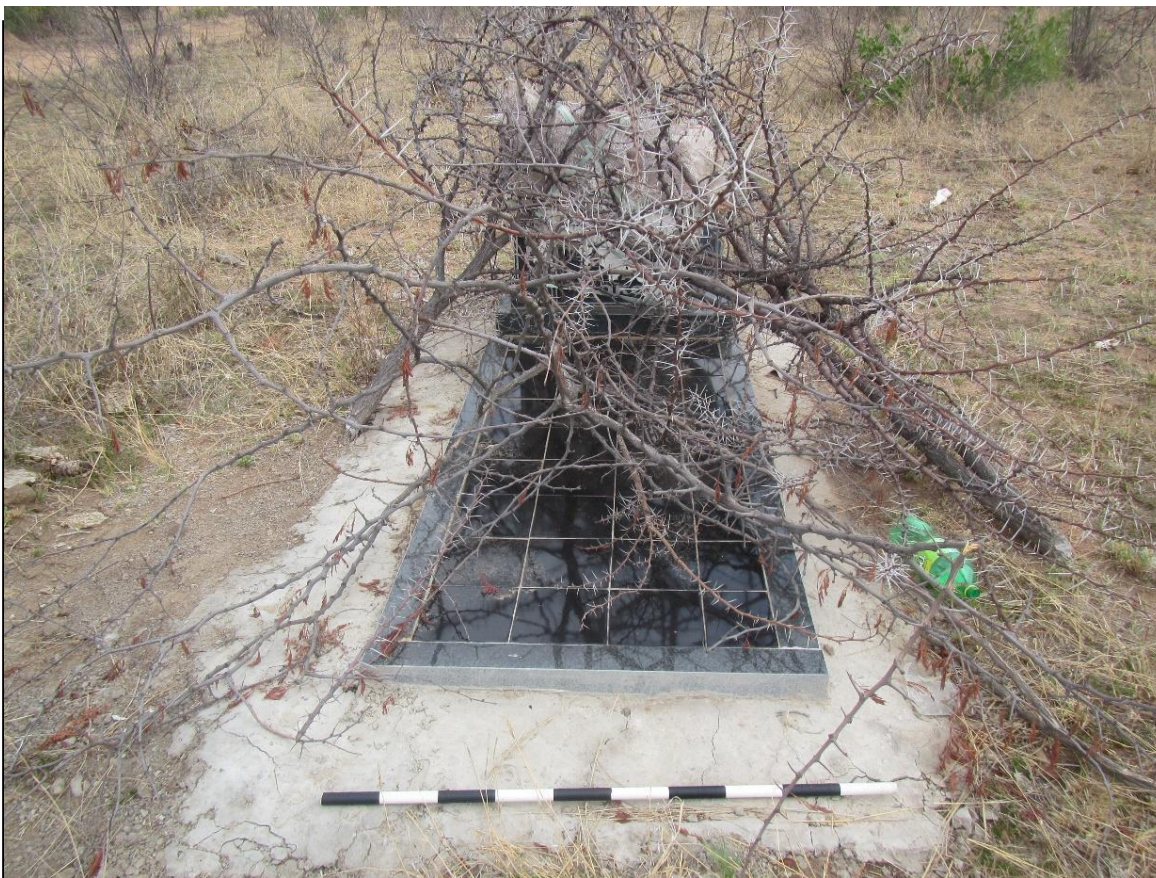
*Figure 23 - View of the grave that was identified in close proximity to the previous stone feature in 2020. This grave was given the site number MGSP 8. The scale is in 10cm increments.*

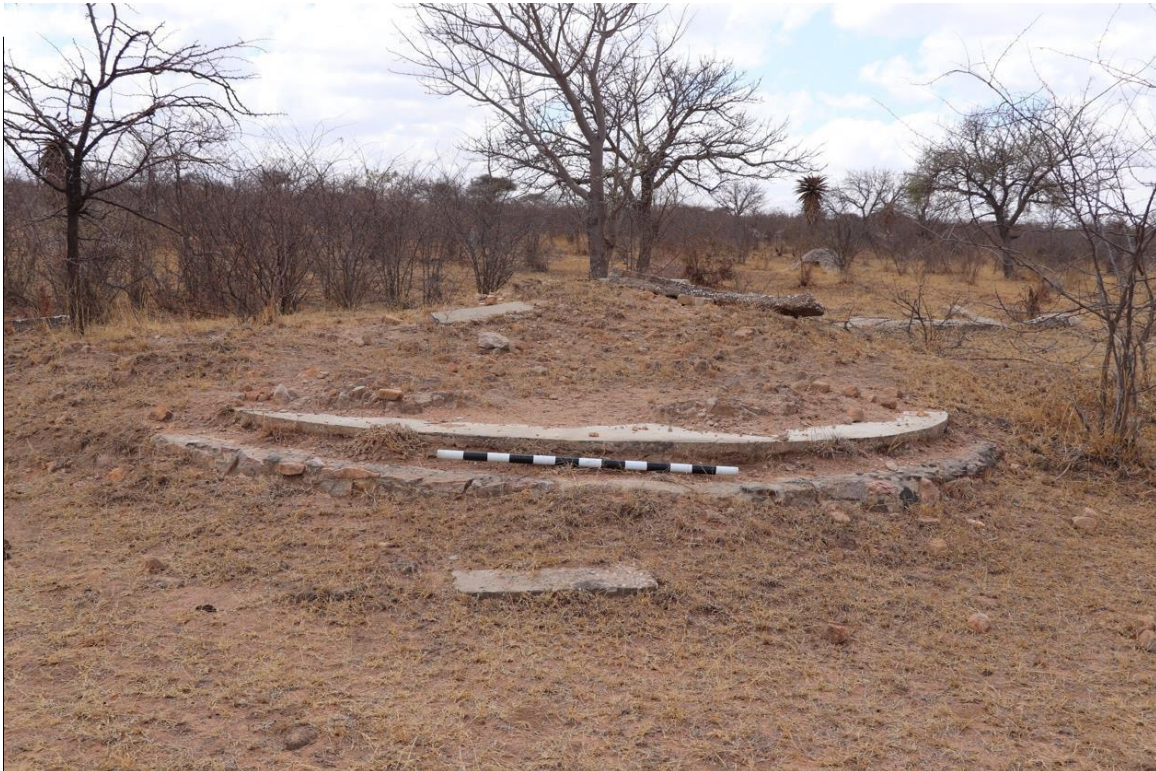
The site comprises the remains of a historic farm dwelling that appears to have been built and used at a time when the farm was still utilise as a farm. This would have been before the establishment of the settlement of Armoede. From the tangible remains still evident on site, it seems that the farmhouse was originally comprised a rondavel, which over time was extended by adding a second rondavel and finally by linking the two rondavels into one dwelling.

The exact age of the structure is not presently known. It is also not depicted on any of the available historic maps. As it is not depicted on the topographic maps that were surveyed from 1970 onwards, it would appear that the structure is likely older than the surveying of these maps. However, it is not certain whether the structure is in fact older than 60 years.

Figure 26 – General view of the structure at site MGSP 5 (MGSP 22). The scale is in 10cm increments.

The author suggests that the circular structure/s was in fact a bungalow or hut, however these structures are rarely constructed from reinforced concrete with stone foundations. Where rural people have started to adopt these superior building materials they have reverted to more western styled square or elongated structures. Rondawel huts were almost exclusively built in this area using mud-bricks or lattice and mud construction and would not have left any significant remains, at the most a slightly elevated soil mound.

As indicated in the following section on historic maps, there were also no indications of a homestead on this section of the farm Armoede 823 LR. One structure that is however often encountered on these historic maps are concrete water reservoirs. When the structures at MGSP 5 is reevaluated with this background knowledge it becomes very likely that these remains are that of concrete reservoir/s rather than dwellings. Even modern rural houses are not constructed using reinforced concrete and stone foundations. When you look at the floor of the structure it is obviously a floated concrete floor that was meant to be waterproof. The "interconnecting structures" could well be water troughs although there are no photographs of these supplied in the HIA report.

This site is more contentious and from the small amount of information available it is suggested that this could rather be the remains of a concrete water reservoir than a homestead as suggested by the original HIA report. Once again this will need to be verified on the ground and the archival study cannot confirm this.

It is recommended that this site undergoes a second phase of field-investigation since the original HIA findings were not conclusive enough. Based on these findings the claims from Mr. Molekana can be measured against the information he supplies about the building. This can go a long way towards determining legitimacy.

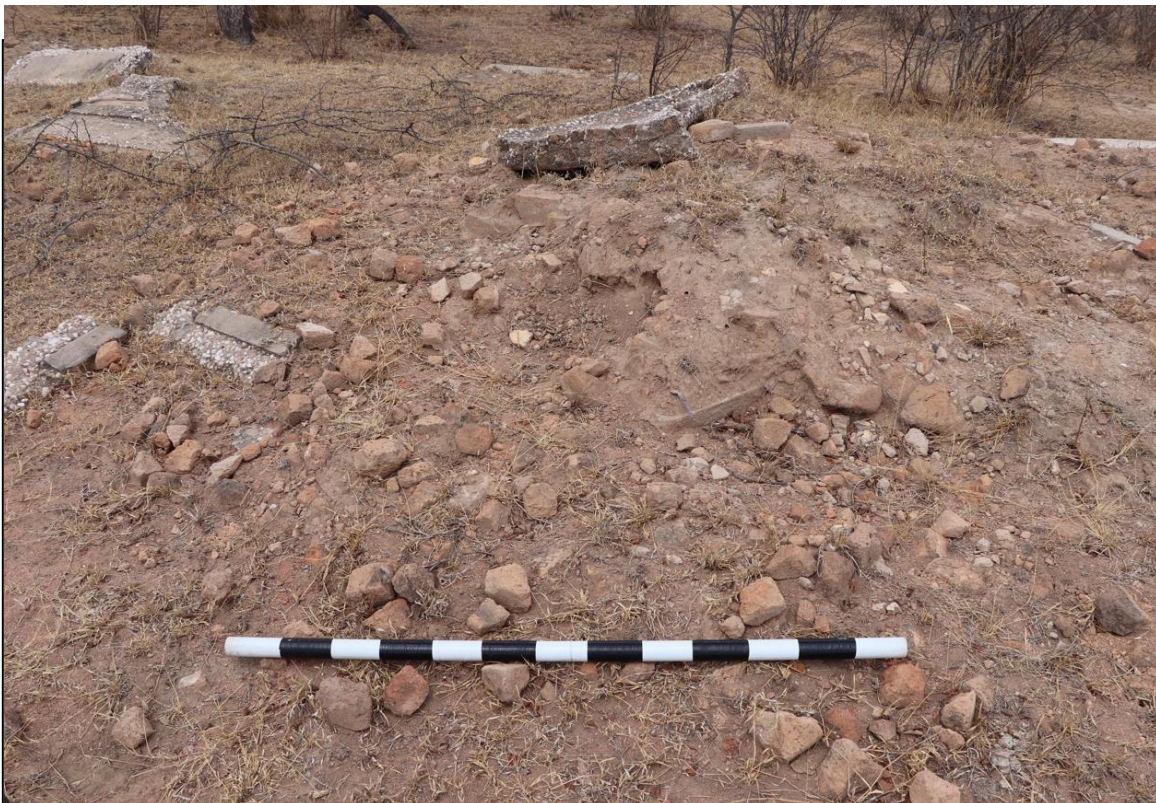
Figure 27 – This heap of bricks and collapsed walling was observed on the surface of the structure. The Scale is in 10cm increments.

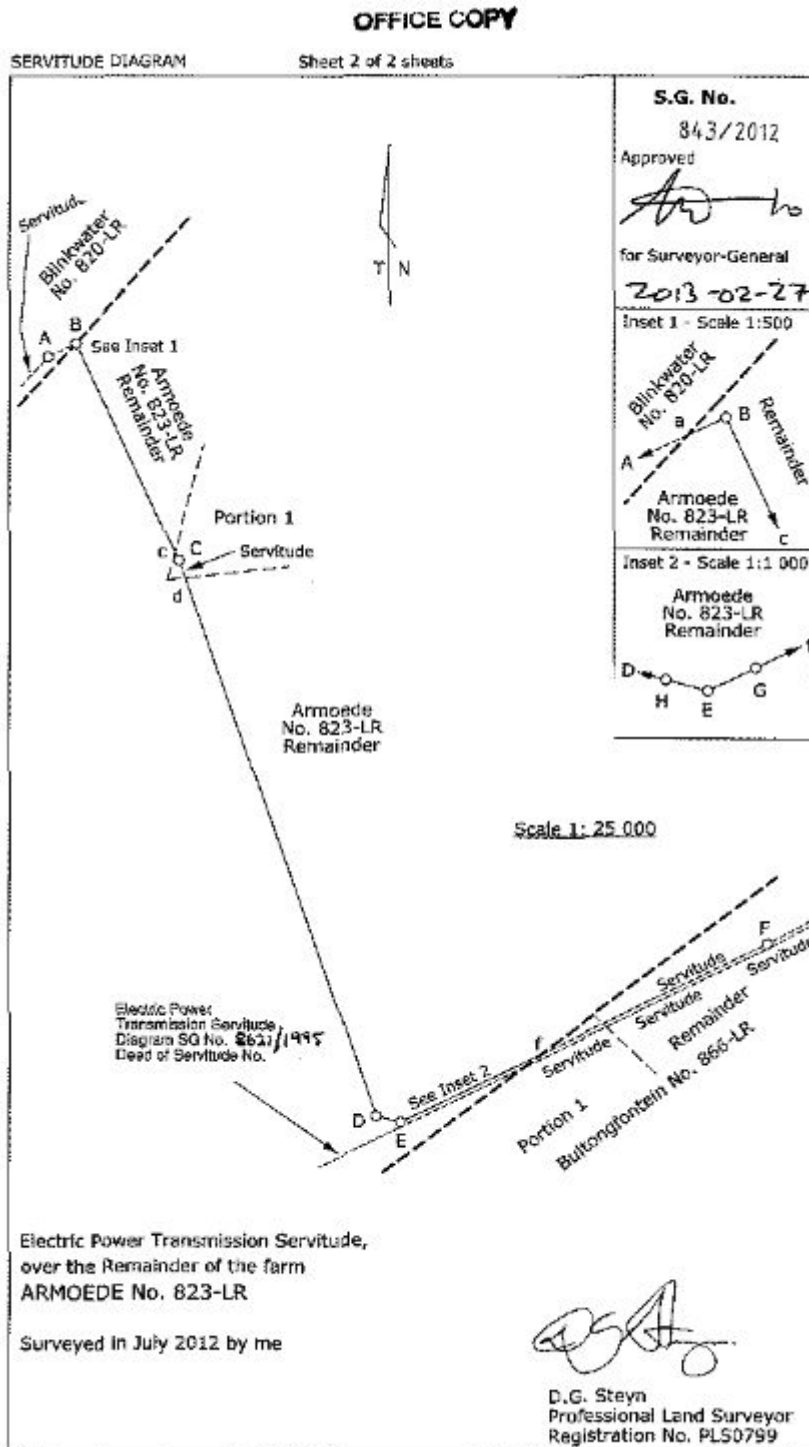
Figure 1. Armoede 823 LR Surveyors diagram

Again, this site is an isolated find with no known written records. The original surveyors' diagrams often indicated known structures such as homesteads, however none were indicated on the Armoede 832 LD diagram.

Although this survey was dated as 2013 they are usually redrawn from the original survey diagrams.

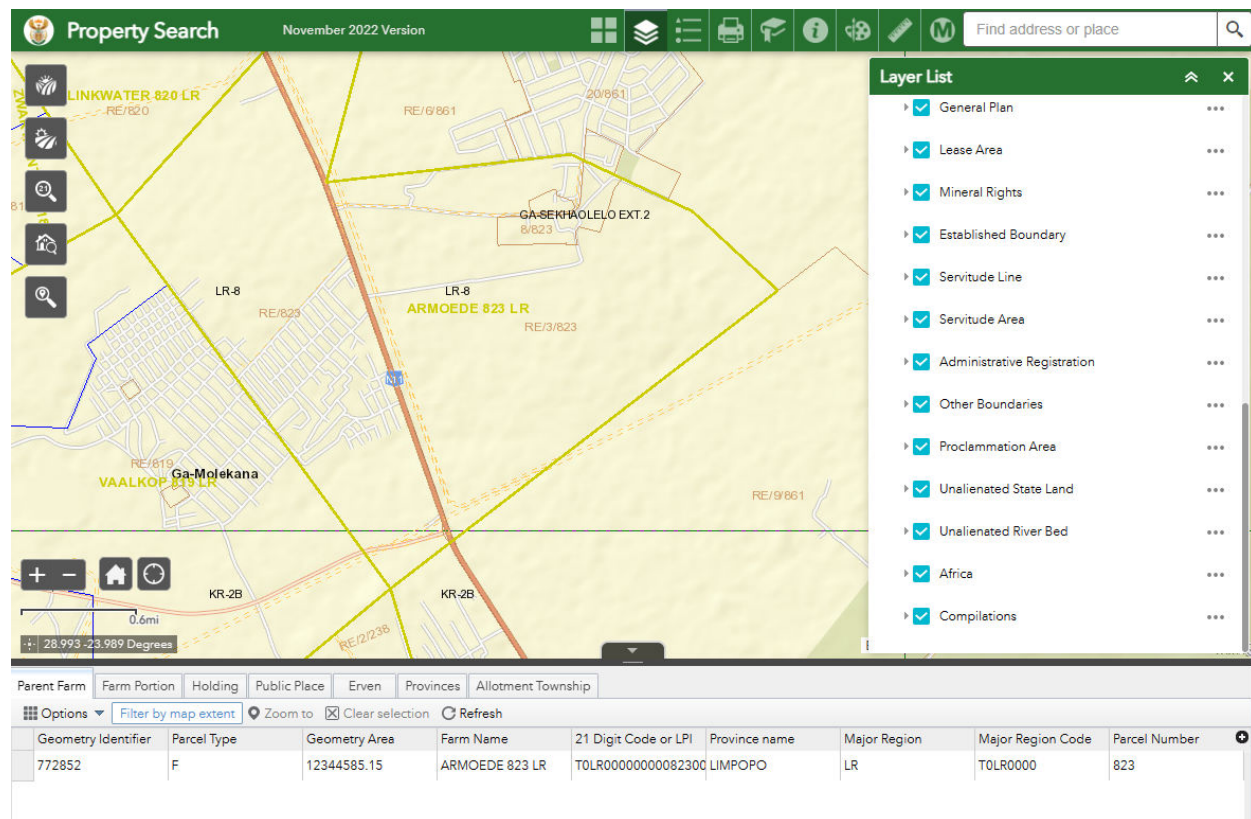
Figure 2. Surveyor General's Database for Armoede 823 LR

The Surveyor General's GIS database also does not indicate any homestead here.

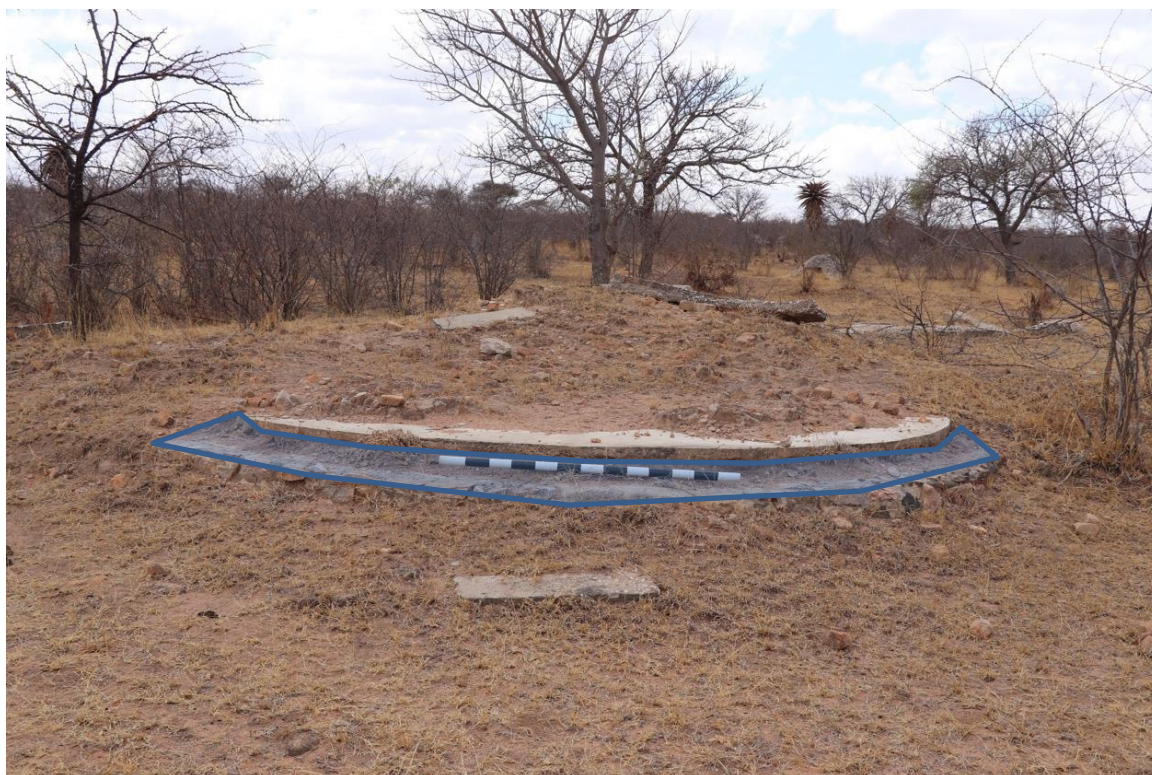
Figure 3. Wall foundations that are common in water reservoirs

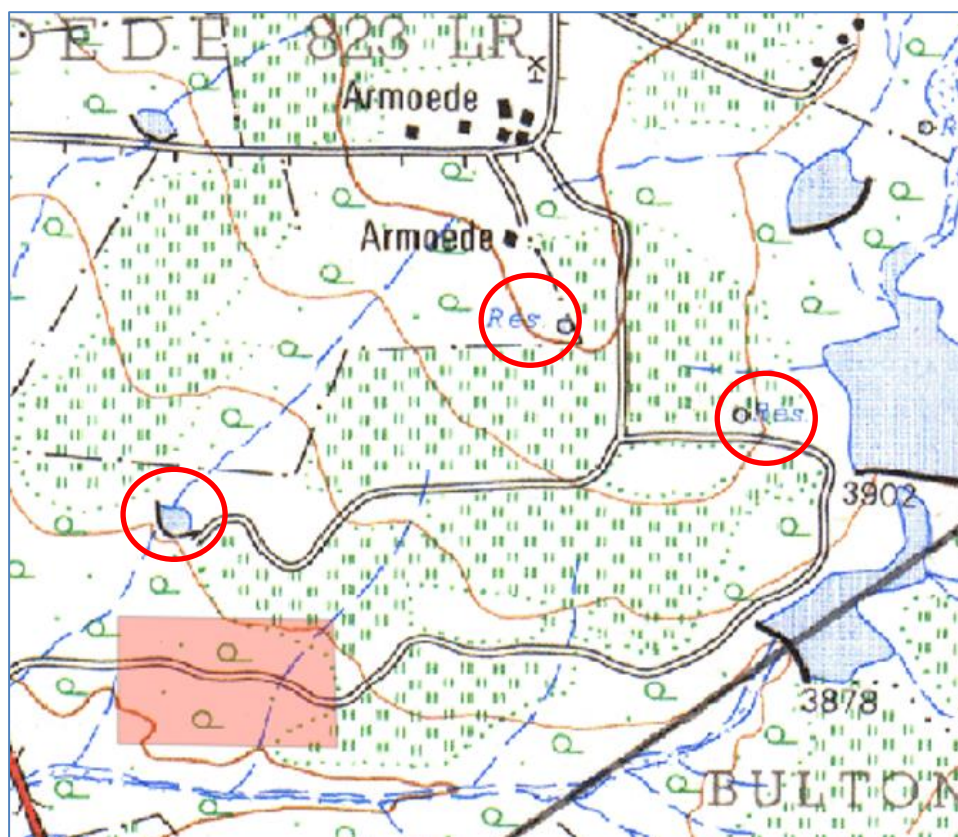
Figure 4. 1970 Map indicating several circular reservoirs within the general area

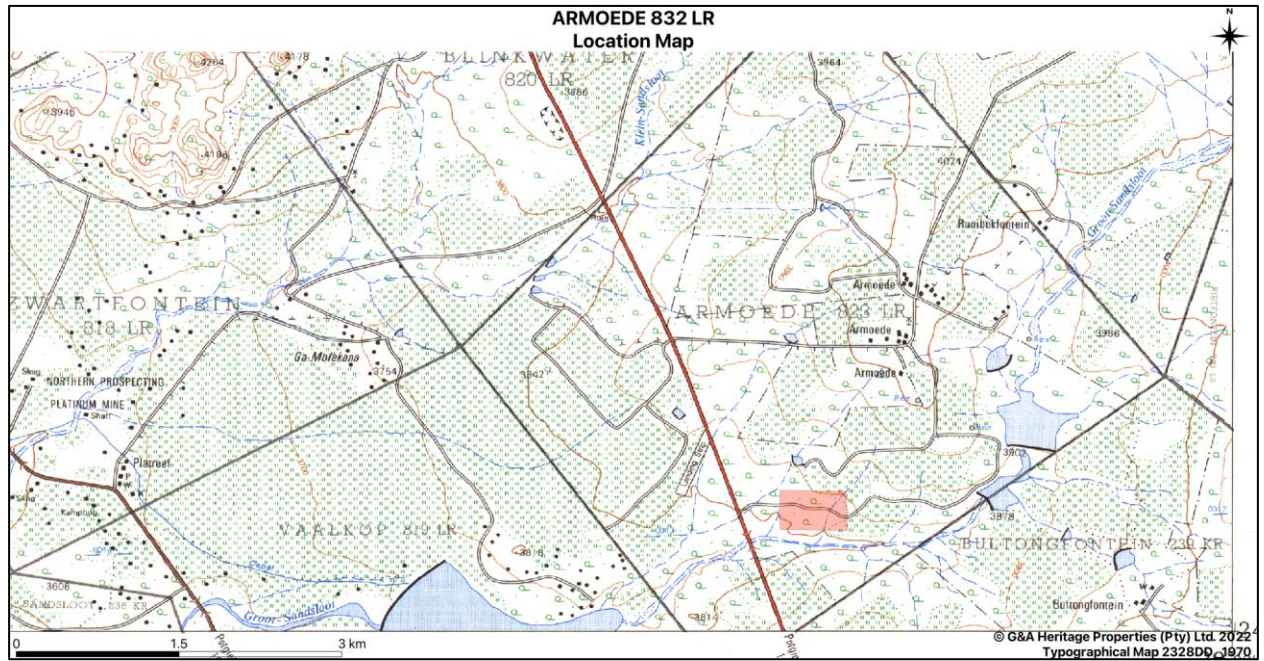
Figure 5. 1970's

None of the above maps indicate either the burial site or a formal homestead structure.
